Fuel Contamination can still pose a Risk

**Presented by
Captain Victor Liu
Hong Kong Civil Aviation Department (HKCAD)**

Introduction

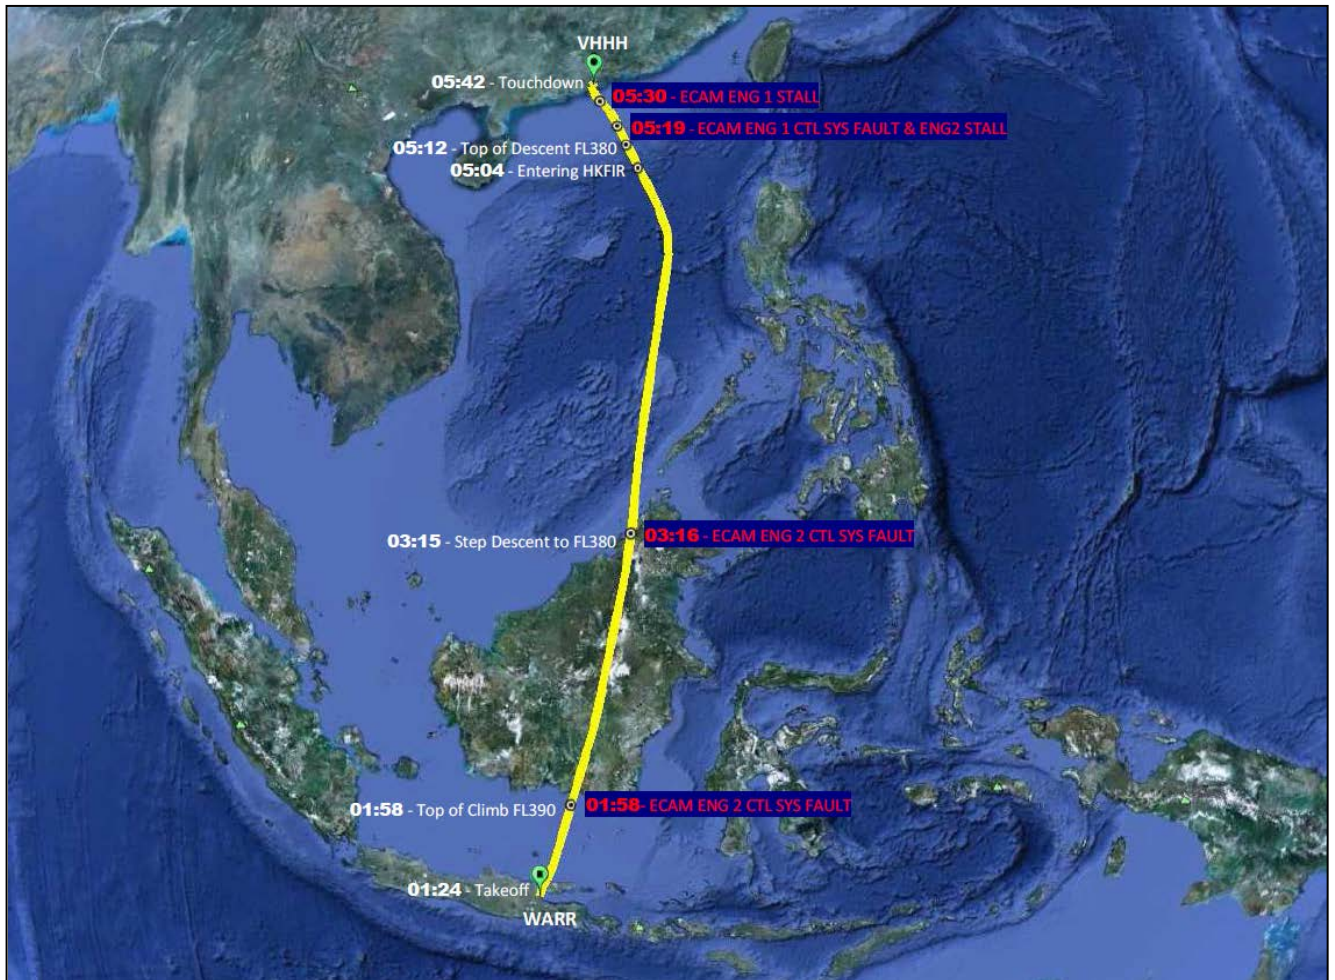
On 13 April 2010, the flight crew of an Airbus A330 aircraft from Juanda International Airport (WARR), Surabaya, Indonesia to Hong Kong International Airport (VHHH) declared "MAYDAY" when approaching VHHH. The aircraft experienced control problem on both engines. The aircraft landed at a groundspeed of 231 knots, with No.1 engine stuck at about 70% N1 and No.2 engine stuck at about 17% N1. Five main tyres were deflated after the aircraft came to a complete stop on the runway. After being advised by the rescue leader that there was fire and smoke on the wheels, the aircraft commander initiated an emergency evacuation of passengers. Some passengers and cabin crew were injured during the evacuation.

Figure 1 – Event Details of the flight from WARR to VHHH

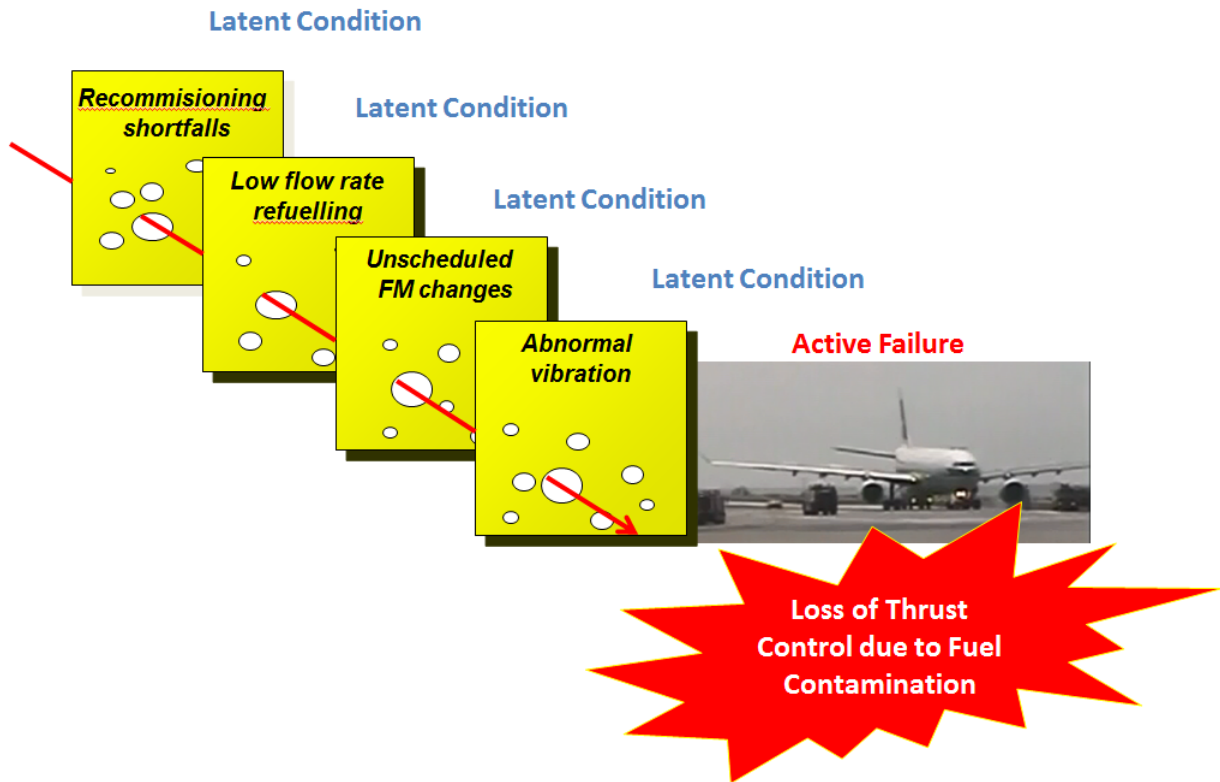
6. There were a series of events and contributing factors leading to penetration of all the safety layers and the formation of such a “perfect storm”, i.e. the uplifting of contaminated fuel to the aircraft.

Figure 4 – The Swiss-Cheese Model in Safety Management System
