# A340 Tailstrike Melbourne Airport

Is good airmanship enough for gross error detection?

**AO-2009-012 A6-ERG Tail-strike and Runway Overrun, Melbourne Airport**

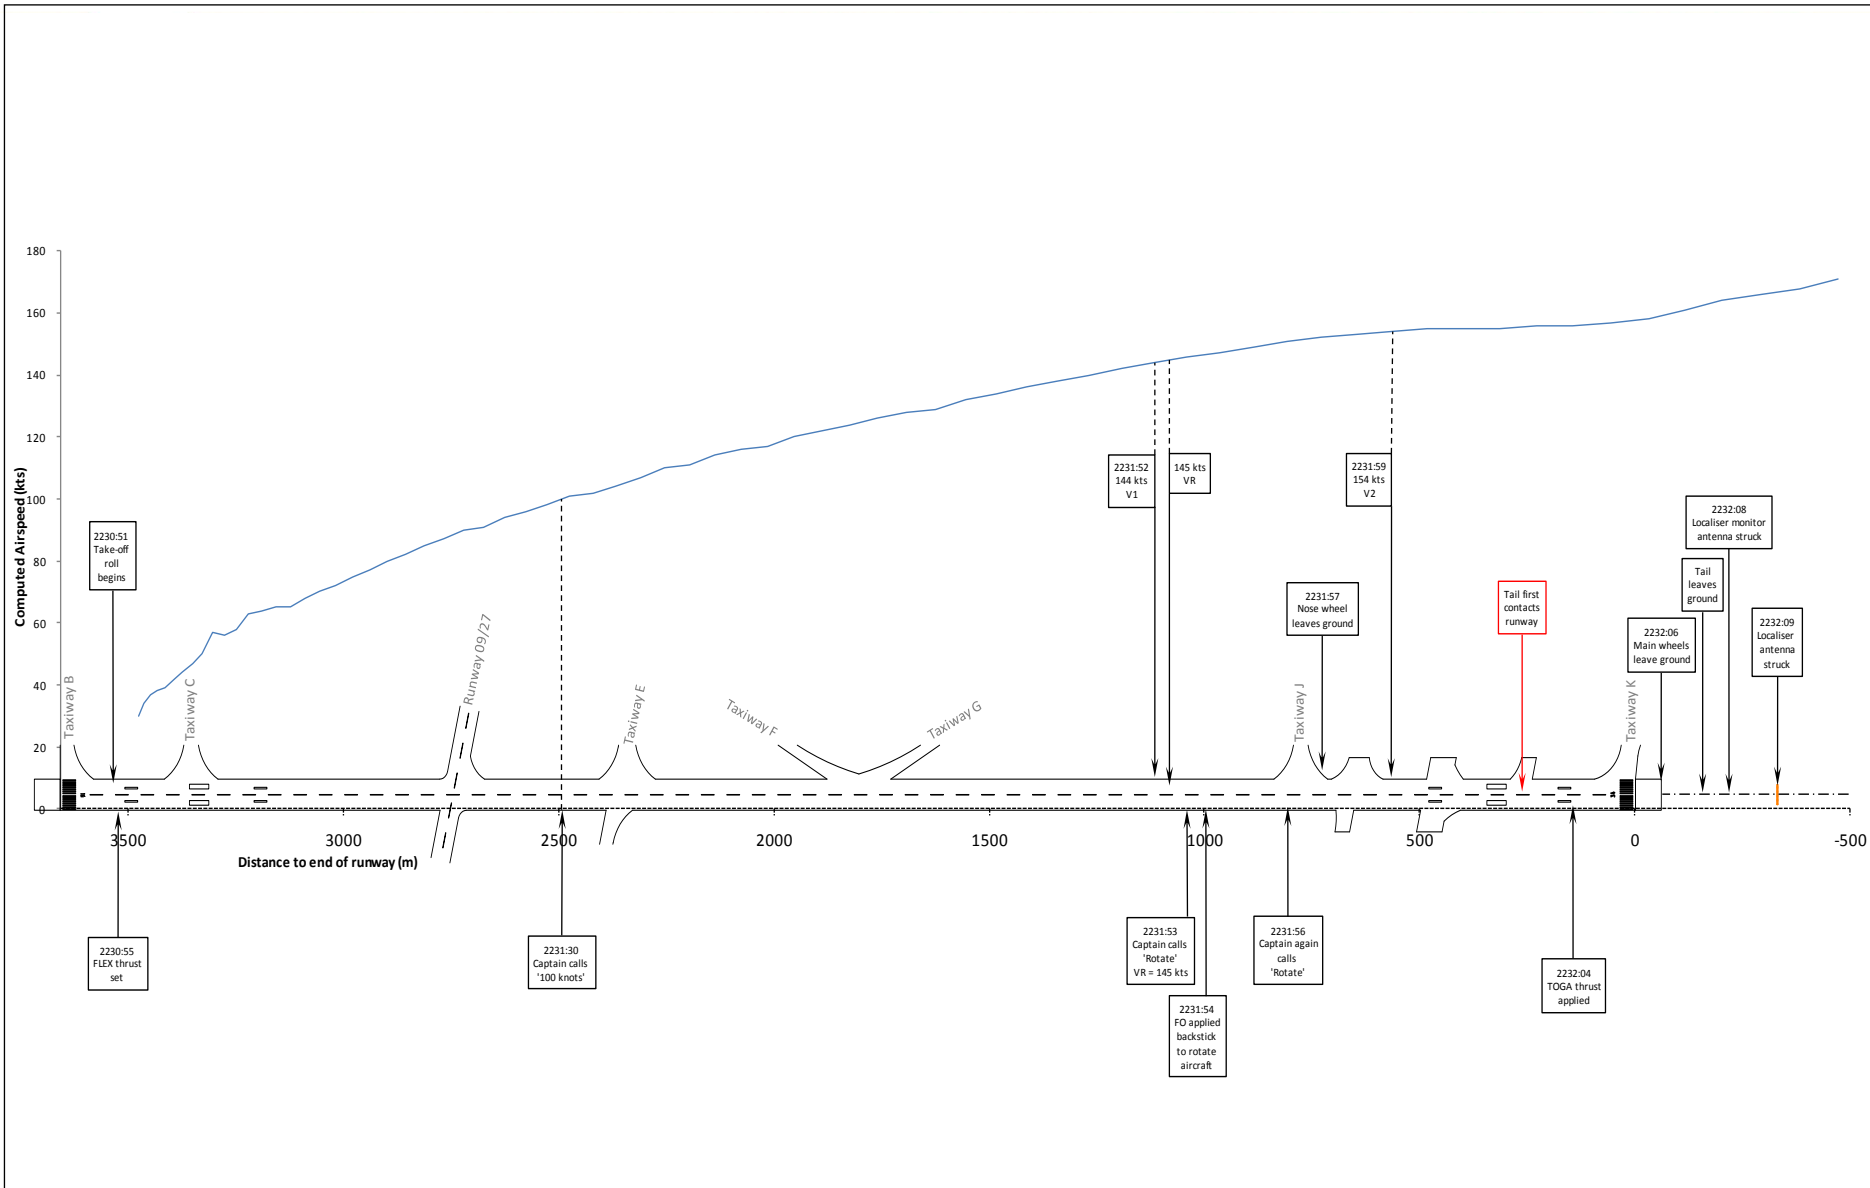
V <sub>1</sub>		V <sub>R</sub>		V <sub>LOF</sub>		V <sub>2</sub>	
	Speed	Dist	Speed	Dist	Speed	Dist	Speed	Dist
<b>Expected</b>	149	1,710	161	2,065	174	2,540	173	2,470
<b>Actual</b>	144	2,418	145	2,496	161	3,652	154	2,973

- Erroneous performance figures resulted in:
  - Over-rotation and tailstrike (low  $V_R$  and flap setting)
  - Long take-off roll and runway overrun (low thrust setting)
- Erroneous TOW entry likely due to ‘finger trouble’
- Erroneous take-off weight in performance calculations not detected (opportunities missed)
  - Non-adherence to standard operating procedures
  - Captain’s check of EFB (task interruption)
  - FO read correct weight during loadsheet check
  - FO changed flight plan without investigation
  - Green dot speed check (2 occasions)
