The Australian Transport Safety Bureau

AIRCRAFT AVIONICS WIRING & ELECTRICAL SYSTEMS

TWA 800
230
LIVES LOST

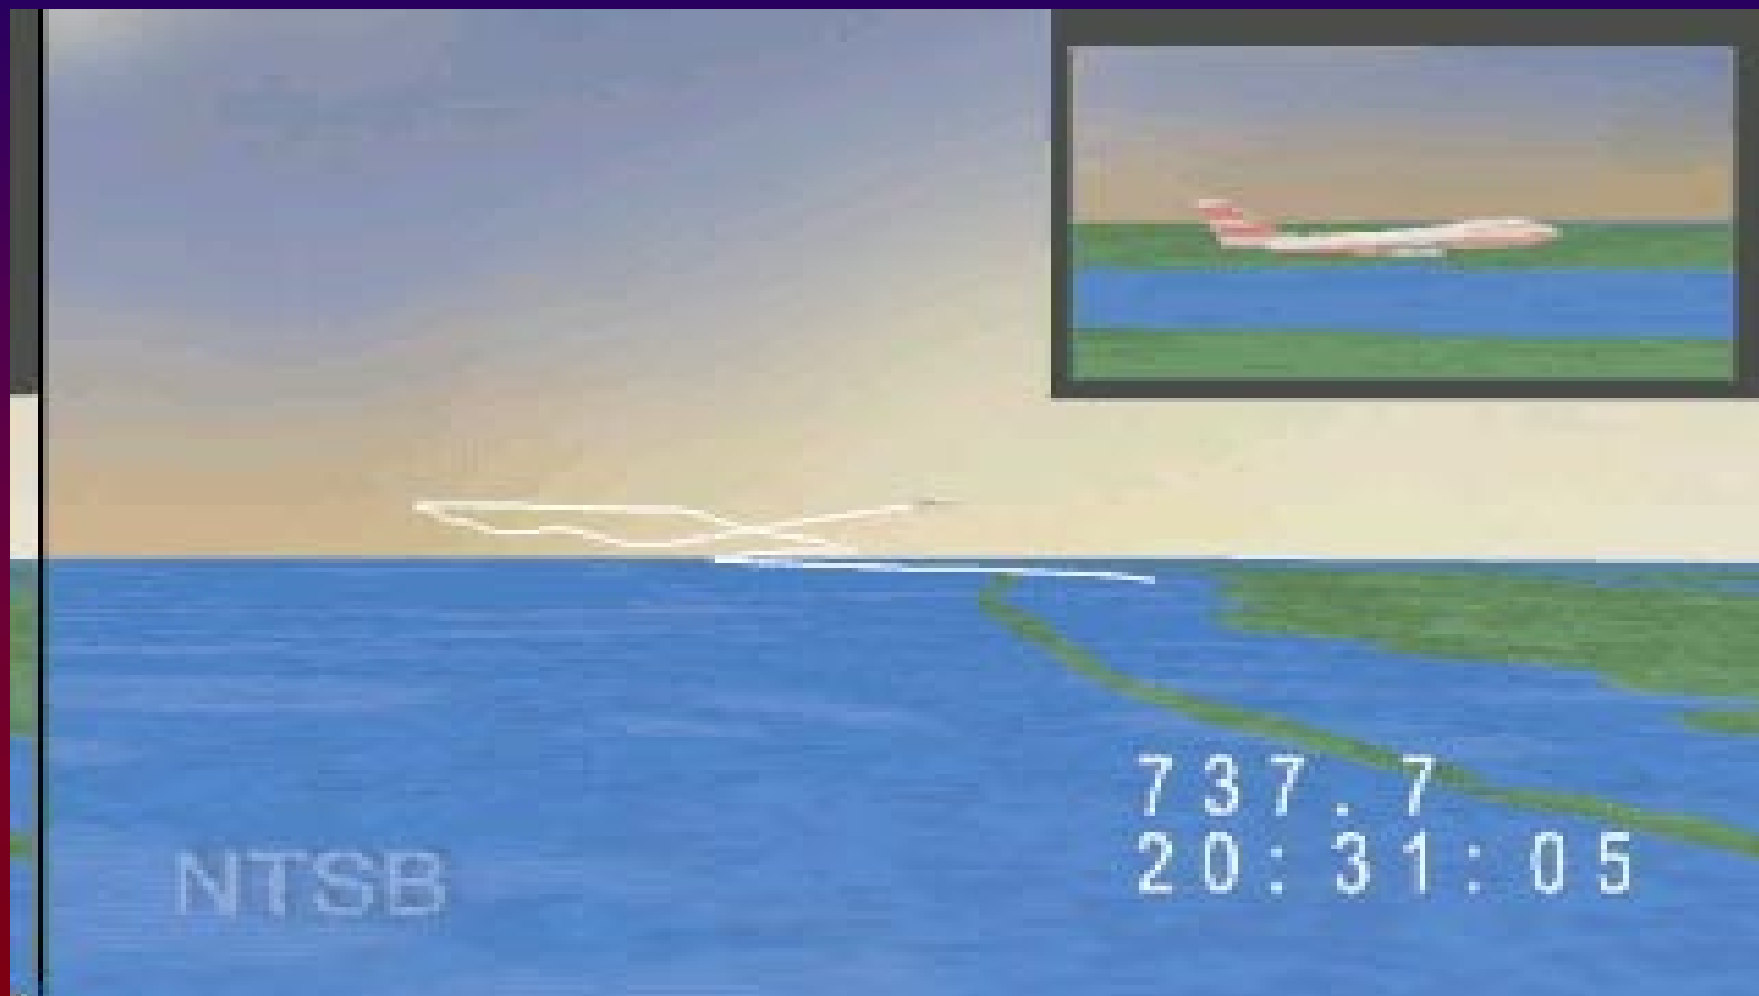
CENTRE WING TANK

-
- 1. HOT DAY WITH DELAYS
ON TAKE OFF***
 - 2. LOW FUEL QUANTITY IN
CENTRE WING TANK***
-

***3. HEATING OF THE LOW
QUANTITY OF FUEL BY THE AIR
CONDITIONER PACKS
LOCATED UNDER THE CENTRE
WING TANK, CREATING A
VOLATILE FUEL AIR MIXTURE.***

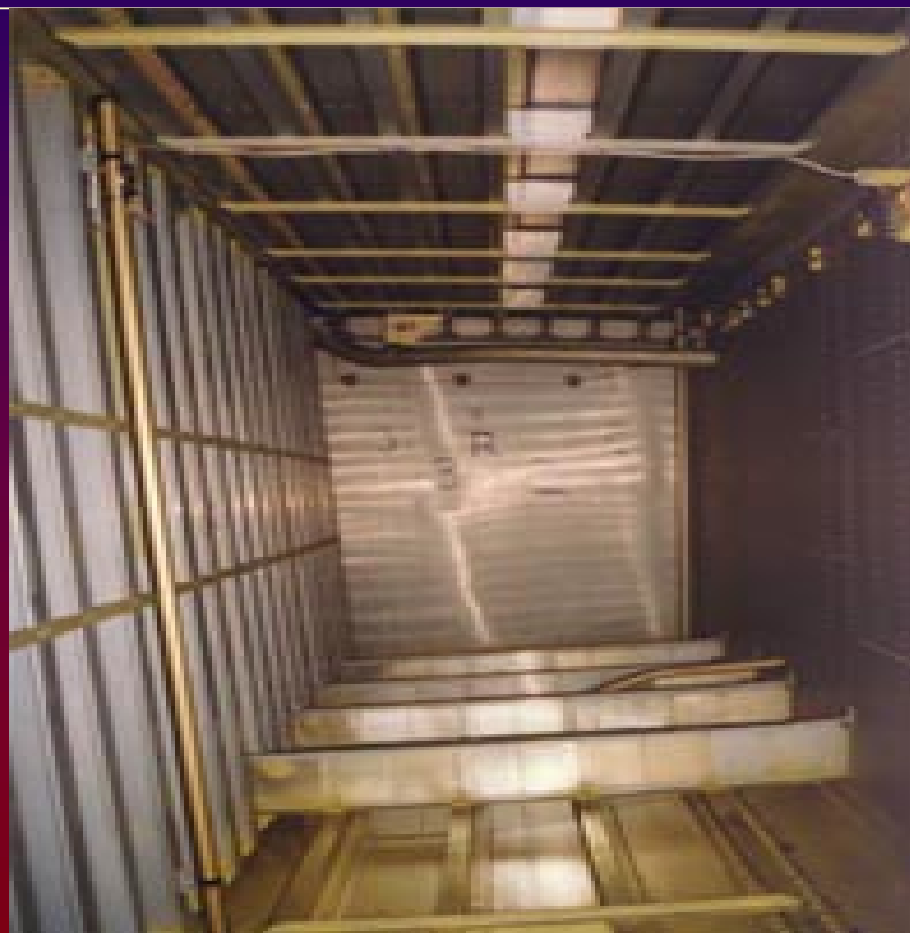
FUEL QUANTITY PROBE

***ALLOWING EXCESSIVE
VOLTAGE TO ENTER THE
CENTRE WING TANK
THROUGH ELECTRICAL
WIRING ASSOCIATED WITH
THE FUEL QUANTITY
INDICATION SYSTEM (fuel probe)***

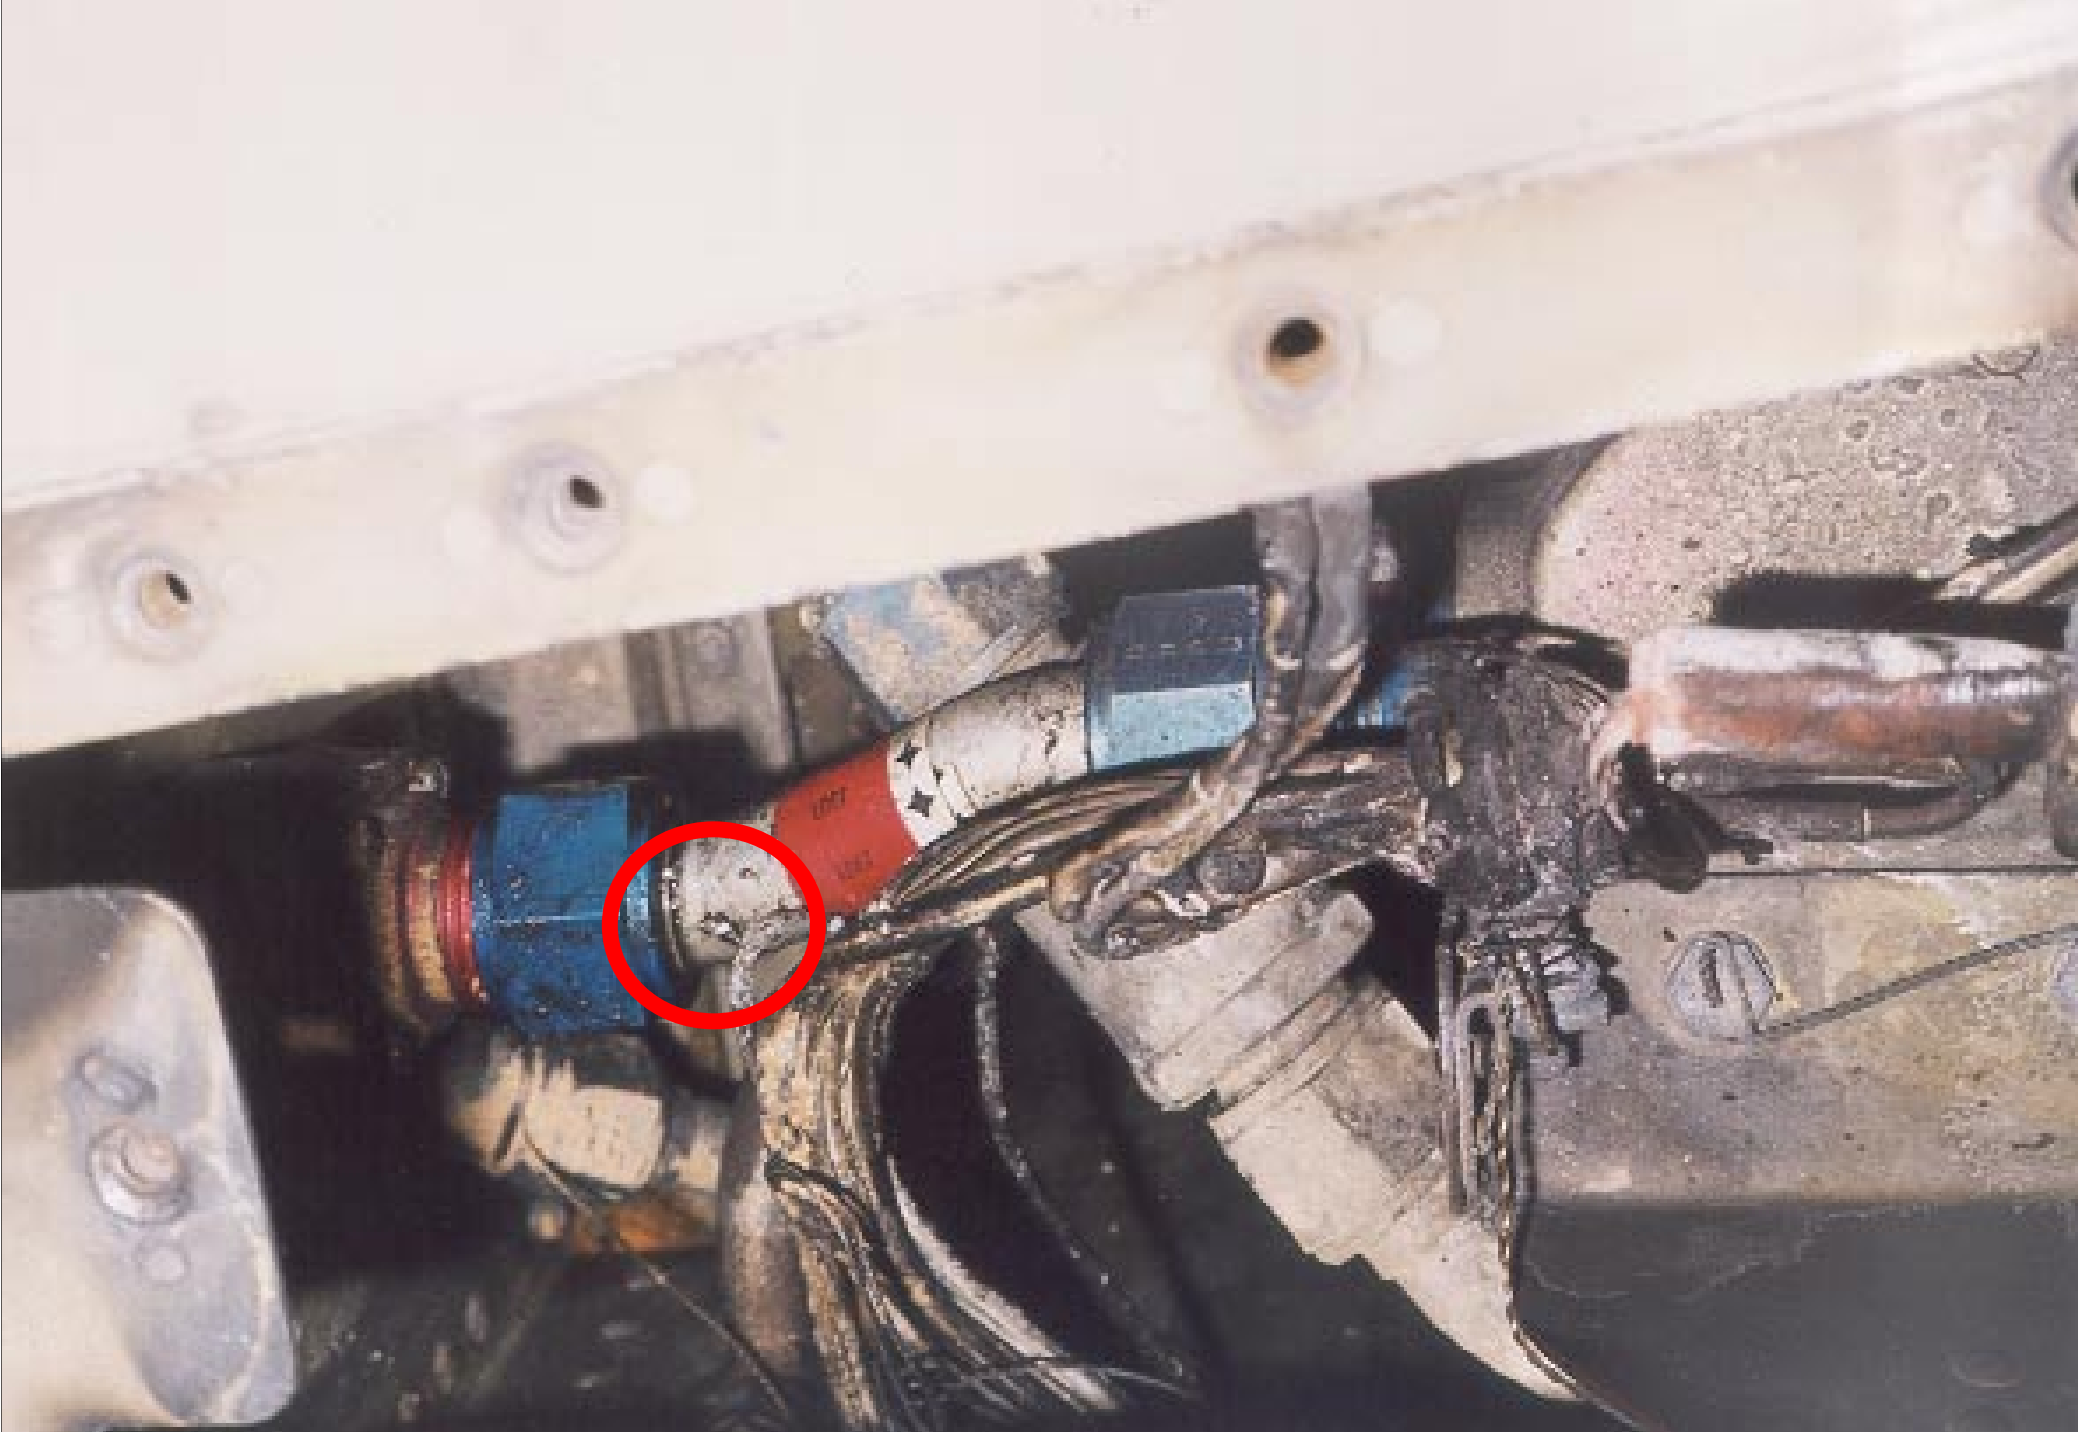
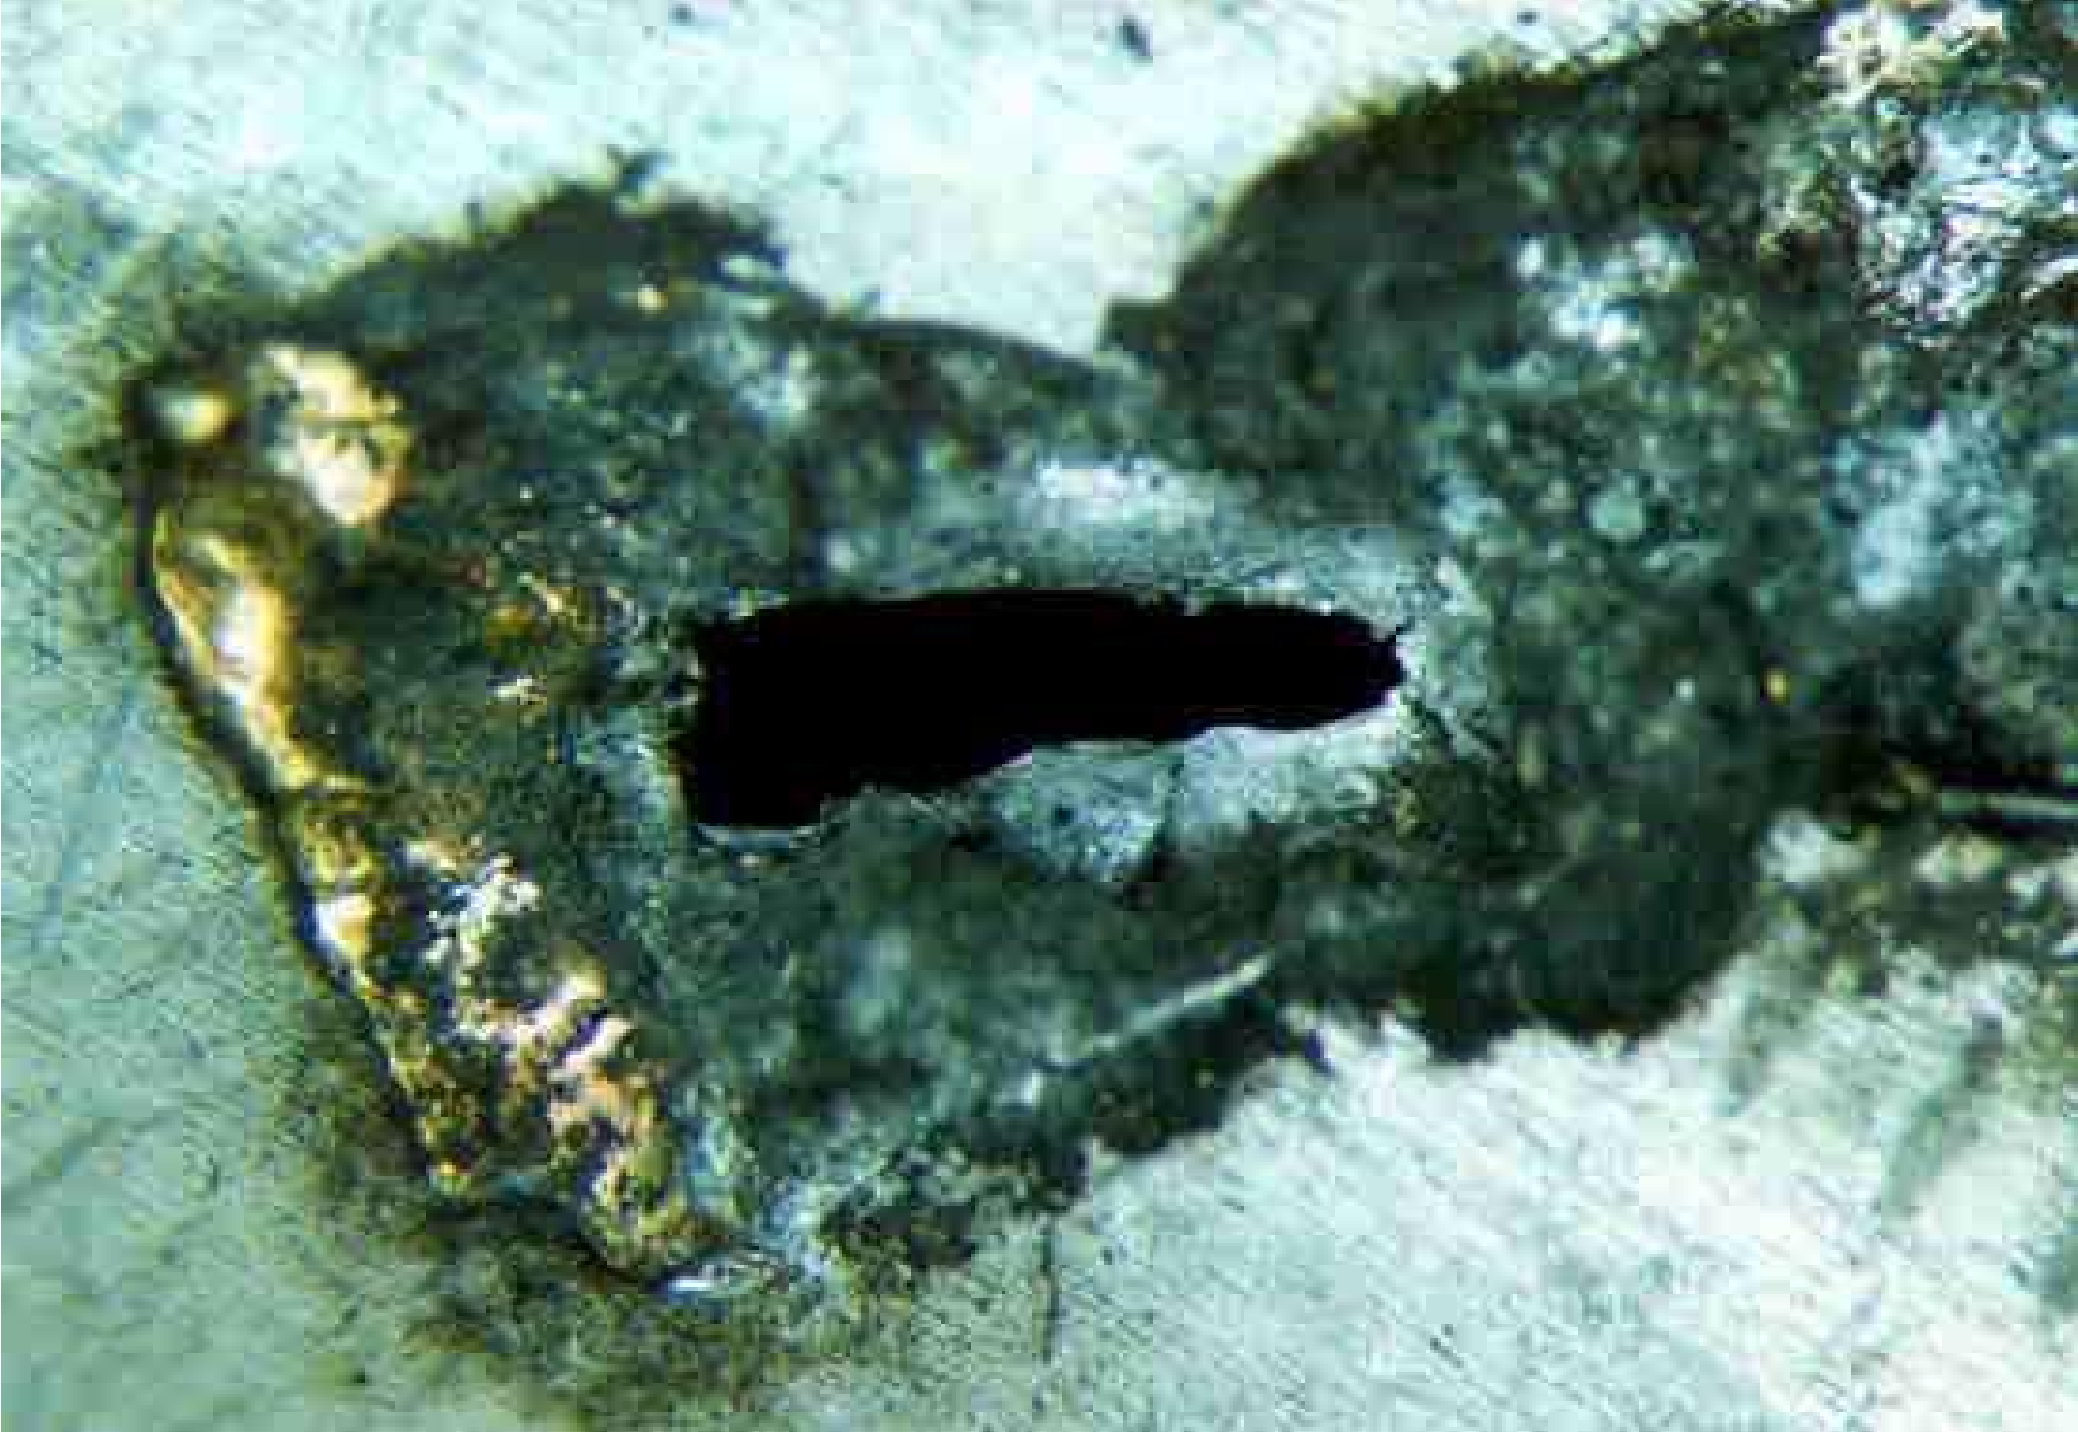
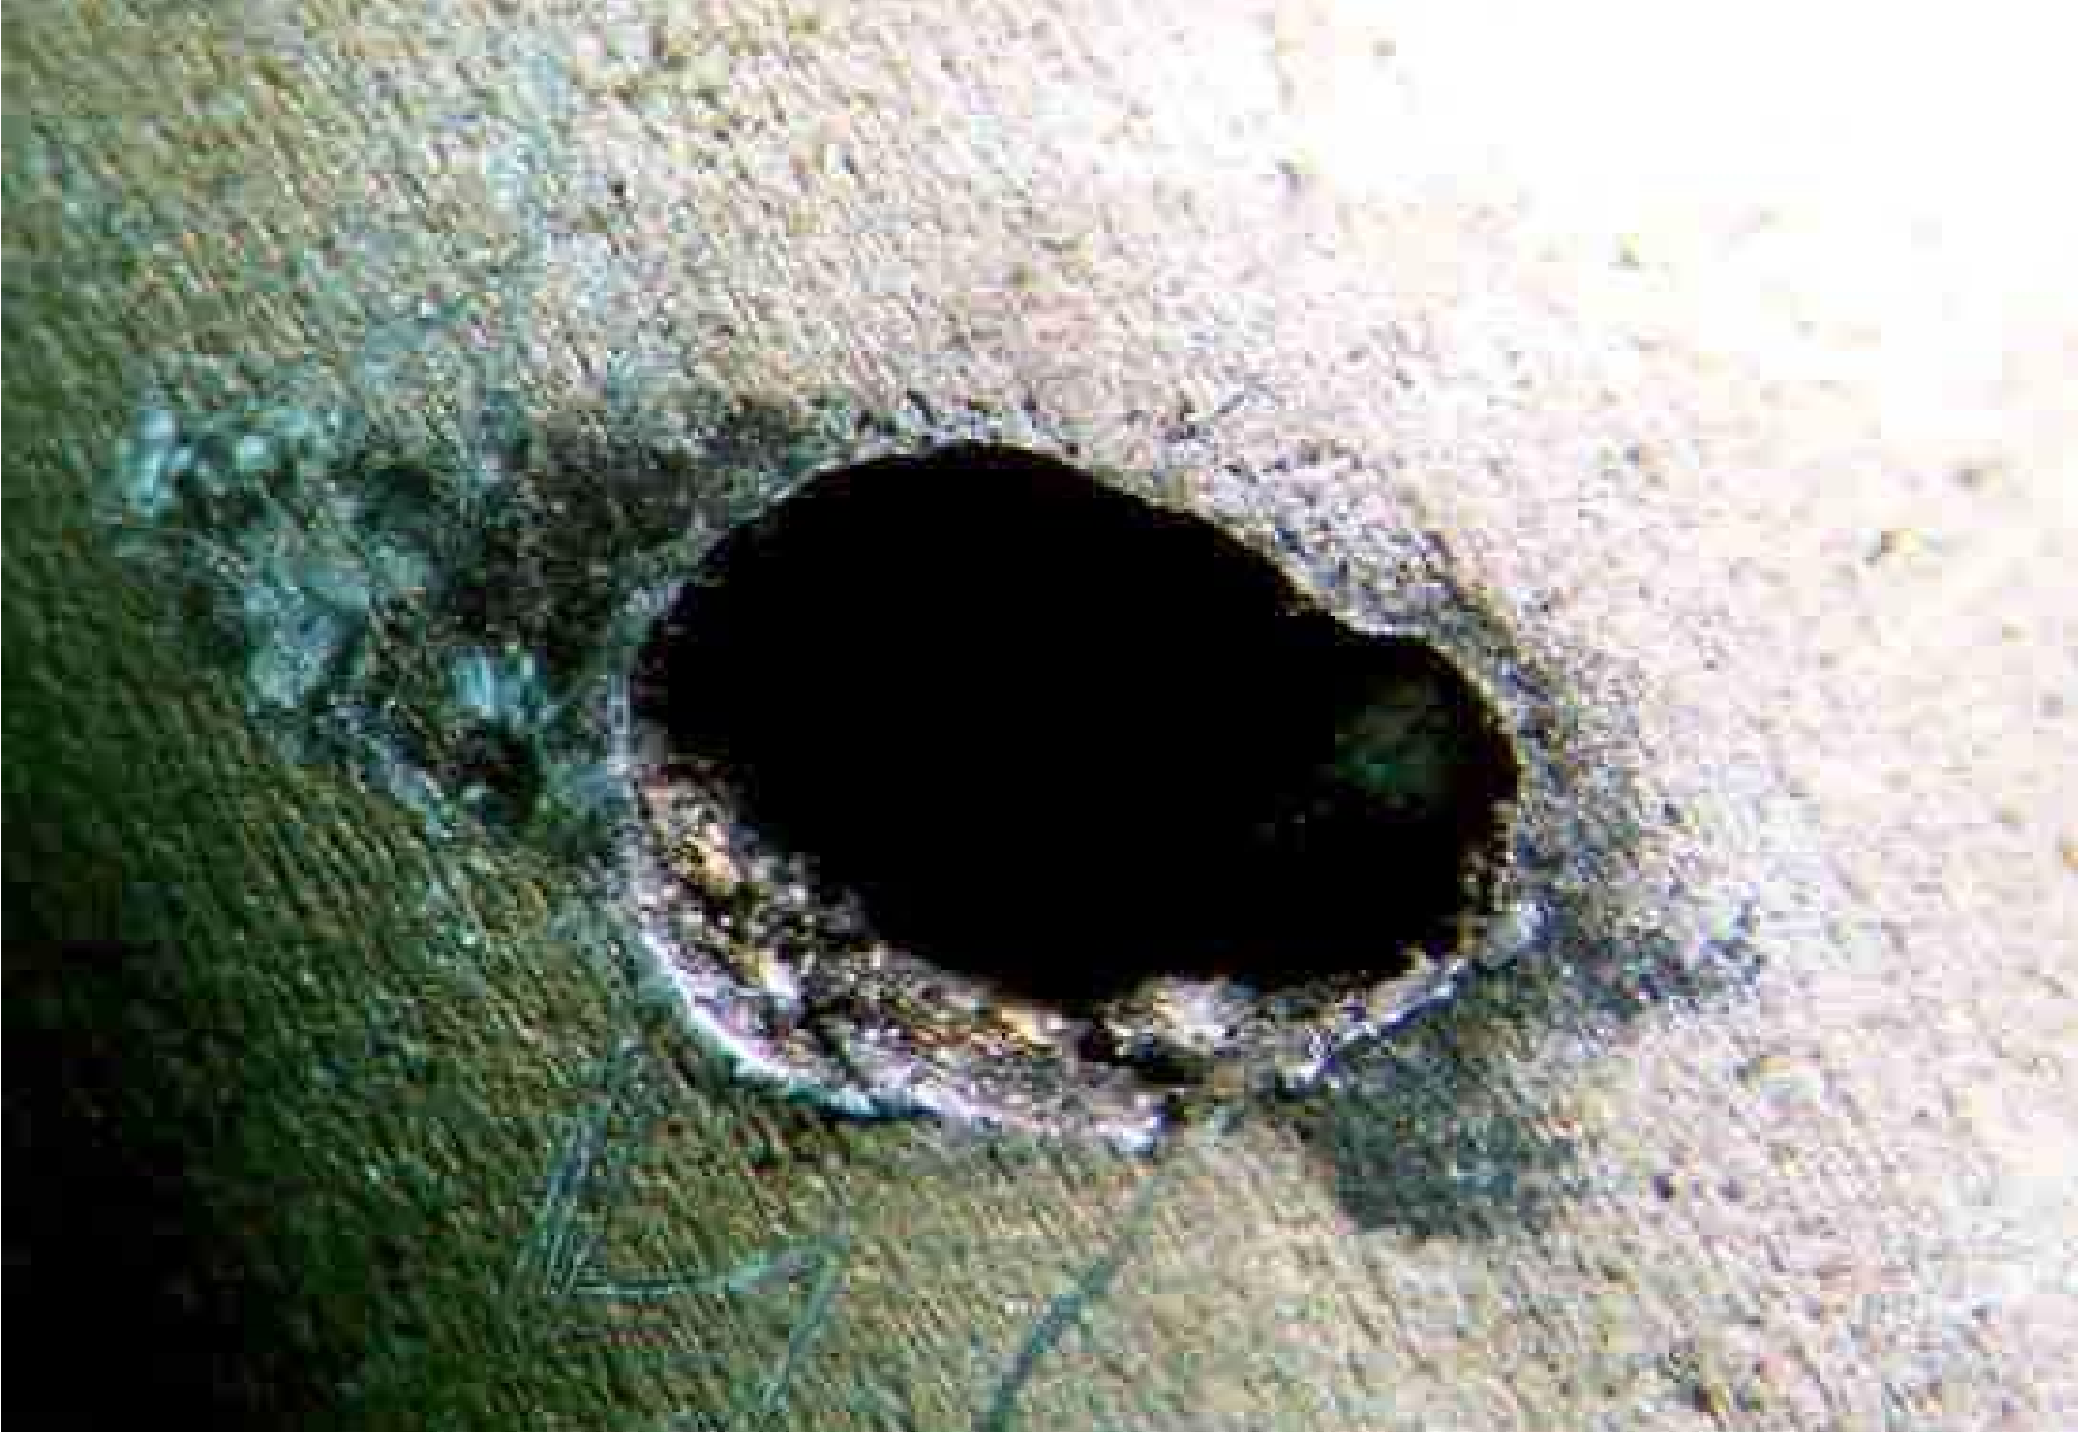
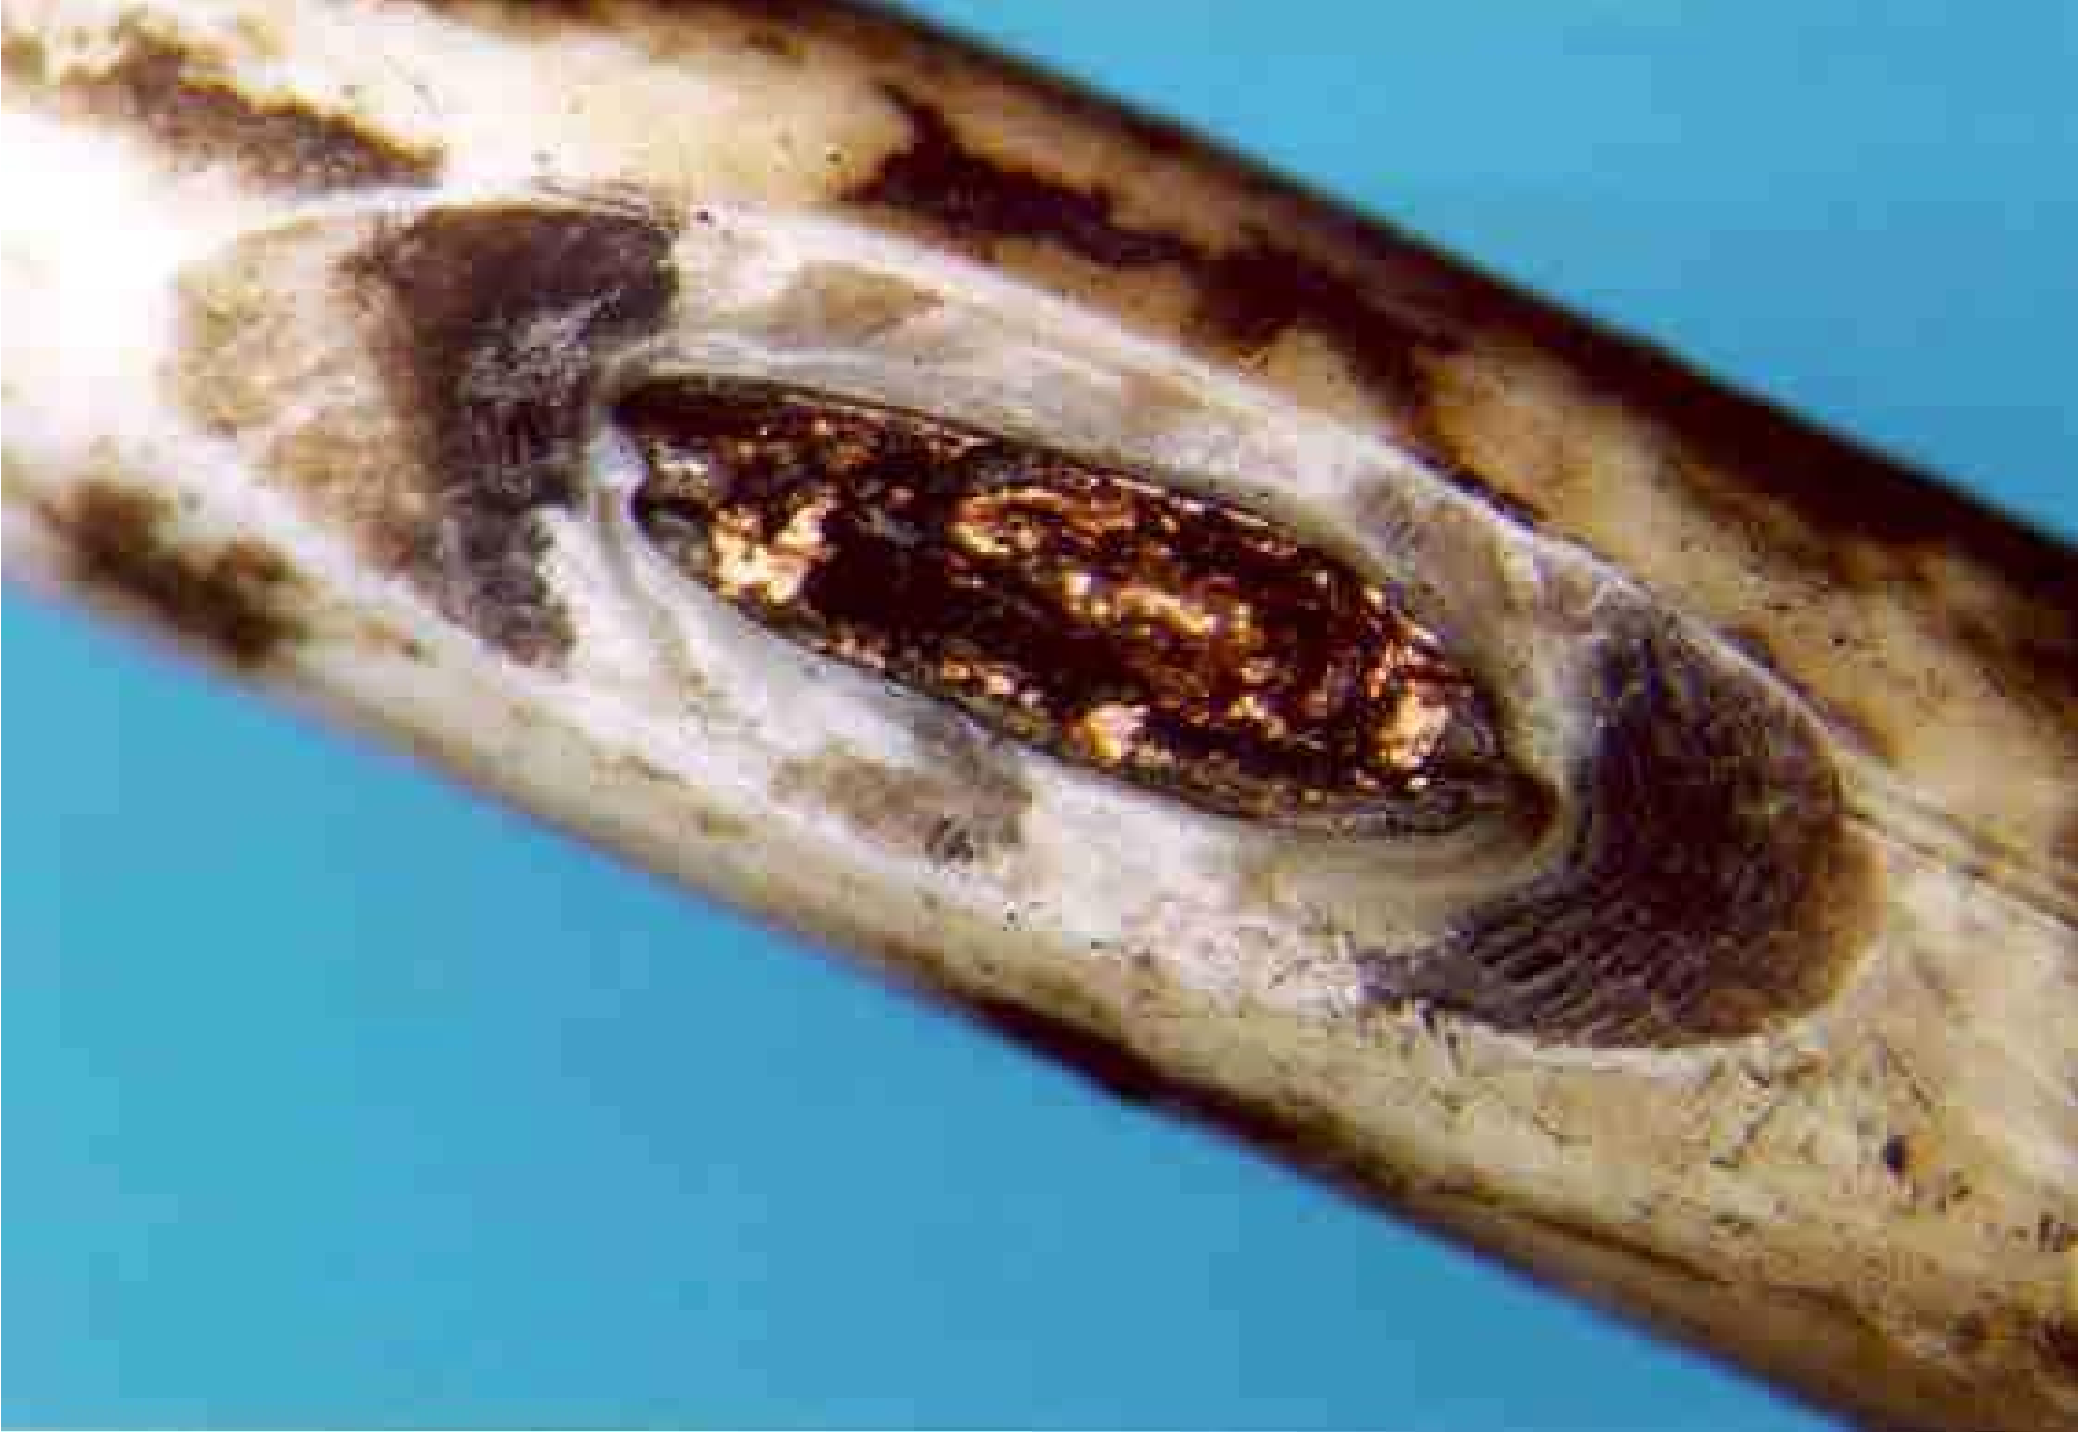
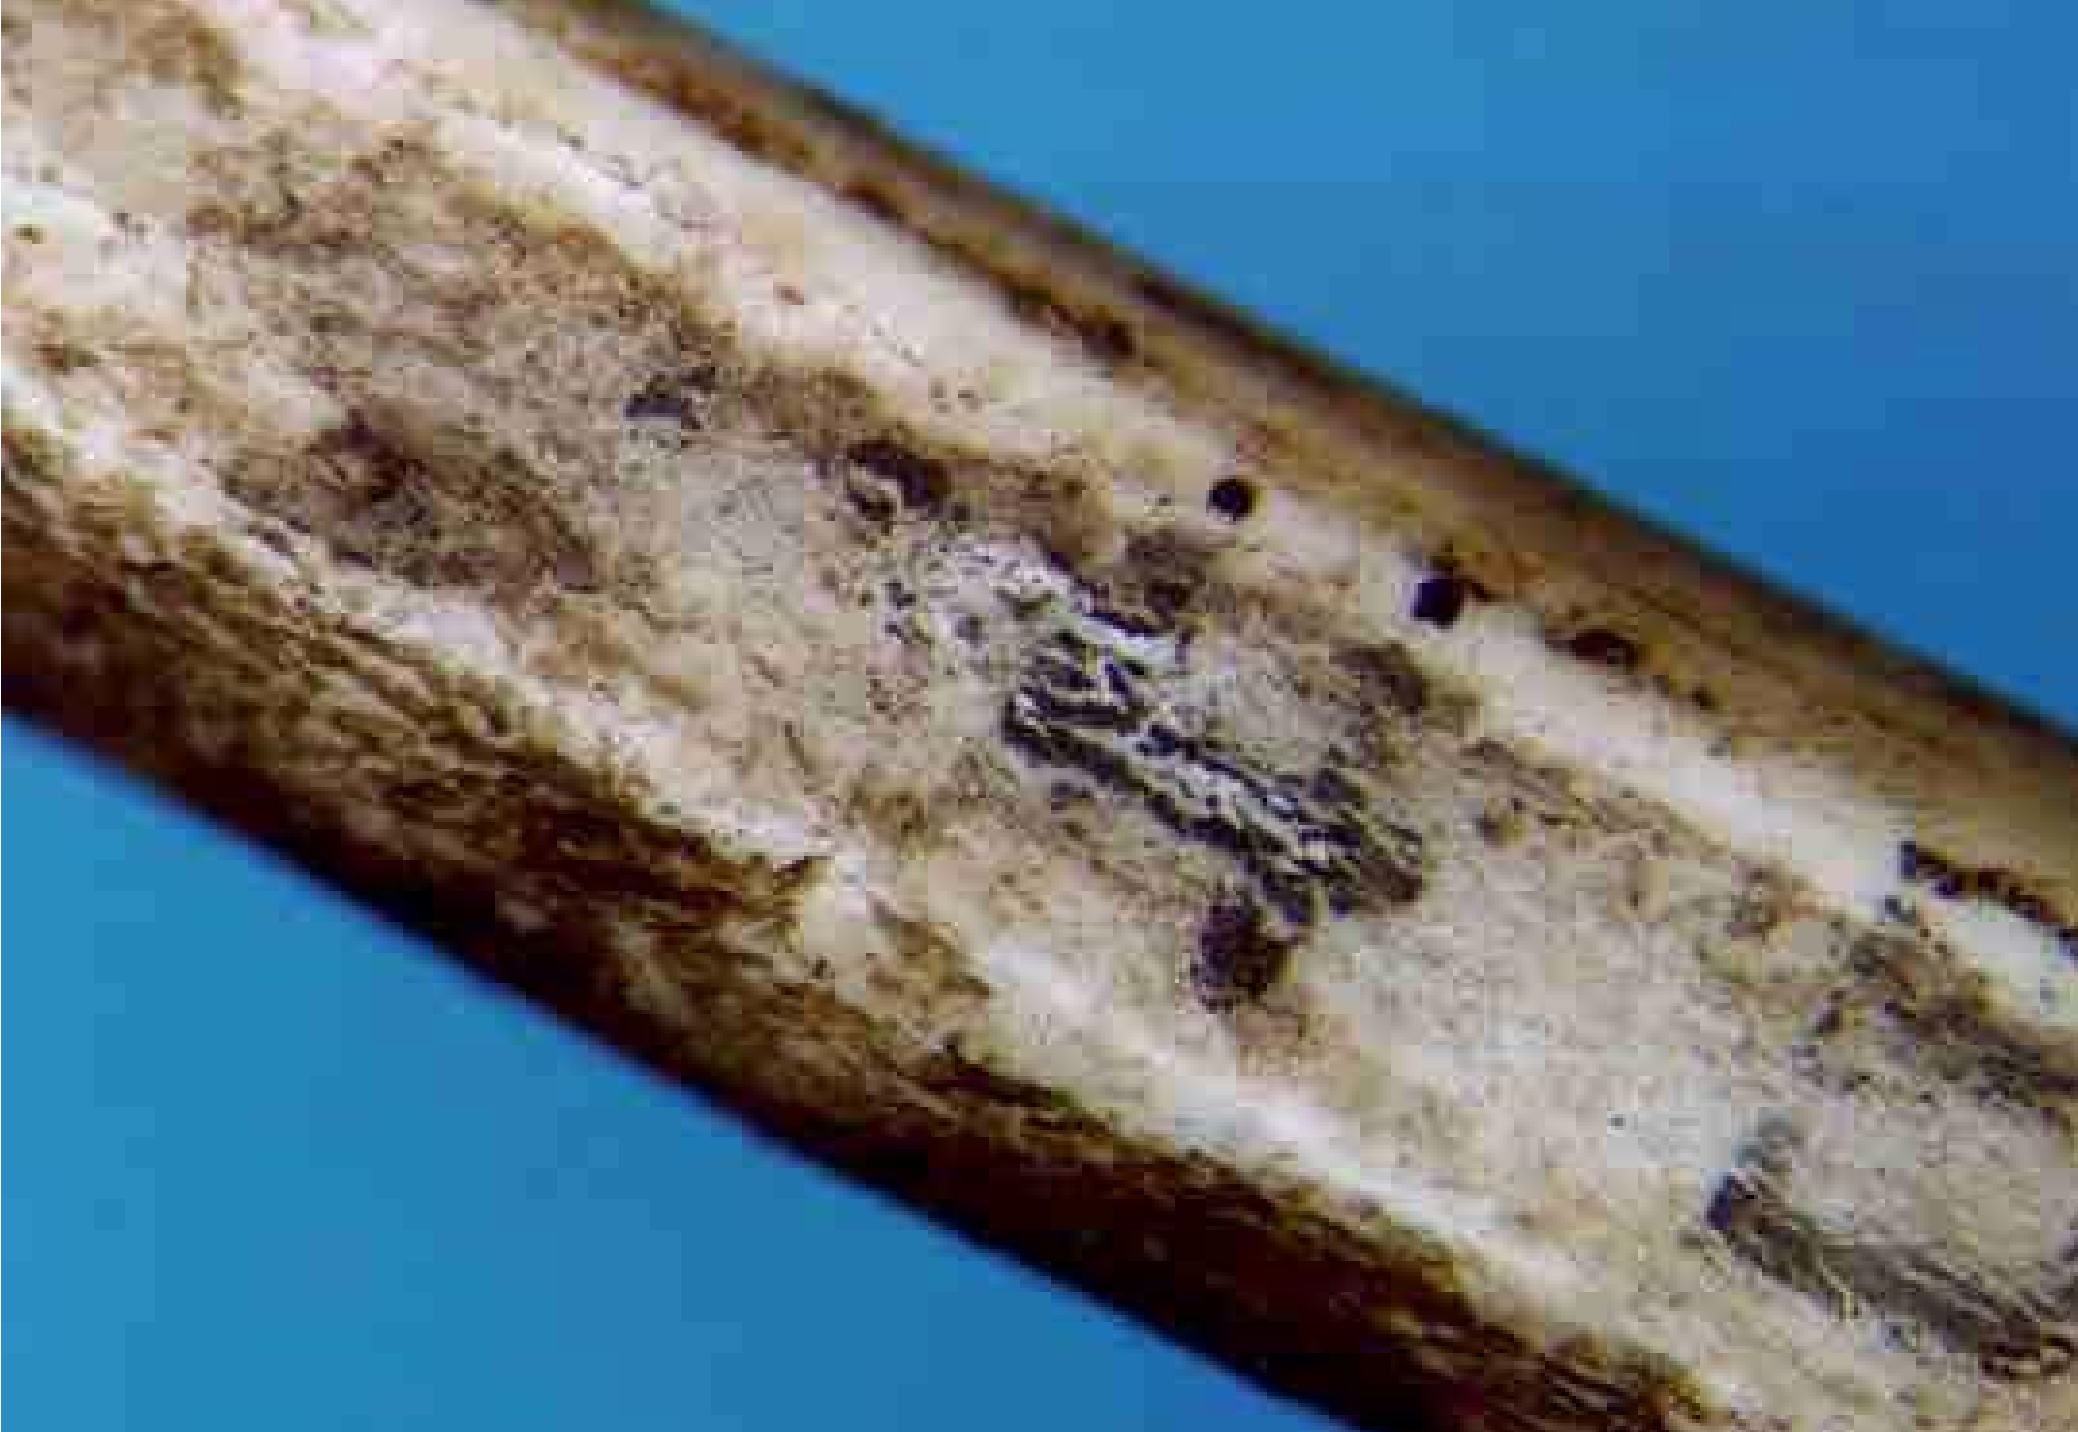
***FUEL TO THE FIRE HAD BEEN
SUPPLIED FROM TWO
DAMAGED ALUMINIUM ALLOY
FUEL TANK LINES IN THE
RIGHT WING EQUIPMENT BAY***

***THE AIRCRAFT INVOLVED IN
THIS ACCIDENT HAD BEEN
REPAIRED PRIOR TO THE
ACCIDENT AND THE
CORRECT WIRING STAND -
OFFS WERE NOT INSTALLED***
