Breakdown of separation B737 / WW24, 22 km S Williamtown, NSW 1 February 2011

Presented by
Samantha Moran
Senior Transport Safety Investigator

Breakdown of separation 22 km S Williamstown (Newcastle Airport), NSW 1 February 2011

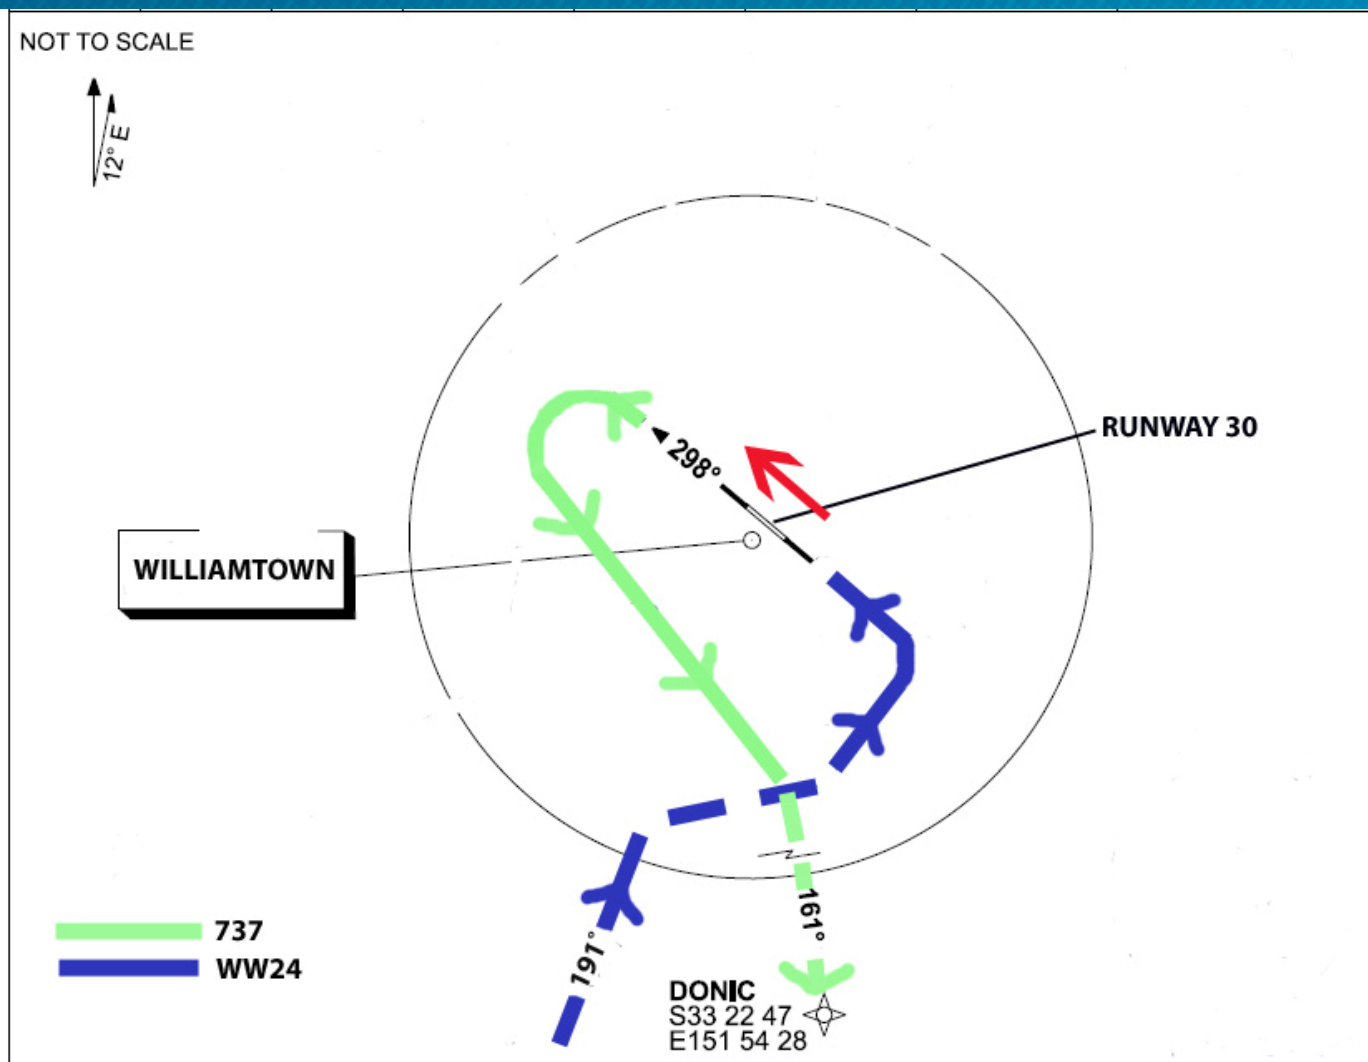
WW24 inbound from Nowra, NSW, assigned non-standard 5,000 ft visual by Approach High

B737 taxis at Williamtown for Melbourne, assigned 5,000 ft by Approach Low

LOSA between B737 and WW24

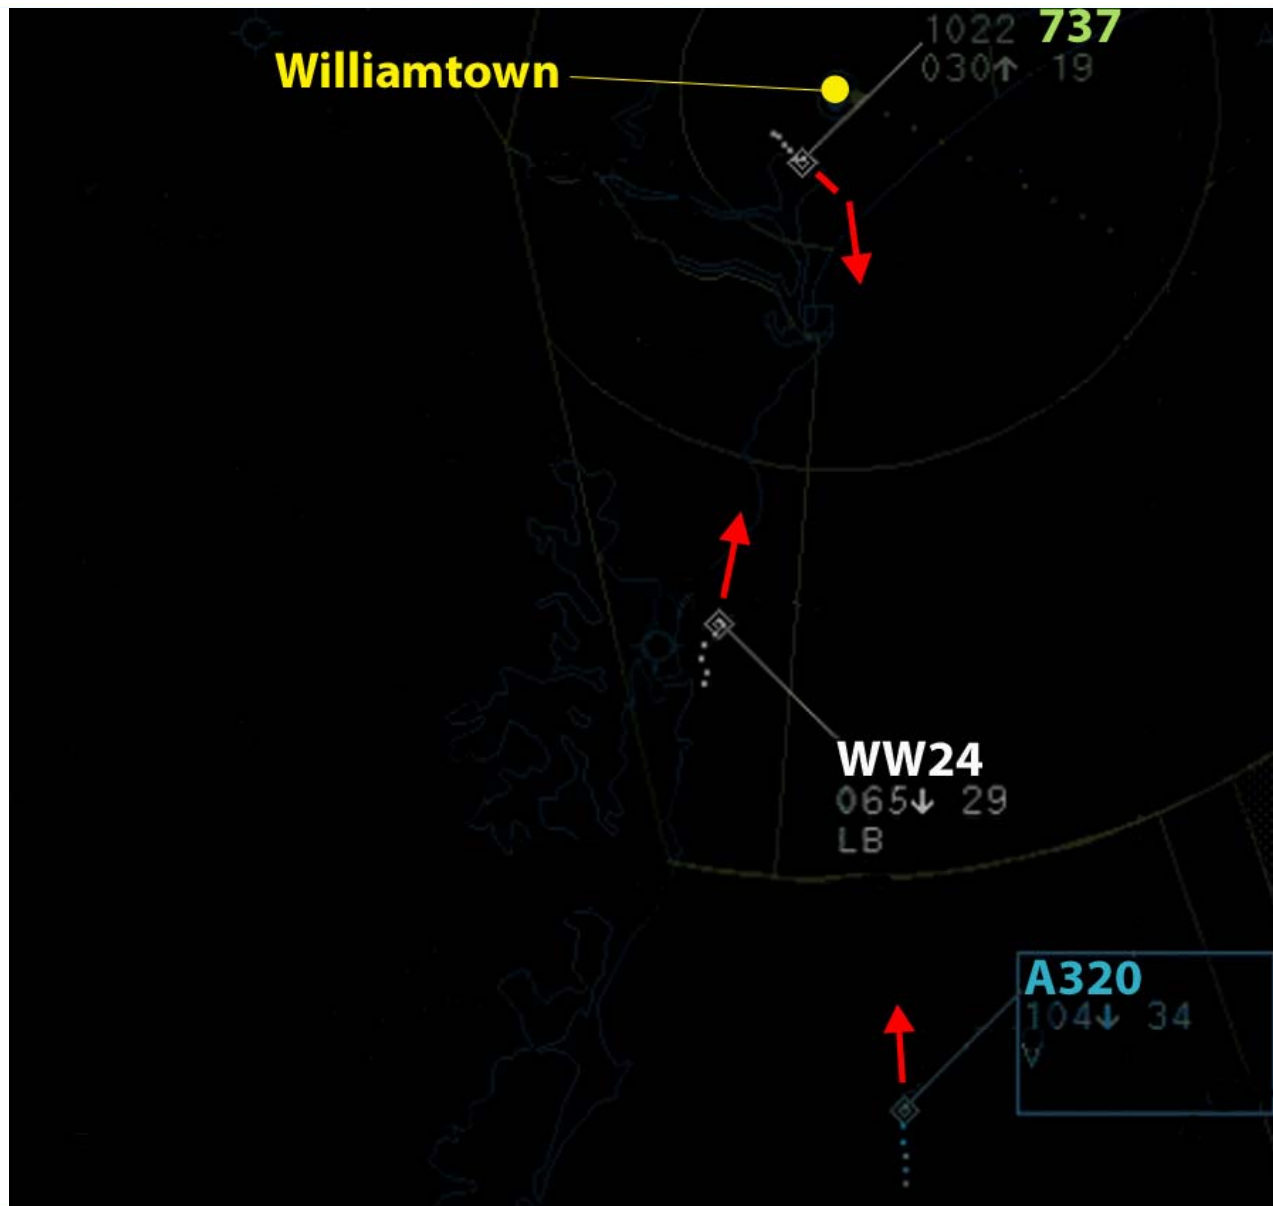
1303:56 local

WW24 transferred to Approach Low frequency

B737 departs – radar return does not couple –
Approach Low controller does not coordinate departure
with Approach High

Approach Low controller annotates WW24 label with
'LB'

A320 tracking to Williamstown calls Approach High – is
assigned 6,000 ft, 250 kt descent

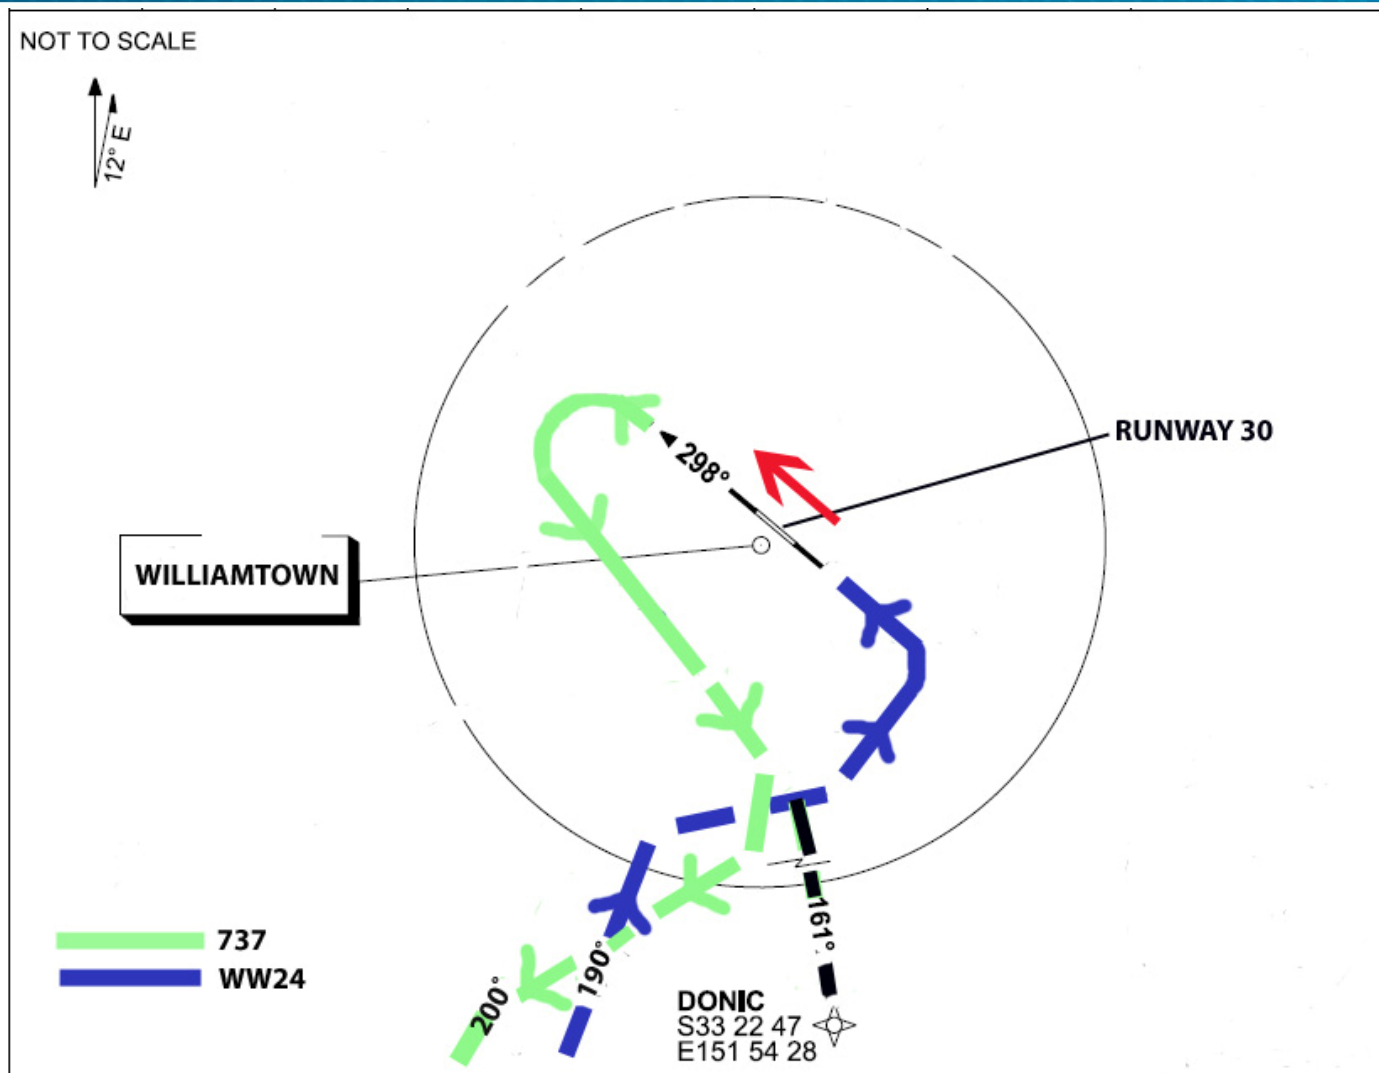
B737 transferred from ADC to Approach High

Approach High controller assigns the B737 a right turn to heading 200°

WW24 is still tracking direct – not for left base runway 30

Approach High controller queries the Approach Low controller's separation plan

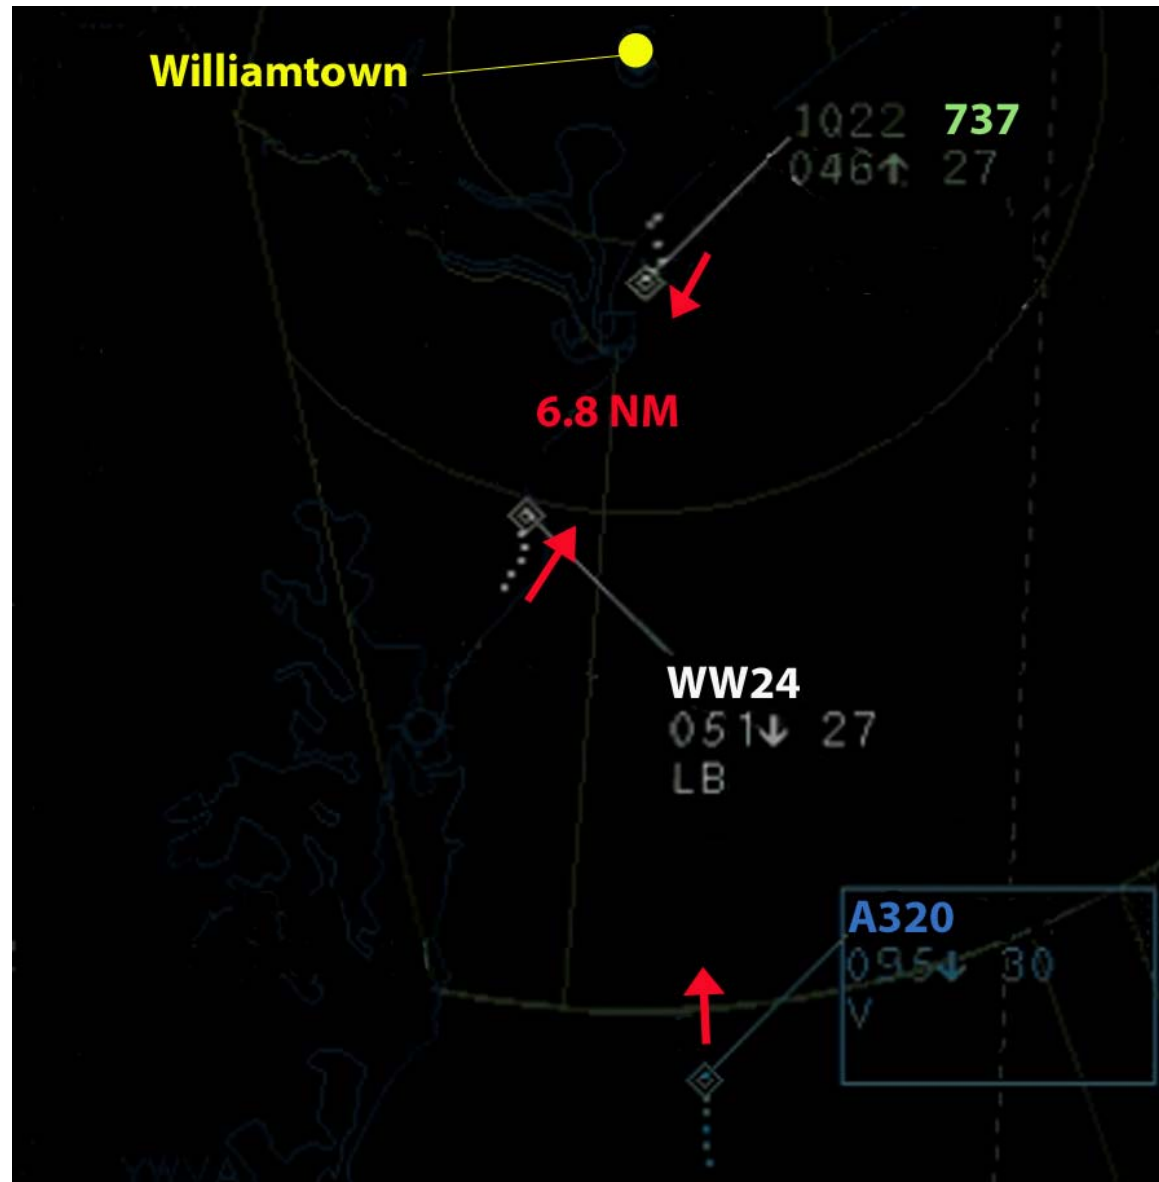
Approach High controller suggests that Approach Low turn the WW24 east to separate with B737 and A320

Approach Low controller instructs the WW24 to turn right heading 090°

The training officer taking over Approach Low instructs the Approach High controller to track the A320 to a 15 NM final, which that controller issues.

WW24 and B737 are 6.8 NM apart on reciprocal tracks

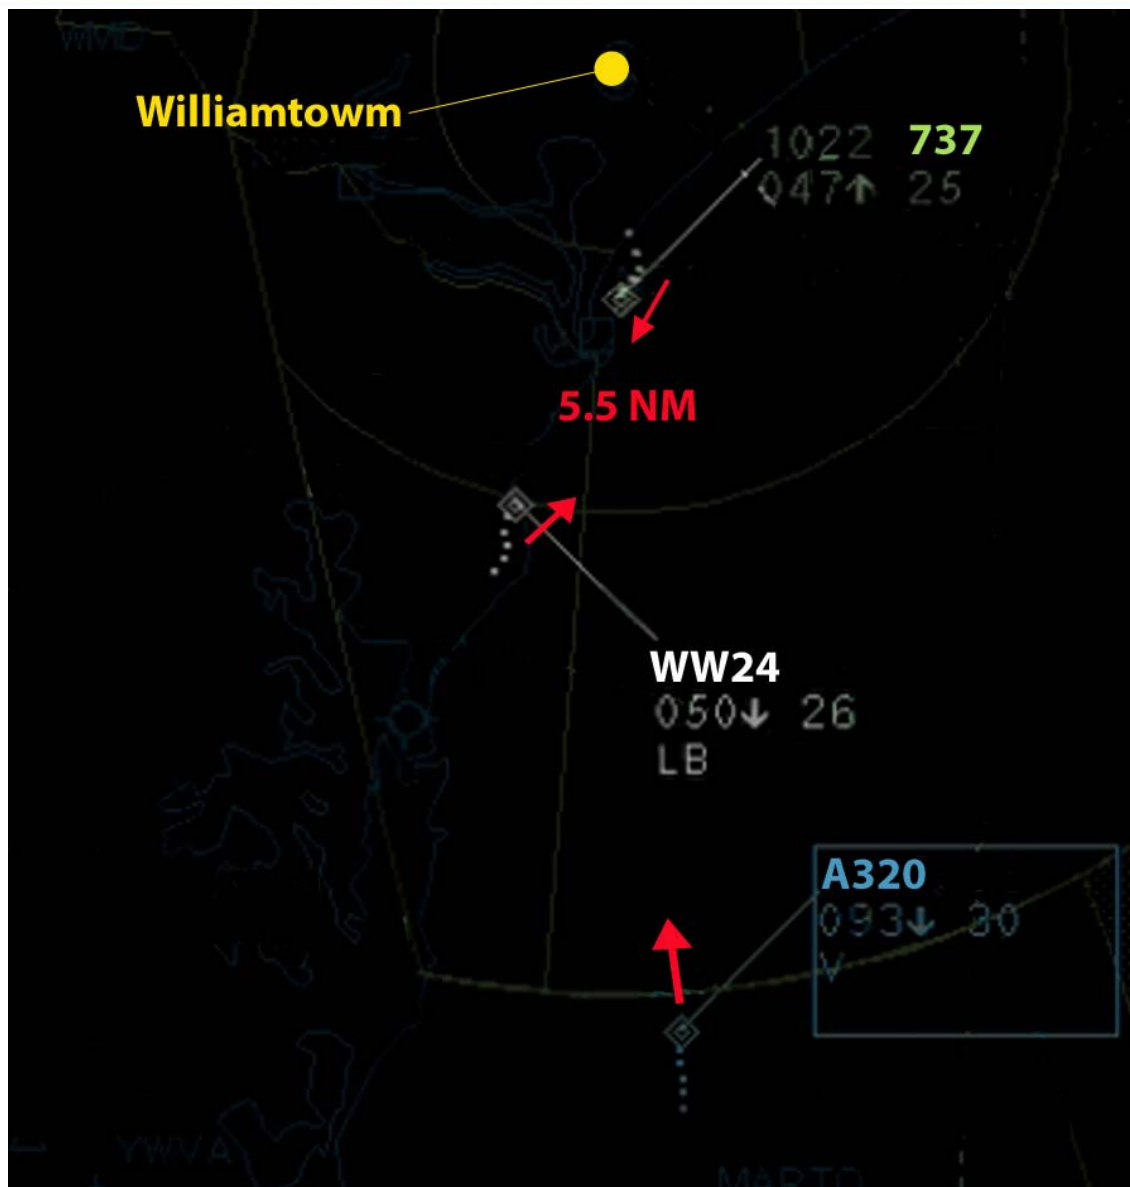
1305:10 local

WW24 and B737 are 6.8 NM apart on reciprocal tracks

Approach High controller instructs the B737 to turn further right – crew respond with a traffic query

WW24 and B737 are 5.5 NM and 300 ft apart
