Challenges in Material Selection for Repair and Re-manufacture

A study of the sometimes hidden complications associated with the selection of materials for customised repair, remanufacture or restoration schemes.

Cessna 404 *Titan,* VH-ANV Jandakot Airport, WA 11 August 2003

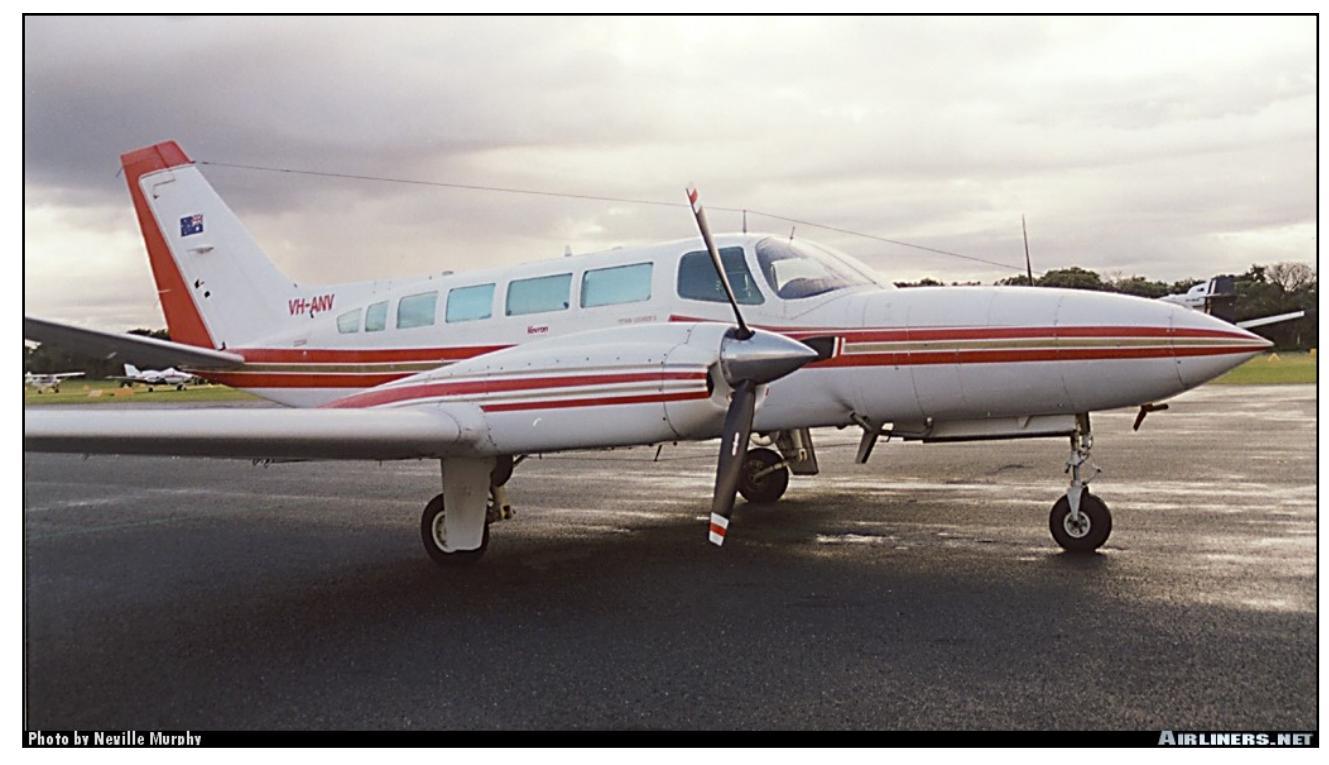
- •Departed Jandakot on a geotechnical survey flight, 6 pob + equipment - estimated MTOW margin 37 kg
- •Right engine lost power soon after rotation & was secured
- •Partial circuit completed, aircraft lost altitude and impacted trees and terrain
- •4 pax and the pilot escaped aircraft with burns one died from injuries 85 days later.
