## **Fuel Contamination can still pose a Risk**

**Presented by  
Captain Victor Liu  
Hong Kong Civil Aviation Department (HKCAD)**

## **Introduction**

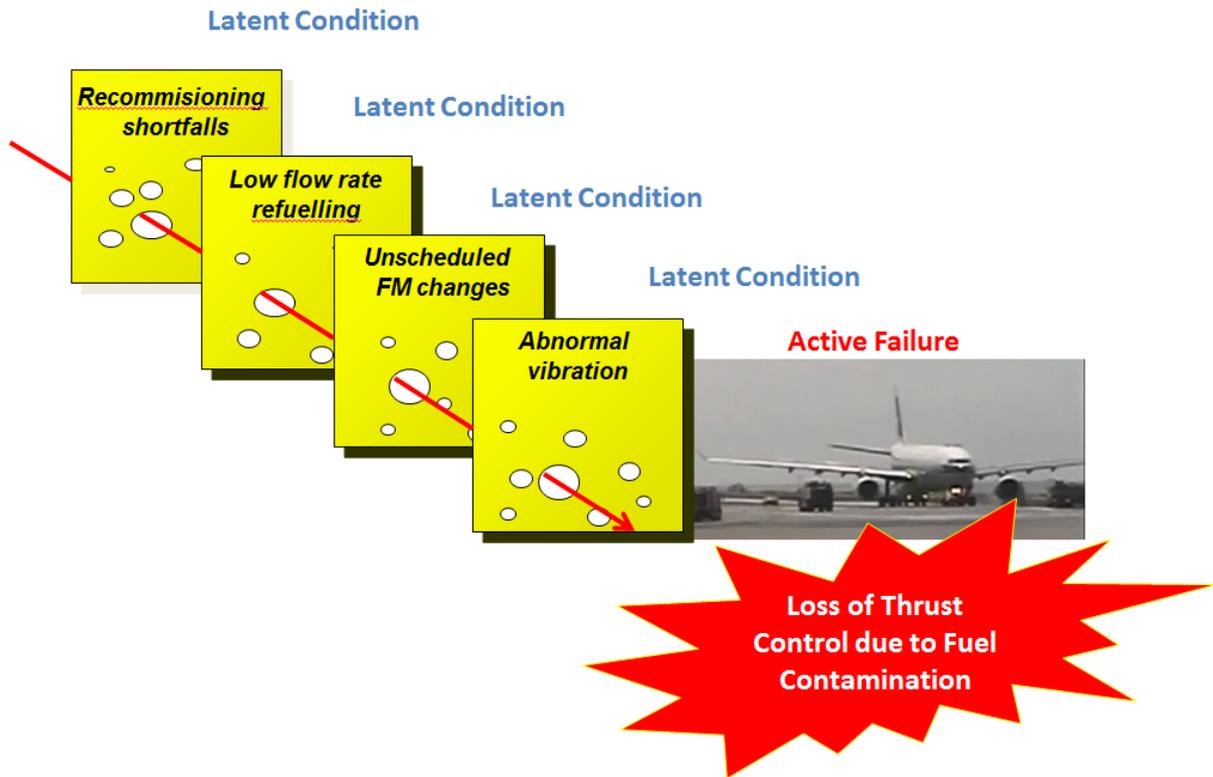
6. There were a series of events and contributing factors leading to penetration of all the safety layers and the formation of such a “perfect storm”, i.e. the uplifting of contaminated fuel to the aircraft.

Figure 4 – The Swiss-Cheese Model in Safety Management System
