Kalkara Investigation

A Kalkara Target Aircraft was lost during an operational flight.

A DSTO investigation determined the cause of the failure and provided recommendations to prevent similar occurrences.

A complete teardown inspection of the aircraft is under way, primarily to determine the effects of long term salt water exposure.

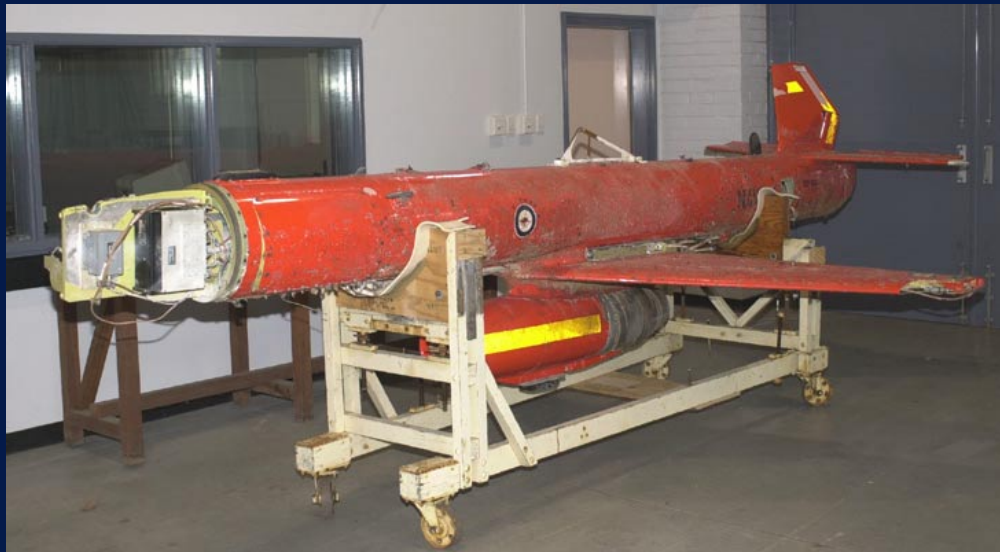
Preliminary failure analysis conducted by OIC Kalkara flight LCDR R. J. Ferry.

- Concluded that the aircraft failed due to loss of the port aileron during flight, and
- Proposed a mechanism by which the aileron became detached.

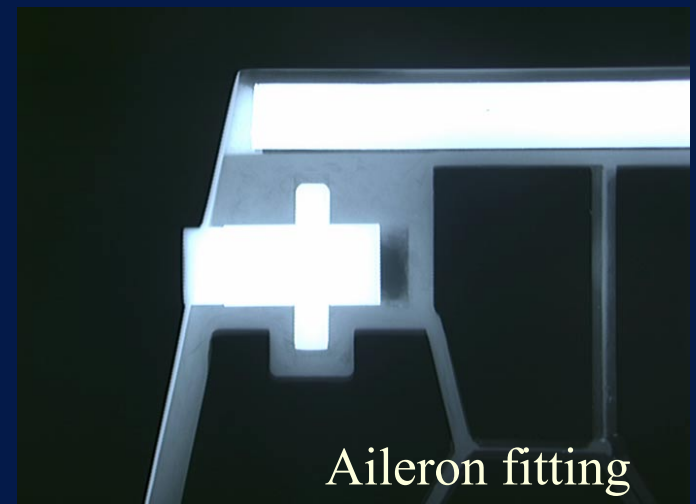
Kalkara - Aileron Attachment Bolt

The aileron attachment bolt was present, but slightly displaced from its normal position

A plastic locking strip which locks the bolt to the aileron was clearly visible after the bolt was cleaned.

The aileron attachment bolt normally fits to a substantial fitting within the aileron.
