Australian Transport Safety Bureau

ANZSASI Seminar, Glenelg SA

Fountain Head Road, Ban Ban Springs NT, 12 December 2006
(Thank you Larry Matters)

Major level crossing collision at Ban Ban Springs at 1356 on 12/12/06

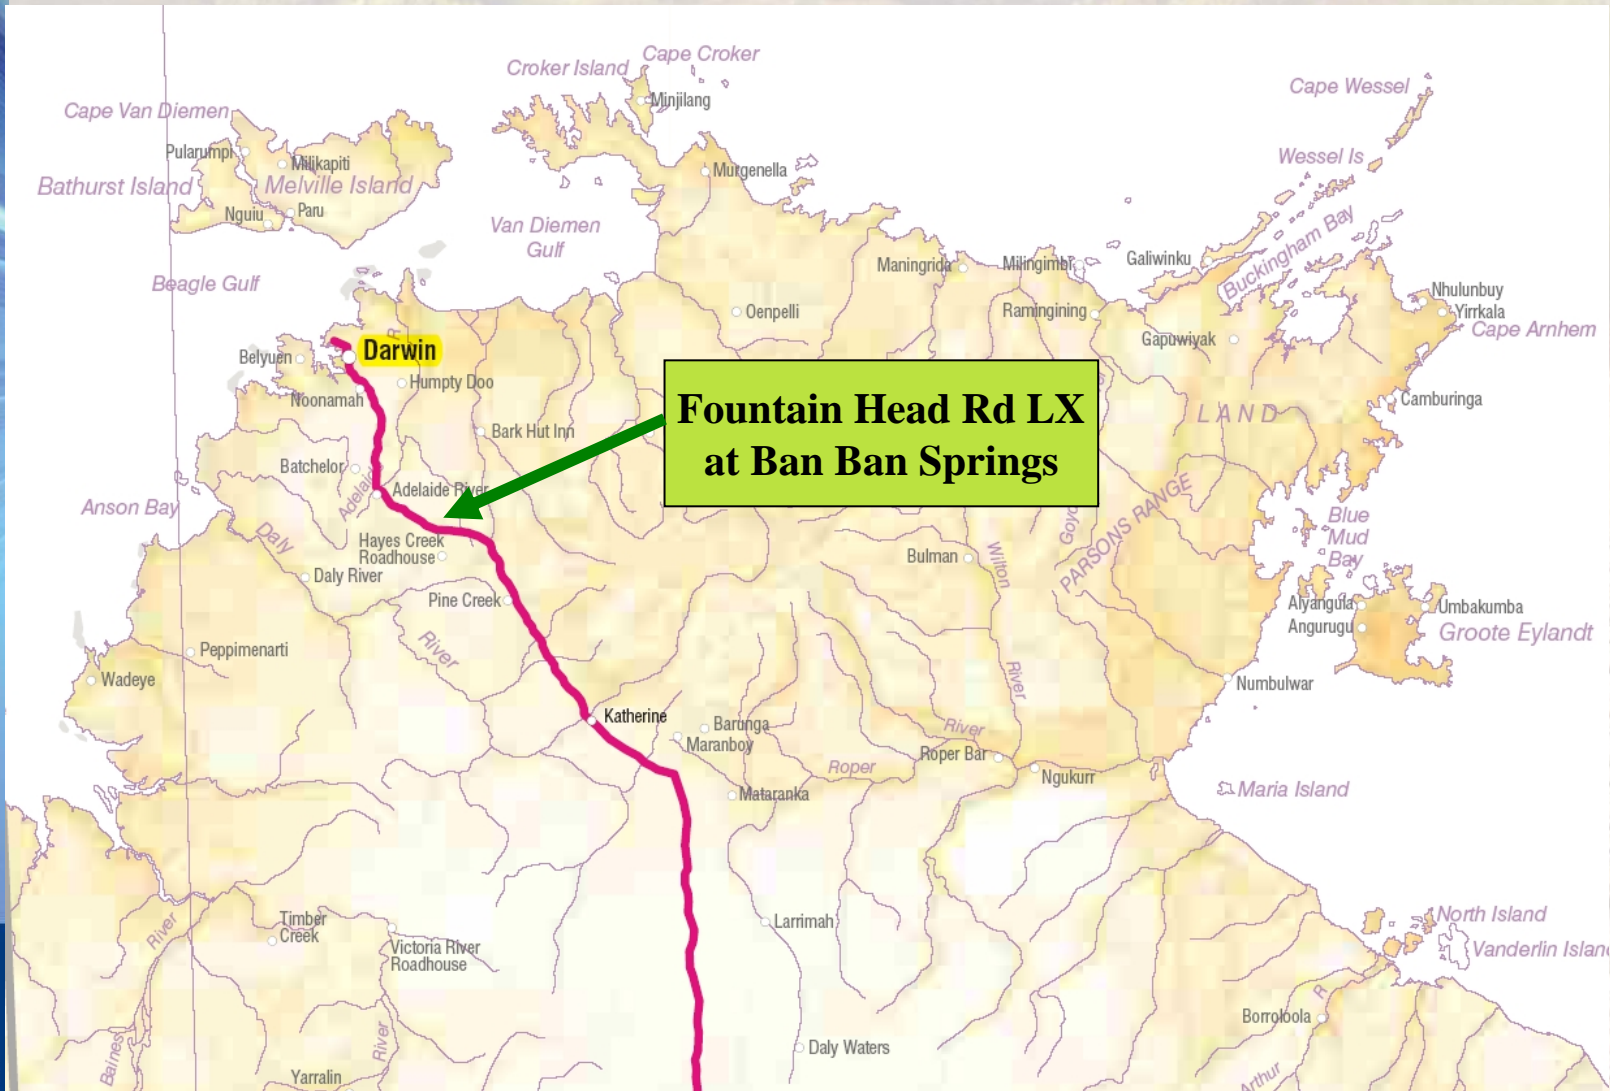
Ban Ban Springs

- Both locomotives, motorail wagon and nine passengers coaches derailed as a result of the collision
- No fatalities
- Injuries incurred were mainly superficial, but a female passenger collapsed and lapsed into unconsciousness about 15 minutes after the collision. The unconscious passenger and the truck driver were the only persons admitted to hospital
- The road-train truck was damaged beyond repair
- The lead locomotive incurred extensive structural damage, two passenger coaches were damaged beyond repair
- About 280 metres of rail infrastructure was extensively damaged.
