Li-Ion Batteries, SMS and Incidents

ANZSASI

Michael Burdick

June 2017

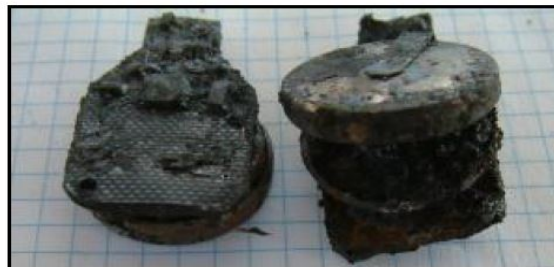
Lithium primary button sized flat cell batteries (watch style) with small circuit board
