# Multi Linear Events Sequencing

Dr Dmitri Zotov, MBE, PhD, MA, FRAeS

## A Case Study

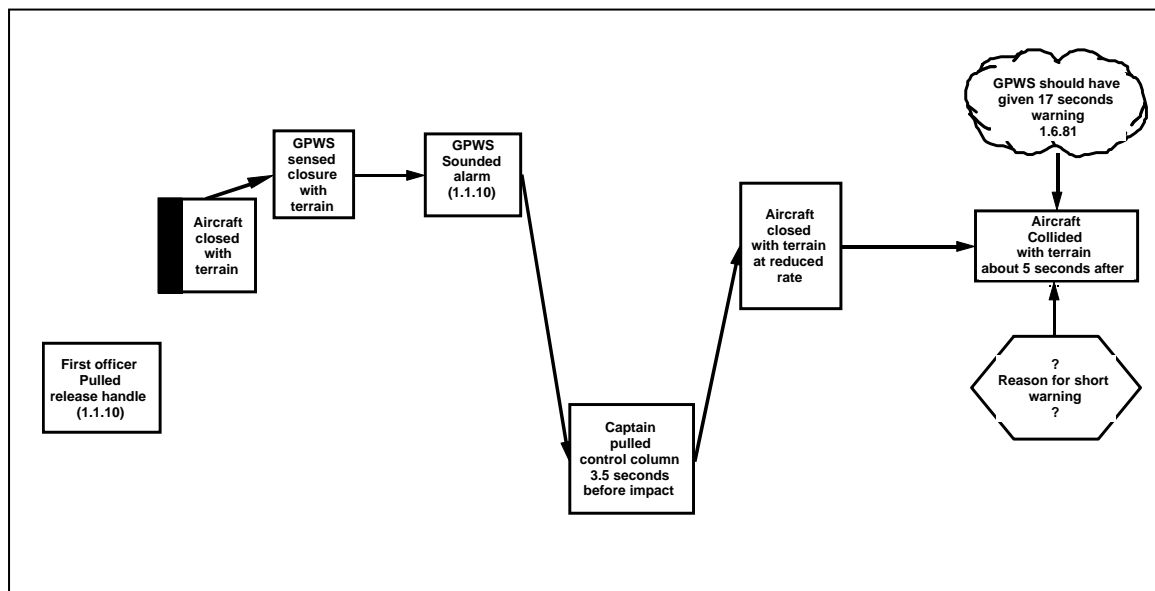
Figure 3. Ground proximity warning.

The captain was the handling pilot, and in view of the very rapid response to the GPWS warning it may be inferred that it was he who applied the nose-up input. So the final section of the MES graph may be re-drawn as in Figure 3.

These linkages meet the test of necessity and sufficiency. If the aircraft was closing with terrain and the GPWS sensed this, the warning would sound. If the warning sounded, the handling pilot would commence avoiding action by raising the nose. If raising the nose resulted in a flightpath change insufficient to avoid terrain, the aircraft would strike the terrain. Without further evidence, it is not possible to include information on why the GPWS did not sound earlier: in MES, the emphasis is on what *did* happen. However, the graph does flag the need to seek such further information.

One limitation is that 'aircraft closed with terrain' is not strictly an *event*; it is a continuing state of affairs, i.e. a *state*,<sup>2</sup> as Ladkin terms it (Ladkin and Loer 1998). For this reason, it has been flagged with a different symbol.

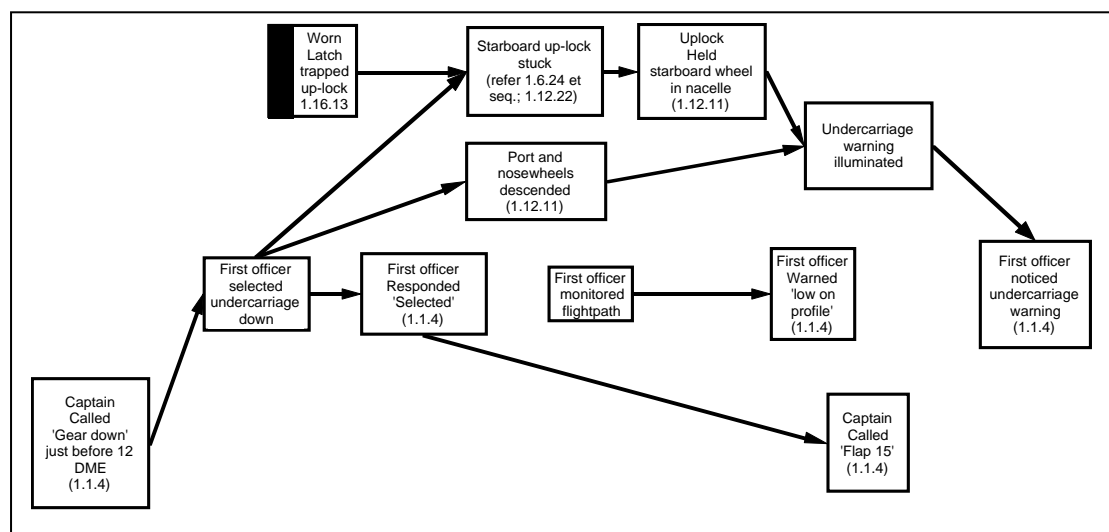
Figure 4. Undercarriage malfunction.

In the sequence relating to the undercarriage malfunction, the Captain's call of 'gear down' did not result in the First Officer's warning 'low on profile', and the Captain's call for 'flaps 15' did not cause the First Officer to notice an undercarriage warning (refer Figure 2). As with the section relating to the GPWS, additional information must be sought. The nosewheel was down at impact (1.12.11, p. 35), indicating that the First Officer not only responded to the Captain's call, but also selected the undercarriage lever to the down position. However, the First Officer's warning 'low on profile', was unrelated to his action of lowering the undercarriage.

It implies that he was monitoring the approach path, and that the aircraft had descended below the optimum descent path at this point. The Captain's call for 'flaps 15' was the logical consequence of the First Officer's response to the 'gear down' call, because this was the next action required to configure the aircraft for landing. But again, the detection of the undercarriage warning by the First Officer is unrelated to the 'flaps 15' call; it is a consequence of the right undercarriage leg remaining retracted after the undercarriage had been selected down. This section of the graph is shown in Figure 4.

From Figure 4, it can be seen that there were four streams of events going on in parallel: hence '*Multilinear* Events Sequencing'. Although 'left and nose wheels' is a compound actor, this does not give rise to any ambiguity. The EBBs and linkages now meet the logical requirements.

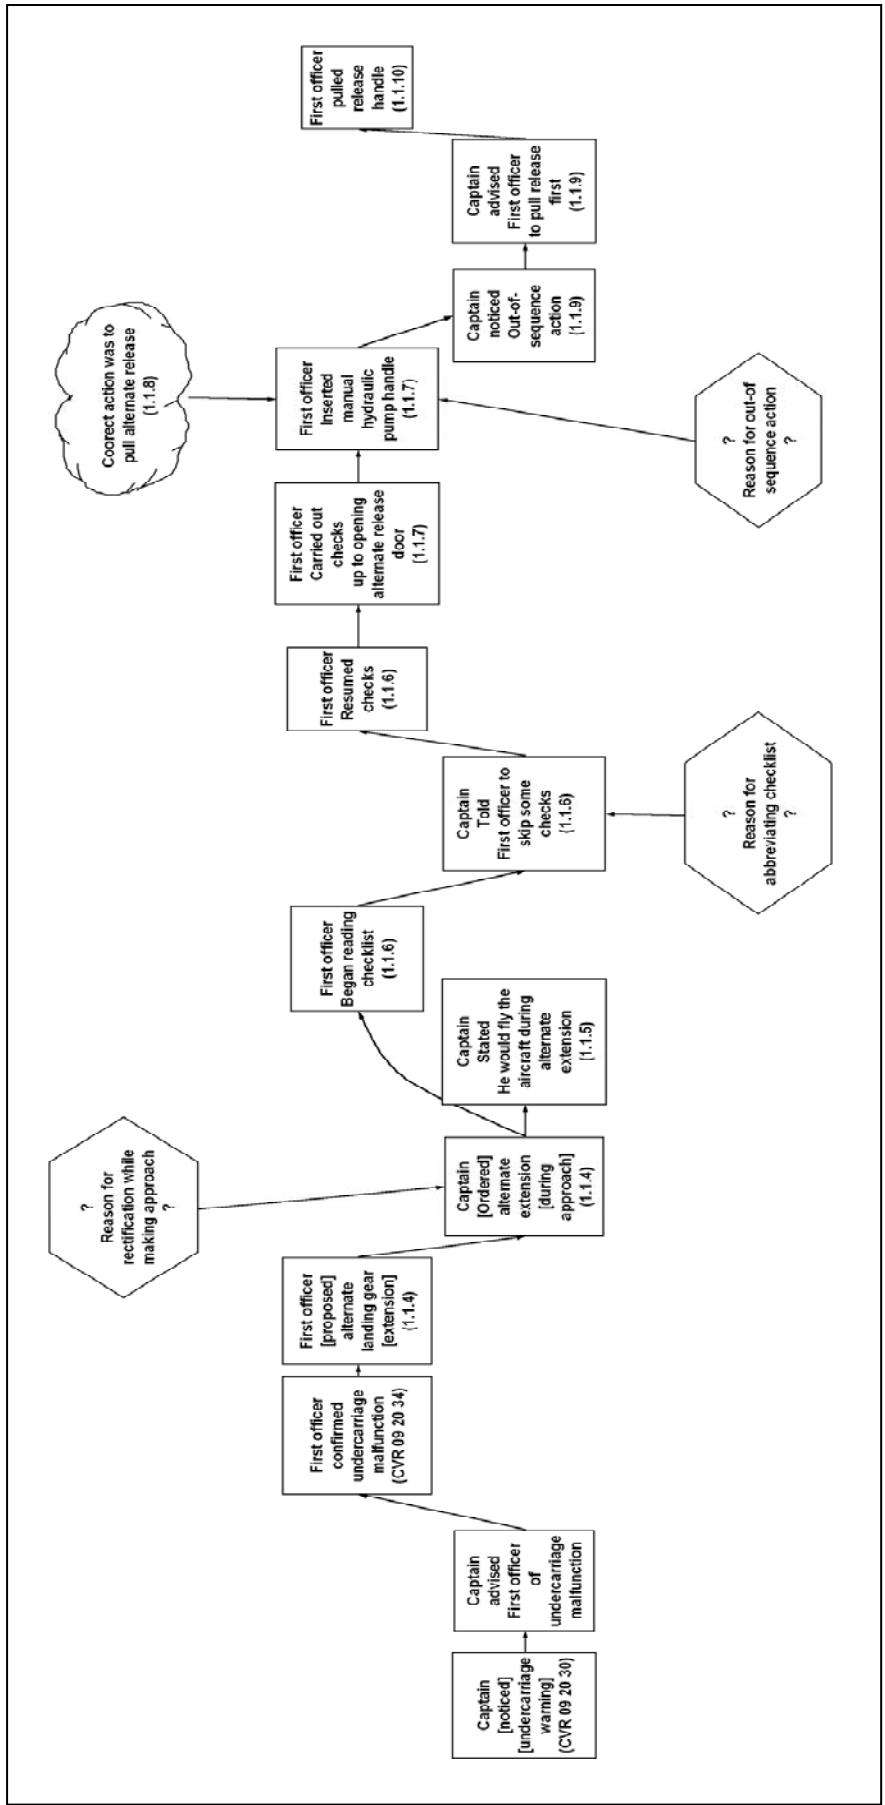
Figure 7. Alternate undercarriage selection (modified).

The first and third boxes in the time sequence have no paragraph references; they are necessary inferences from the material in the report, rather than direct references. However, supporting evidence should be available in the CVR transcript, Appendix C. Appendix C (p. 128; 09:20:30 et seq.) shows that the sequence in 1.1.4 (p. 7) is misleading. It was the captain who observed the undercarriage warning ("Oh #") and then whistled, before the First Officer noticed it. So the MES graph must be modified as in Figure 7.

This change illustrates the use of MES as a quality control measure for checking an existing report. MES would function in exactly the same way if used to check the work during the preparation of a draft. Although a minor matter, such a discrepancy would provide ammunition should the report come under criticism during litigation.

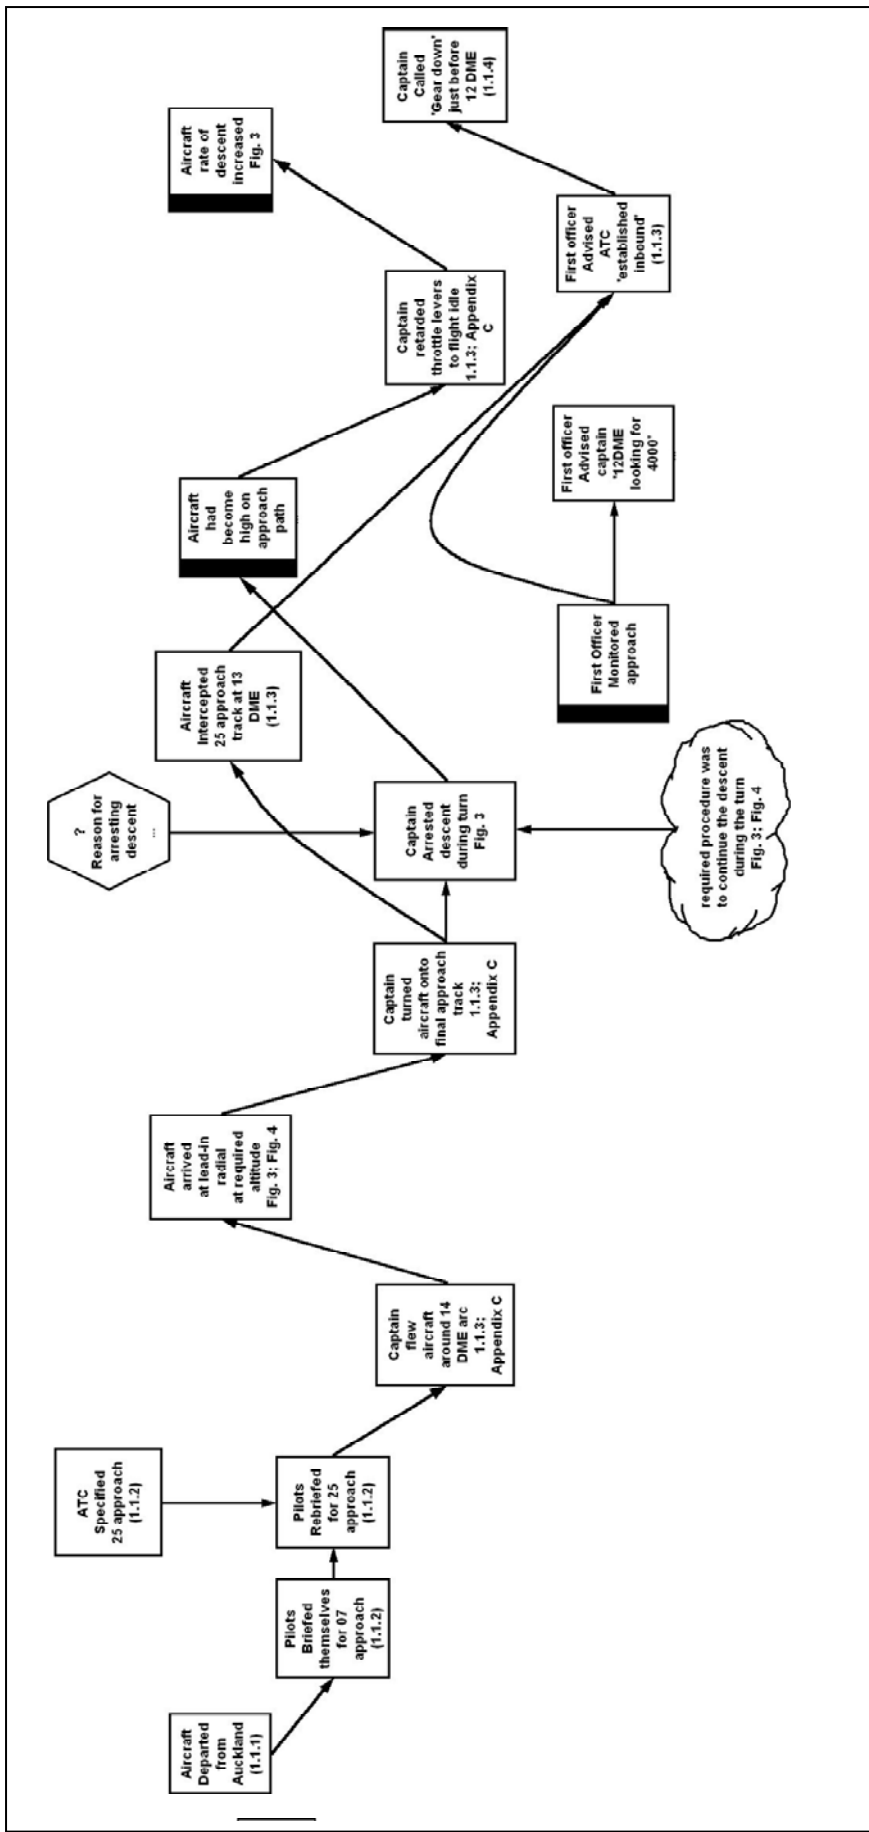
Figure 8. Initial approach to Palmerston North.

The right turn did not cause the power levers to be retarded to flight idle. This action was needed because the aircraft had become high on the glidepath by the time it completed the turn, and this excessive height was the result of the descent being interrupted during the turn (Report, Figure 3, p. 28). MES flags the need to examine *why* the aircraft had become high on the glidepath; again, this would be discussed later in the Why-Because Analysis.

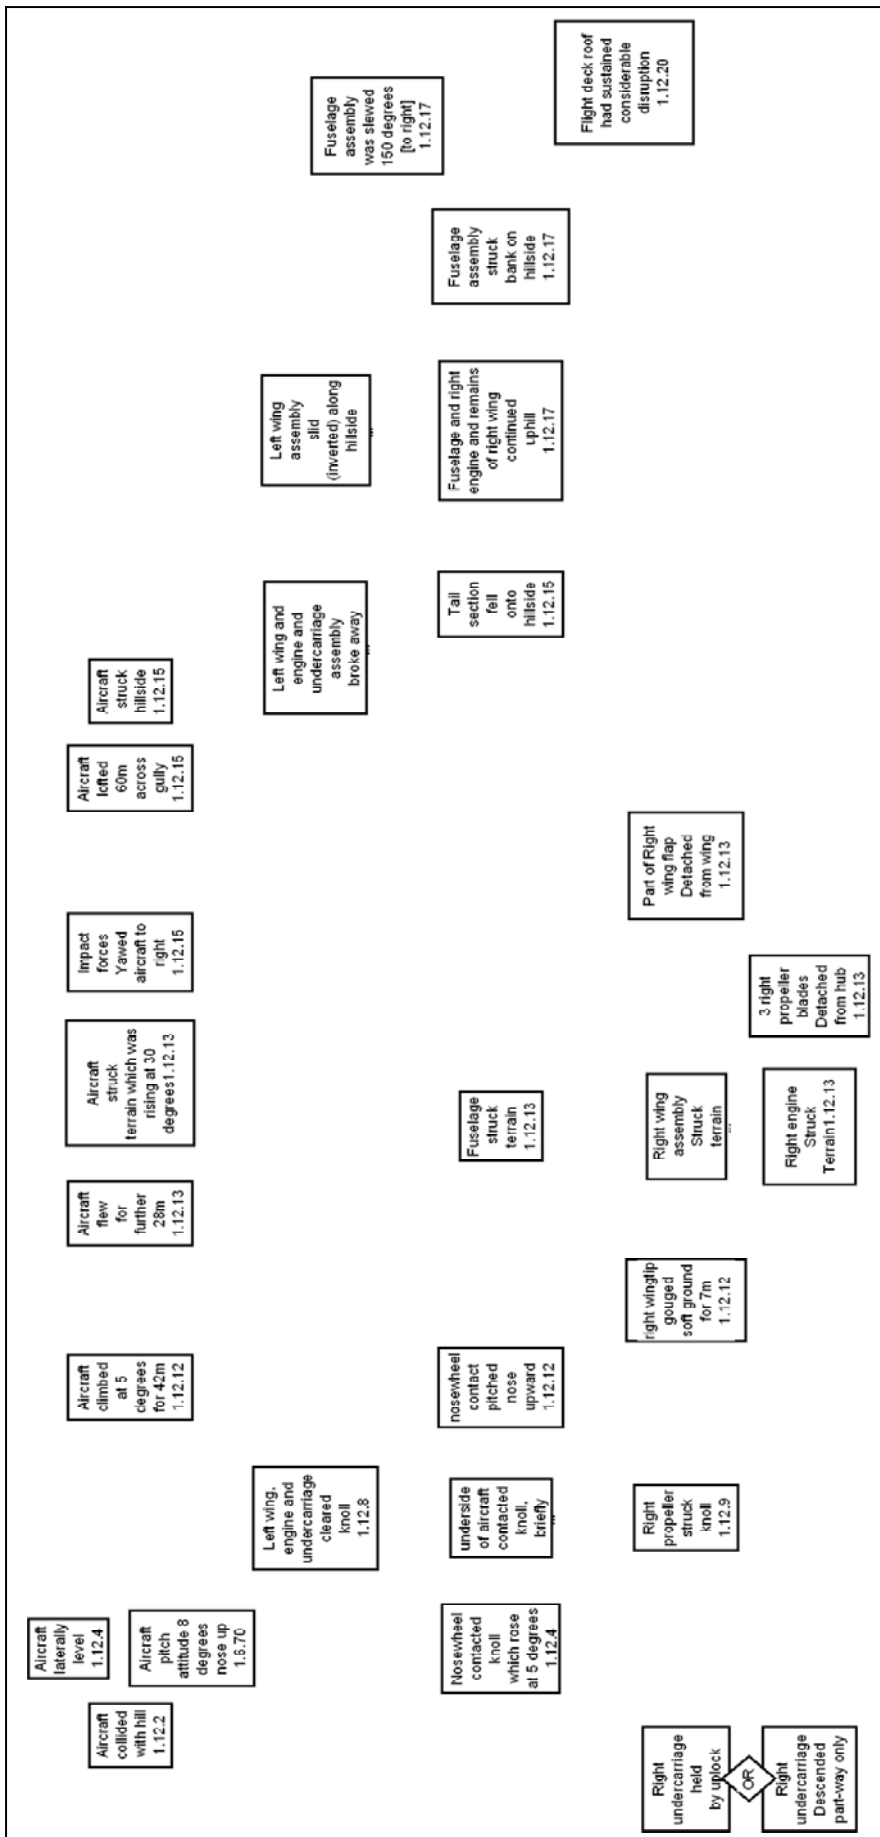
Figure 10. Events from Section 1.12

Section 1.1 (pp. 7, 8) is silent on the impact sequence, though as injuries and some fatalities occurred, the impact sequence is of importance in understanding the accident. Some information is contained in 1.12 (pp. 33-37), 'Wreckage and Impact Information', and the events are displayed in Figure 10.

As with the information from History of the Flight, not all events can be joined by logical linkages: there is essentially a catalogue of events, in sequence, but additional information must be adduced before a 'mental movie' can be formed. For example, 'left wing and engine and undercarriage assembly broke away from fuselage' did not, without more, cause 'left wing (assembly) slid inverted along hillside', and there is no obvious reason why 'fuselage assembly struck bank on hillside' should cause 'fuselage assembly was slewed 150 degrees (to right)'.

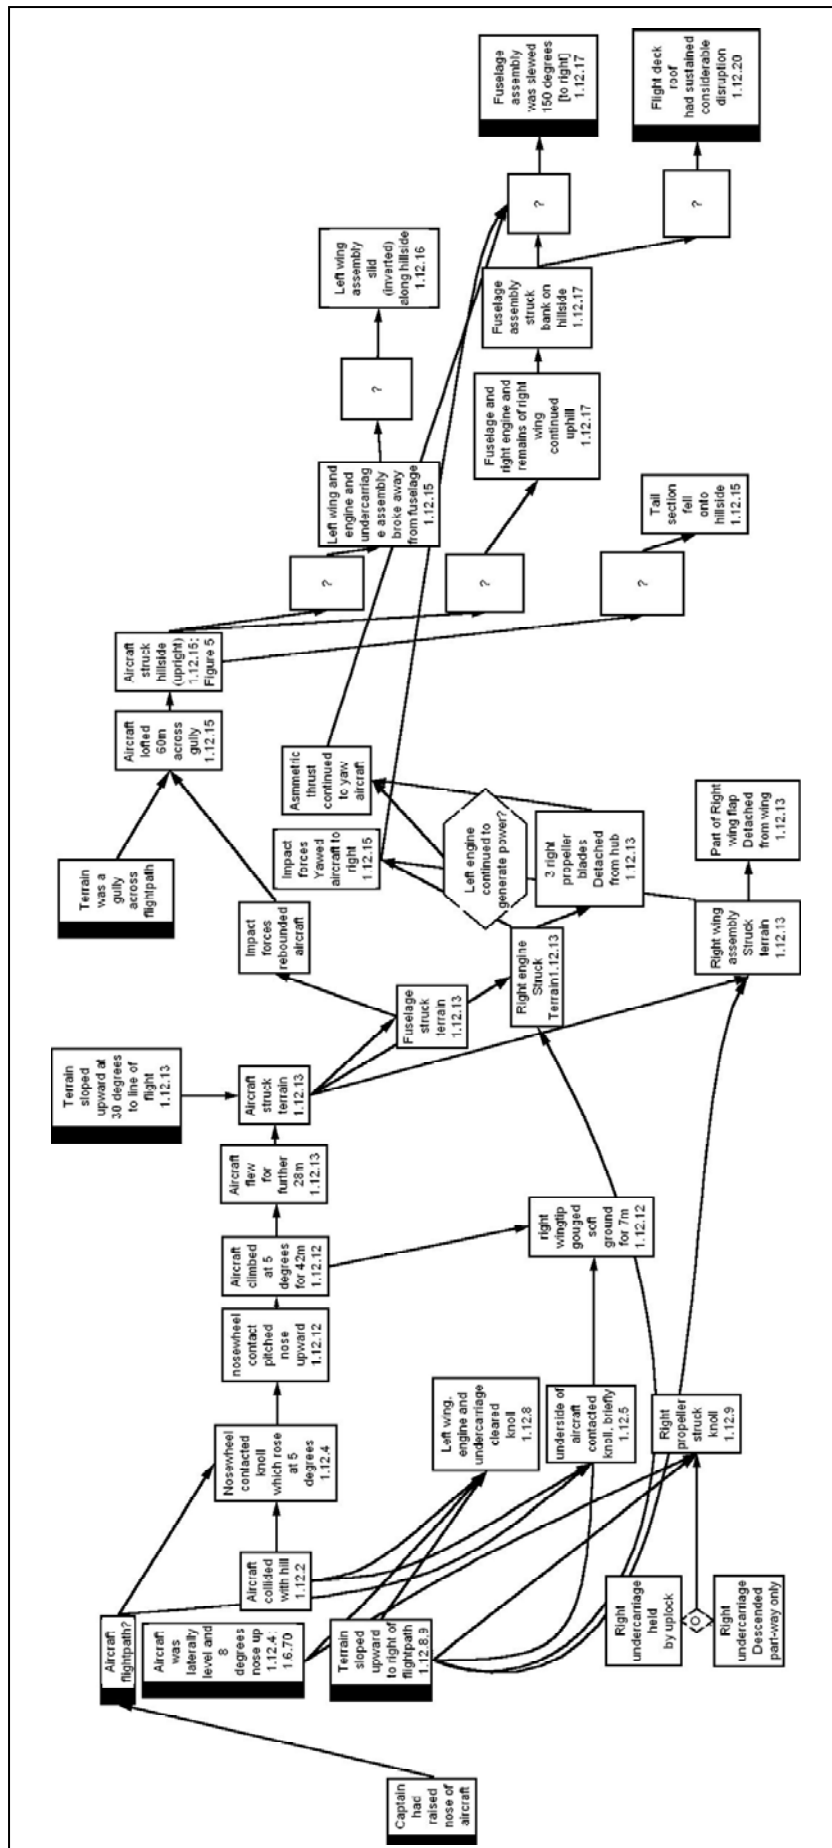
Figure 11. Impact sequence MES graph.

Figure 11 shows the construction of a MES Graph for the impact sequence. The first step is to change the format of the events to that permitted for EBBs: primarily, this involves changing to active voice. As before, it is necessary to incorporate a number of states (i.e. continuing states of affairs) in order to make the sequence of events comprehensible. Consider the group at the beginning of the time sequence in Figure 11, representing the initial contact with the hill. In order to make sense of the points of contact, additional information is needed. For the nosewheel to make rolling contact, which was able to pitch the nose upward (1.12.12, p. 35), it is not sufficient that the aircraft collided with the hill. It is also necessary that the flightpath and the terrain profile were not greatly different. The report advises that the terrain sloped upward to the right of the flightpath (1.12.8, p. 35) - a state - and that the aircraft was laterally level (1.12.4, p. 35) - likewise a state, not an event. These two states account for the absence of contact with the left undercarriage (1.12.8, p. 35). Also, the slope together with the absence of the right undercarriage accounts for the right propeller contacting terrain (1.12.9, p. 35). The states are necessary to understanding the impact, and are included, suitably flagged to show that they are not EBBs.

The series of queries after the second major impact also points to deficiencies in the report. It proceeds directly from 'aircraft struck hillside' (1.12.15, p. 36) to 'left wing assembly broke away' (1.12.15) and 'tail section fell onto hillside' (1.12.15) without saying how these things happened. Also, there is no obvious reason why the left wing assembly should have slid inverted (1.12.16, p. 36). Especially significant is the unexplained damage to the flight deck roof (1.12.20, p. 36), which will be discussed in relation to pilot injuries and additional evidence.

A further limitation in the report is shown by the inconsistency between Figures 11 (the impact sequence) and 12 (the fire sequence). Figure 11 indicates that, for a short period after rebounding from the knoll, the right wing tip scraped the ground, and then the aircraft struck the ground again with the fuselage and the right engine. This is not at all the same as the progressive impact described in Figure 12 - right wing tip, right wing and engine - producing the progressive disruption of the right wing structure alluded to in 1.14.3 (p. 39). While the impact description in section 1.14 would account for the disruption of the integral tanks and so the flash fire, Figure 5 in the report (the wreckage diagram – see Annex A) shows that the description in Figure 11 is accurate.

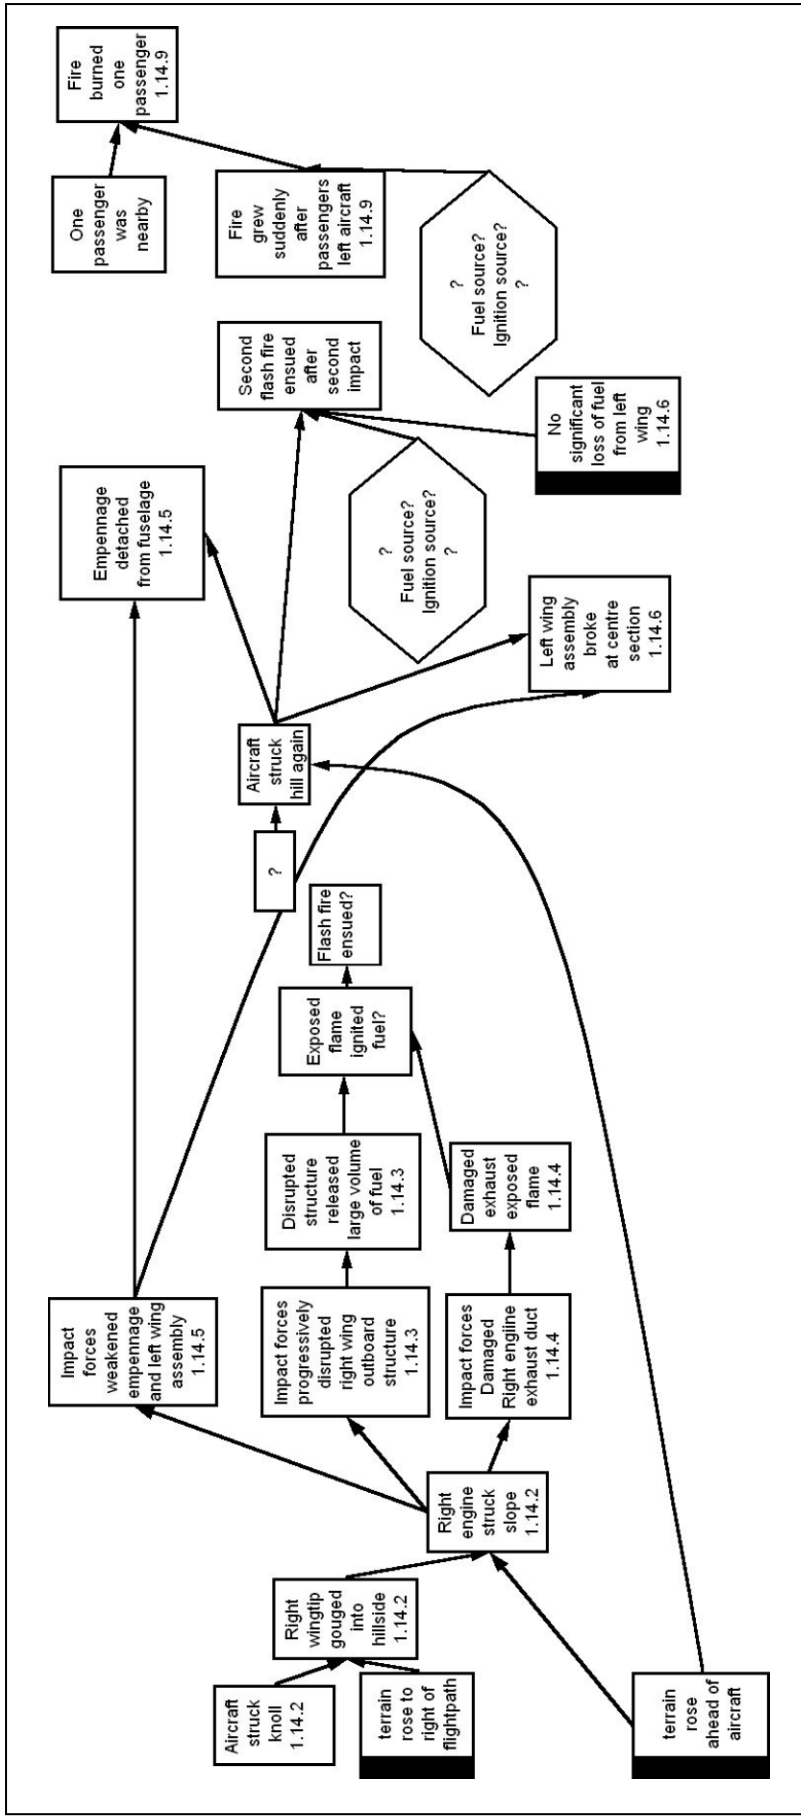
Figure 12. Fire sequence

The fire sequence is shown, in MES format, in Figure 12. Three weaknesses in the report are evident from Figure 12 relating to weakening of the structure, burns to a passenger, and the second flash fire.

The disconnected group at the end of the time sequence, events leading to fatal burns to a passenger (1.14.9, p. 40), indicates an absence of linkage to the rest of the report. There is no information as to the source of the fuel, nor why this fire suddenly flared up. A small slow fire in the neighbourhood of an engine could well have been an oil fire, ignited by the hot section of the engine. However, this would not account for the way in which the fire suddenly flared up, which is characteristic of a kerosene fire where the kerosene has soaked into the ground. The report speaks of 'residual fuel', without saying where this originated (1.14.7, p. 40). Since the left wing with its fuel tank had departed, and the right fuel tank had completely ruptured (see Figure 22, later), the only remaining source of fuel would have been the small quantity contained in the cross-feed lines in the wing centre section. Accordingly, the linkages to the remainder of the fire information are rupture of the cross-feed lines, draining of fuel from these lines, and ignition by a small engine fire. This matter will be addressed when the post-impact diagrams are amalgamated.

No evidence is adduced as to the origin of the second flash fire (1.14.5, p. 39). There was no significant loss of fuel from the left wing, and no indication of fire around the left wing or engine (1.14.6, p. 40), so the source of fuel had to be either the right wing or engine nacelle. As the fuel tank, contained in the outer panel of the right wing, had already separated, the only source of fuel was residual fuel in the fuel lines in the nacelle, or perhaps fuel which had leaked and accumulated in the nacelle (1.6.6, p. 10). It is difficult to envisage either source being a sufficient supply of fuel for a flash fire. Also, there is little evidence as to whether the second flash fire occurred. The alternative, that there was fuel adhering to the empennage which was still burning, is canvassed in the report (1.14.5, p. 39). Further information is needed on this point.

Accordingly, the impact sequence in Figure 12 is wrong. The scrape by the right wing was a transient affair; loads on the wing would have been minor and in-plane, and unlikely to have caused significant damage. The subsequent impact was taken by the right engine, and the belly of the aircraft. Although the engine struck the ground sufficiently hard to damage the engine, the underside of the outer right wing, found further along the wreckage trail, did not display evidence of a major impact. The detachment of the wing, and the fire, remain to be explained. Further evidence must therefore be sought. This will be discussed later, in 'evidence from the wreckage'.

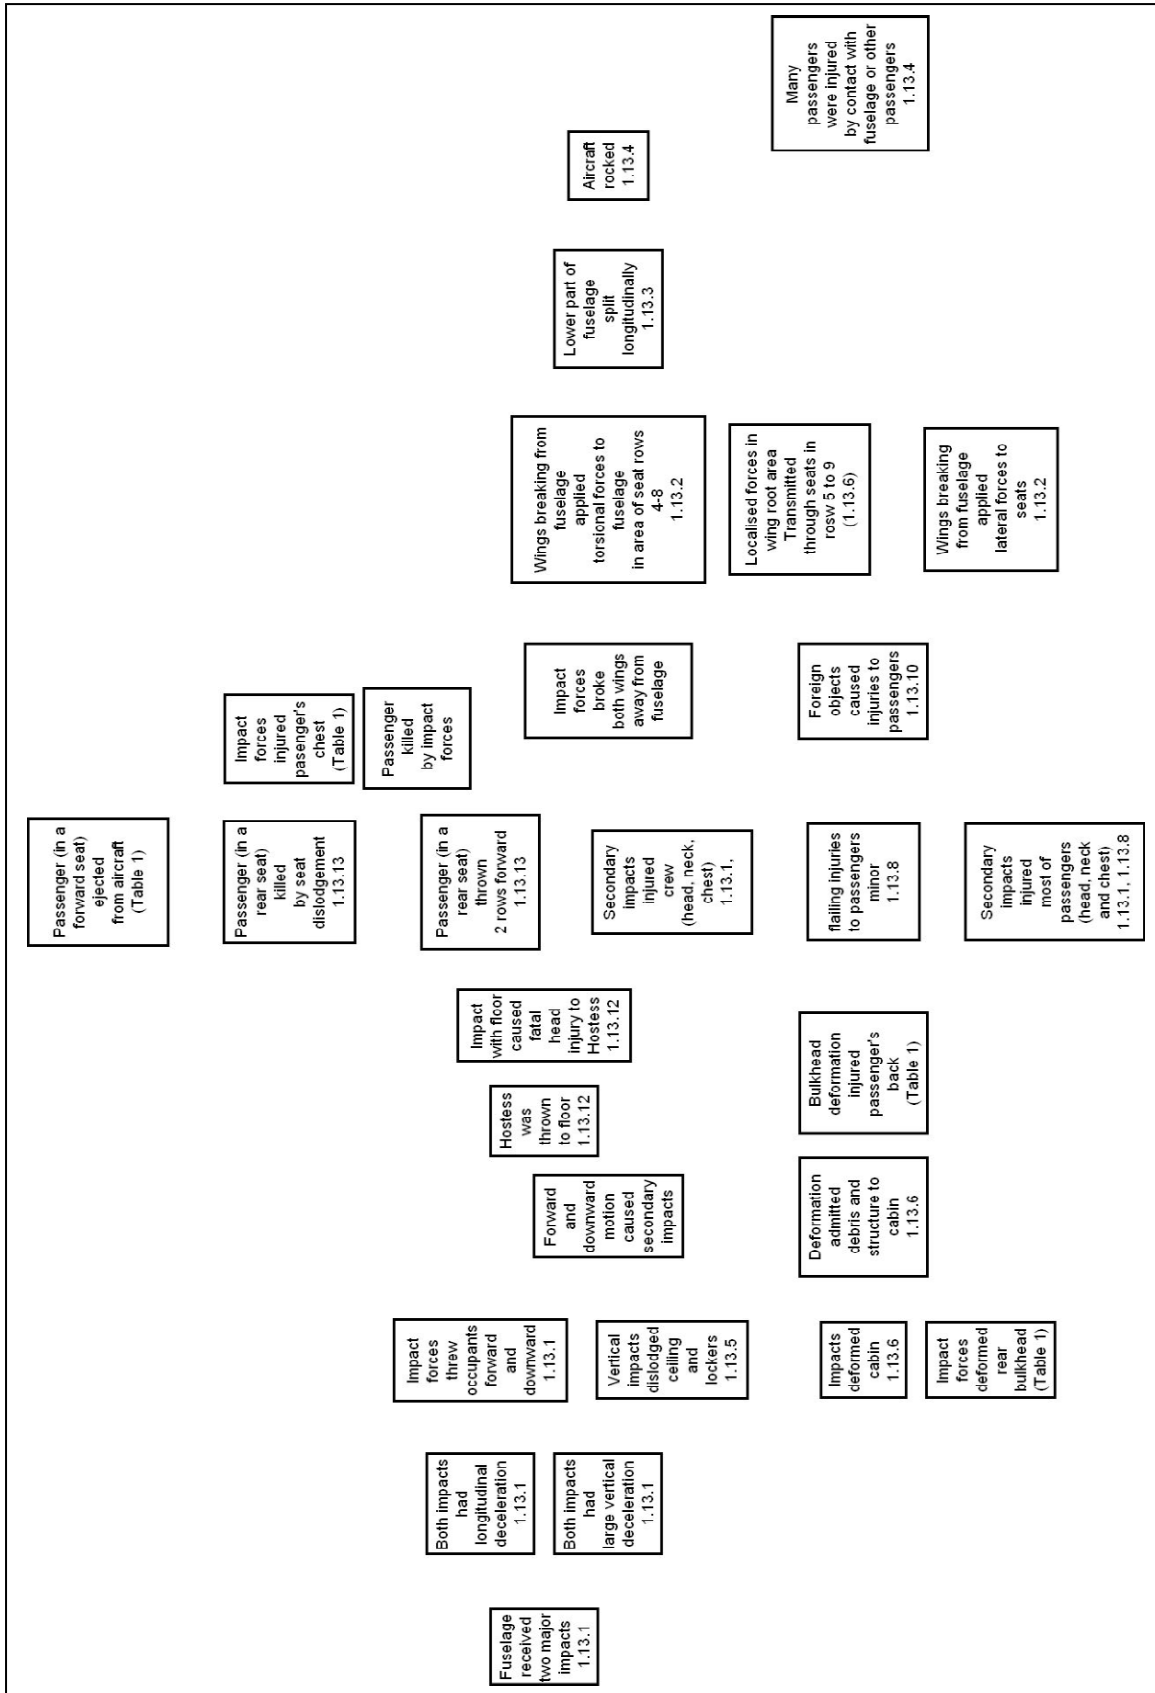
Figure 13. Events in medical information.

Turning now to the crew and passenger injuries, the sequence is shown in Figure 13. As with the section on fire, there is also information on the impact sequence, in this section.

A difficulty arises in trying to determine what events are described in the section on medical information, because of missing and conflicting information.

- Table 1 (p. 38) is silent on the injuries said to have been caused by the entry of foreign objects (1.13.10, p. 39).

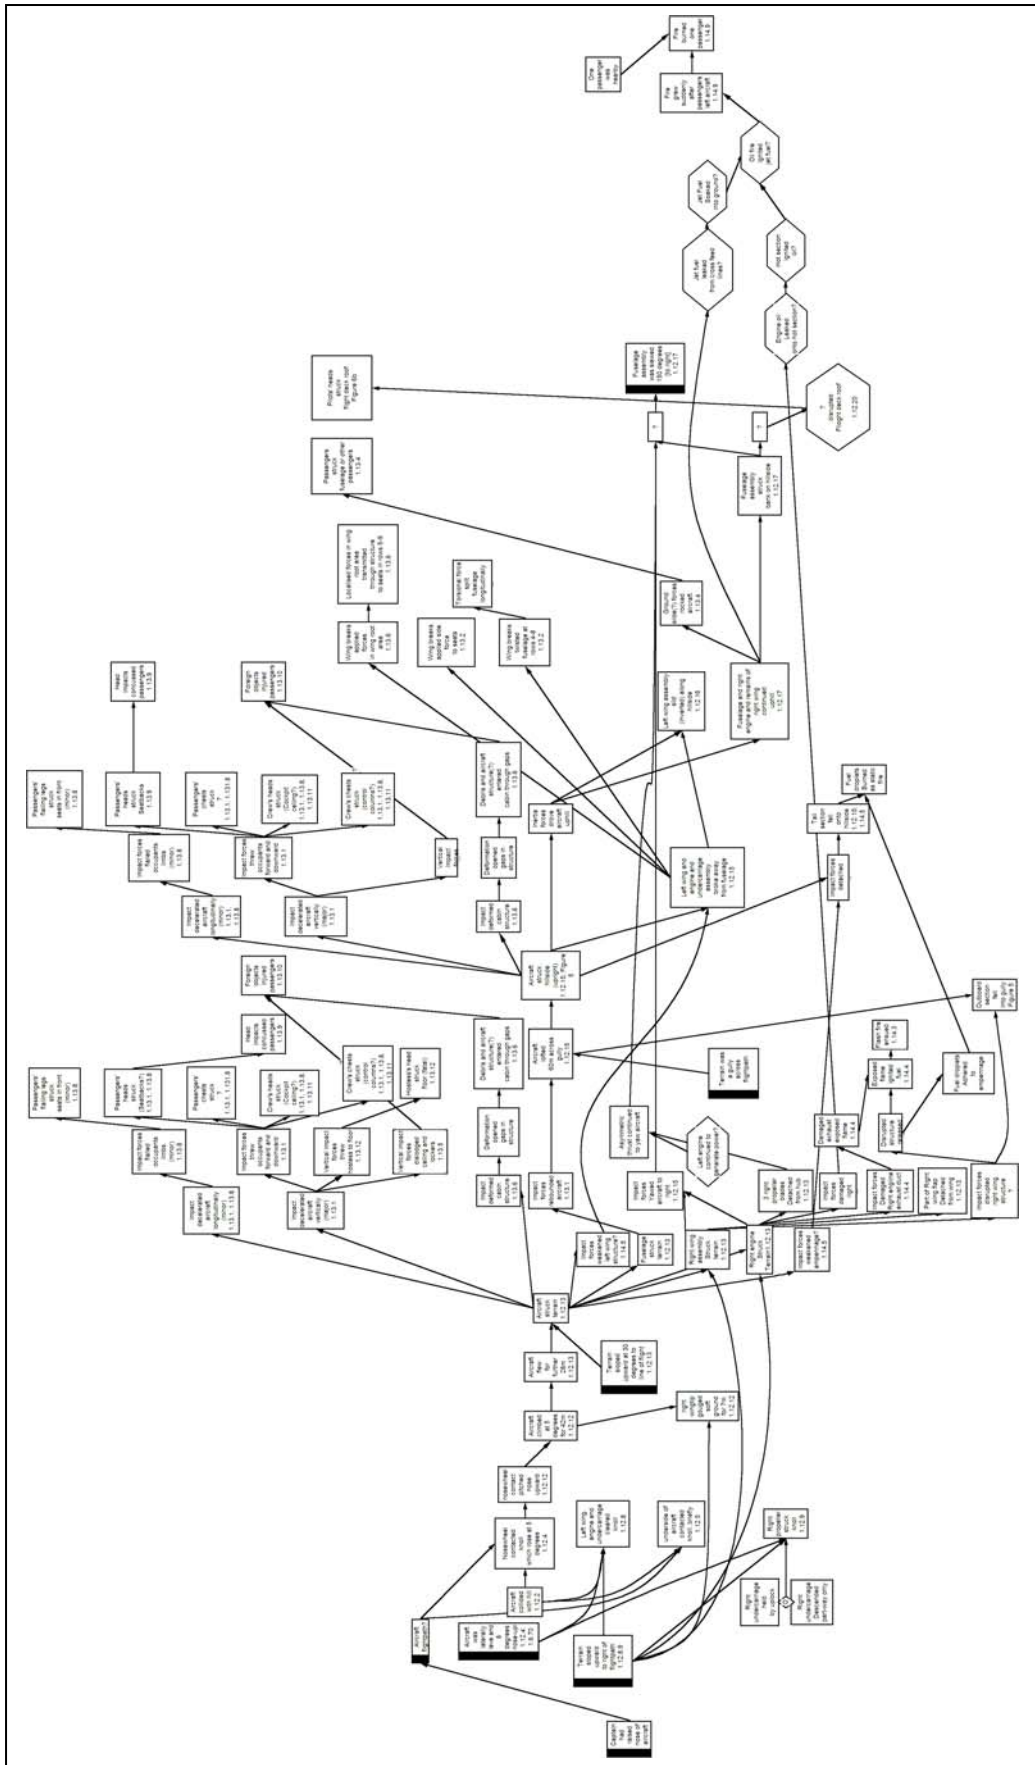
Figure 16. Ansett Dash 8 combined MES graph of impact sequence.

The complete MES graph for the impact sequence, shown in Figure 16, is produced by combining the impact, fire and injury graphs, Figures 11, 12 and 14. Where it has been possible to resolve inconsistencies from the report, this has been done.

First, the 'impact' and 'fire' sequences are combined (Figure 15). (The detail in this graph is too small to be visible at this scale, but is essentially the same as in the individual sectors). Then, the 'injuries' sequence is combined with the already amalgamated information in Figure 15, to form the overall picture of the impact sequence shown in Figure 16<sup>3</sup>.
