Bombardier Q300 nose landing gear incidents

Peter R. Williams
Transport Accident Investigation Commission

ANZSASI Regional Air Safety Seminar
Christchurch, June 2013

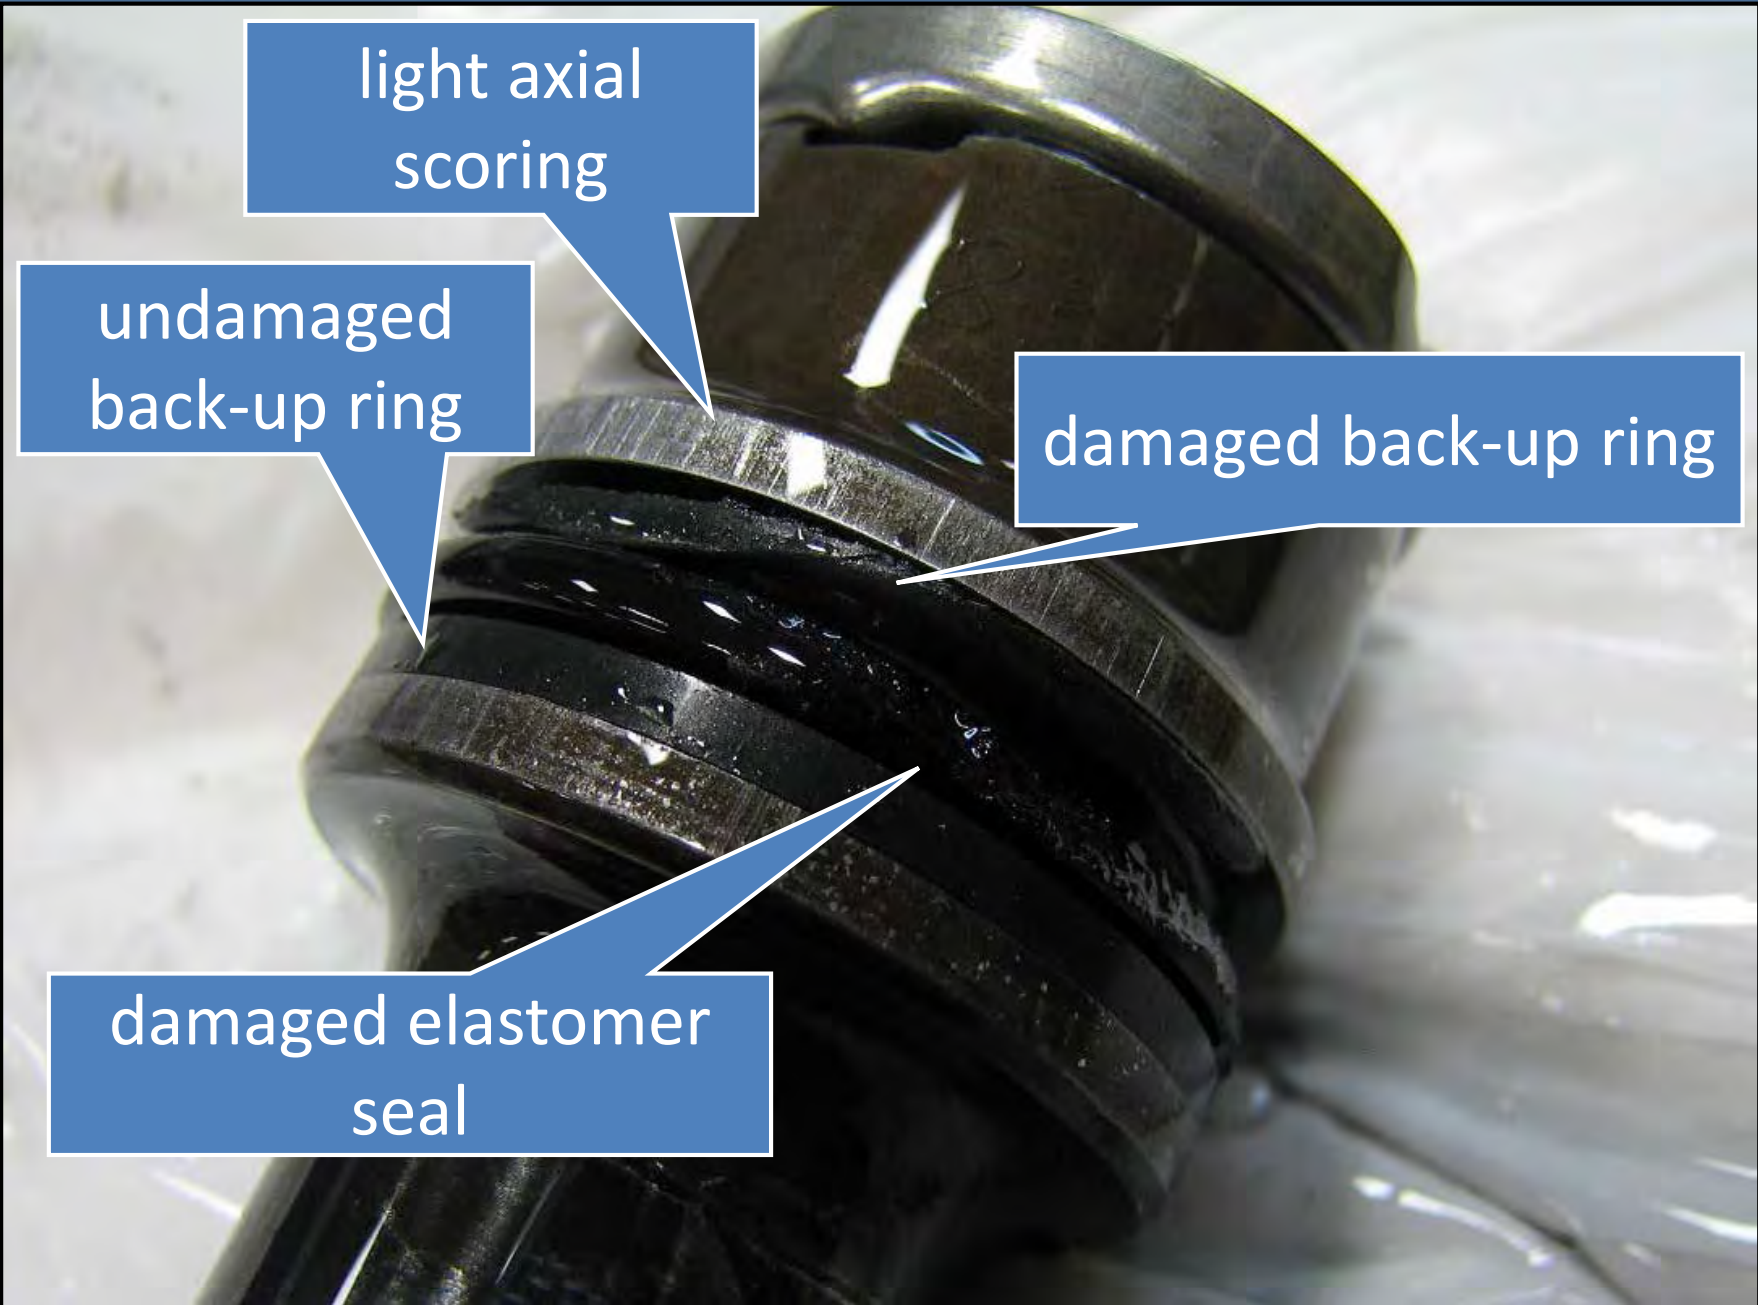
2011-4504
AIRNELSON LTD
(failed packing)

- What caused nose gear to not extend? **Seal debris in actuator ports**
- Damage at manufacture or assembly?
- Damage worsened by other debris in fluid, possibly from door actuator
- Alt extension drill unlikely to have succeeded; cycling gear might have
- Previous symptoms not resolved

light axial
scoring

undamaged
back-up ring

damaged back-up ring

damaged elastomer
seal

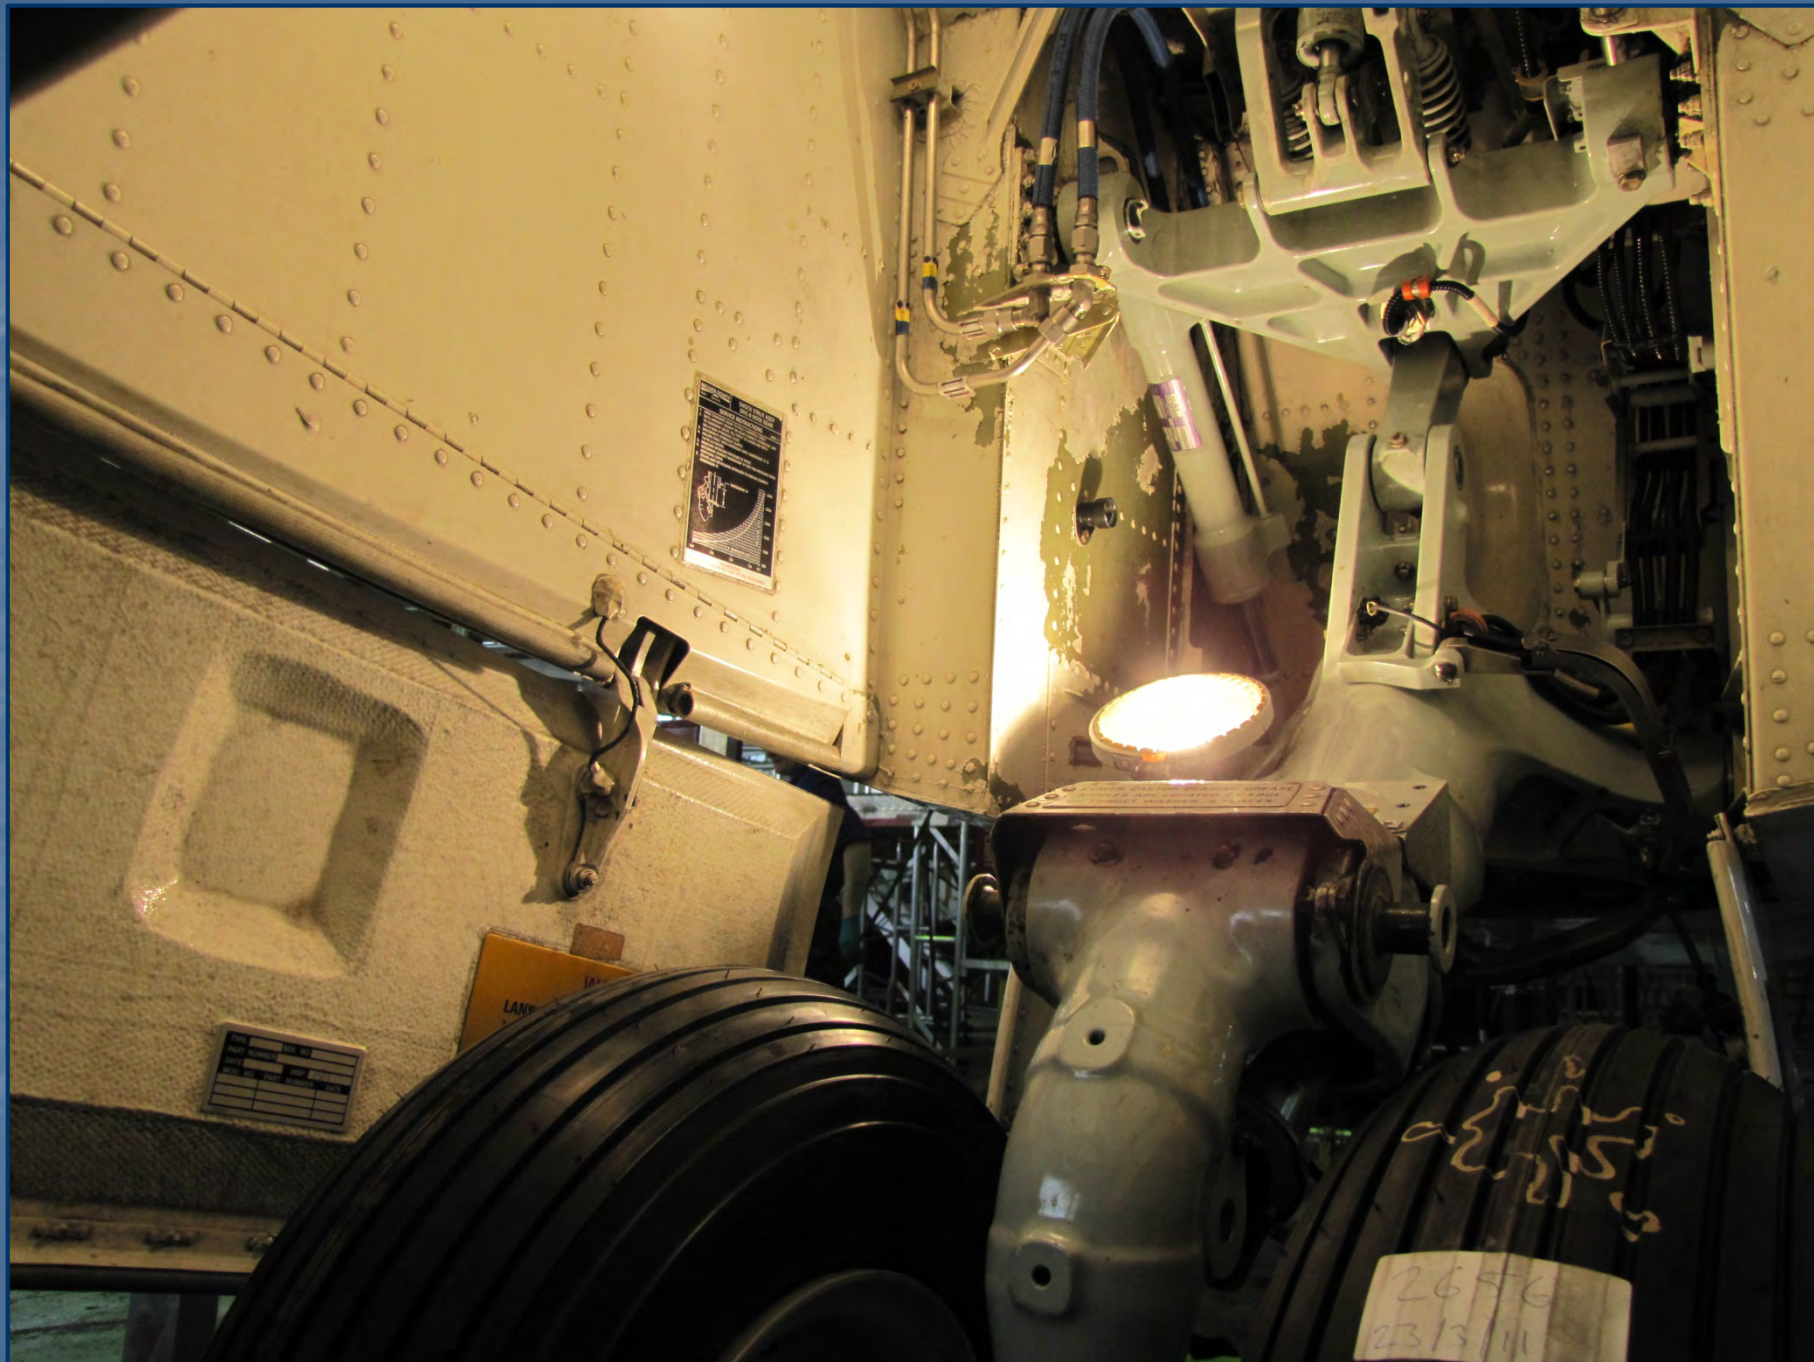
- Why the erroneous verification?
Verification system was deficient
- Taxi light had to be off during check of verification system
- Sensors prone to water ingress

down-lock
verification
sensor

down-lock
verification
light source

aligning hole in link,
and light path

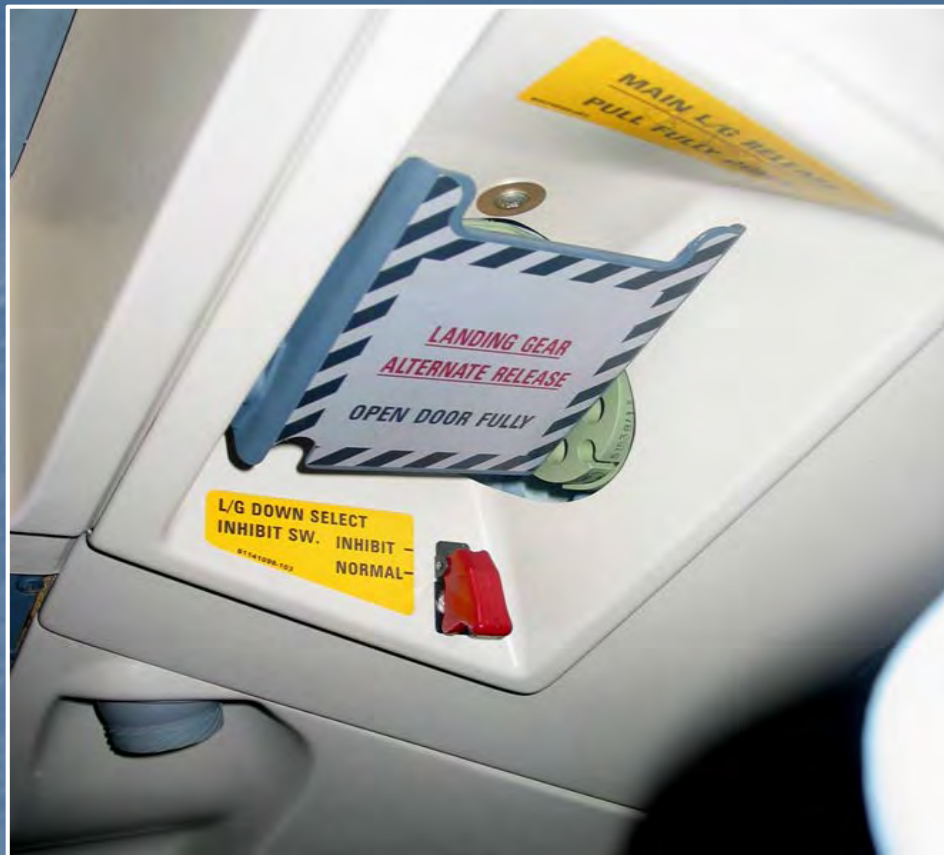
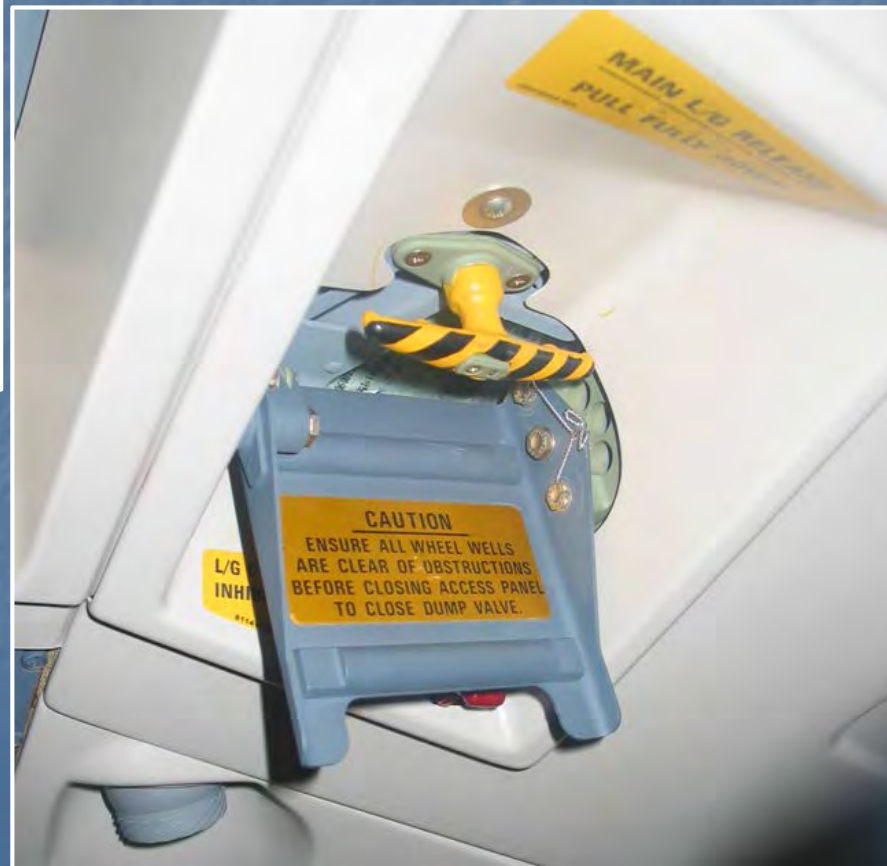
nose gear
up-lock release
handle

verification
lights (3 green
= all gear
locked down)

- Why didn't NLG extend under alt system? **There was no defect with alt system - FO didn't pull hard enough or hold tension for long enough**
- Bombardier noted high forces in its AFM and SLs, but not in its QRH. Air Nelson training and custom QRH did not include that information.
