In-flight fuselage rupture and depressurisation QF30, 25 July 2008

A presentation to the 2009 ANZSASI Regional Air Safety
Seminar

VH-OJK B747-438 Depressurisation 25 July 2008

AO-2008-053

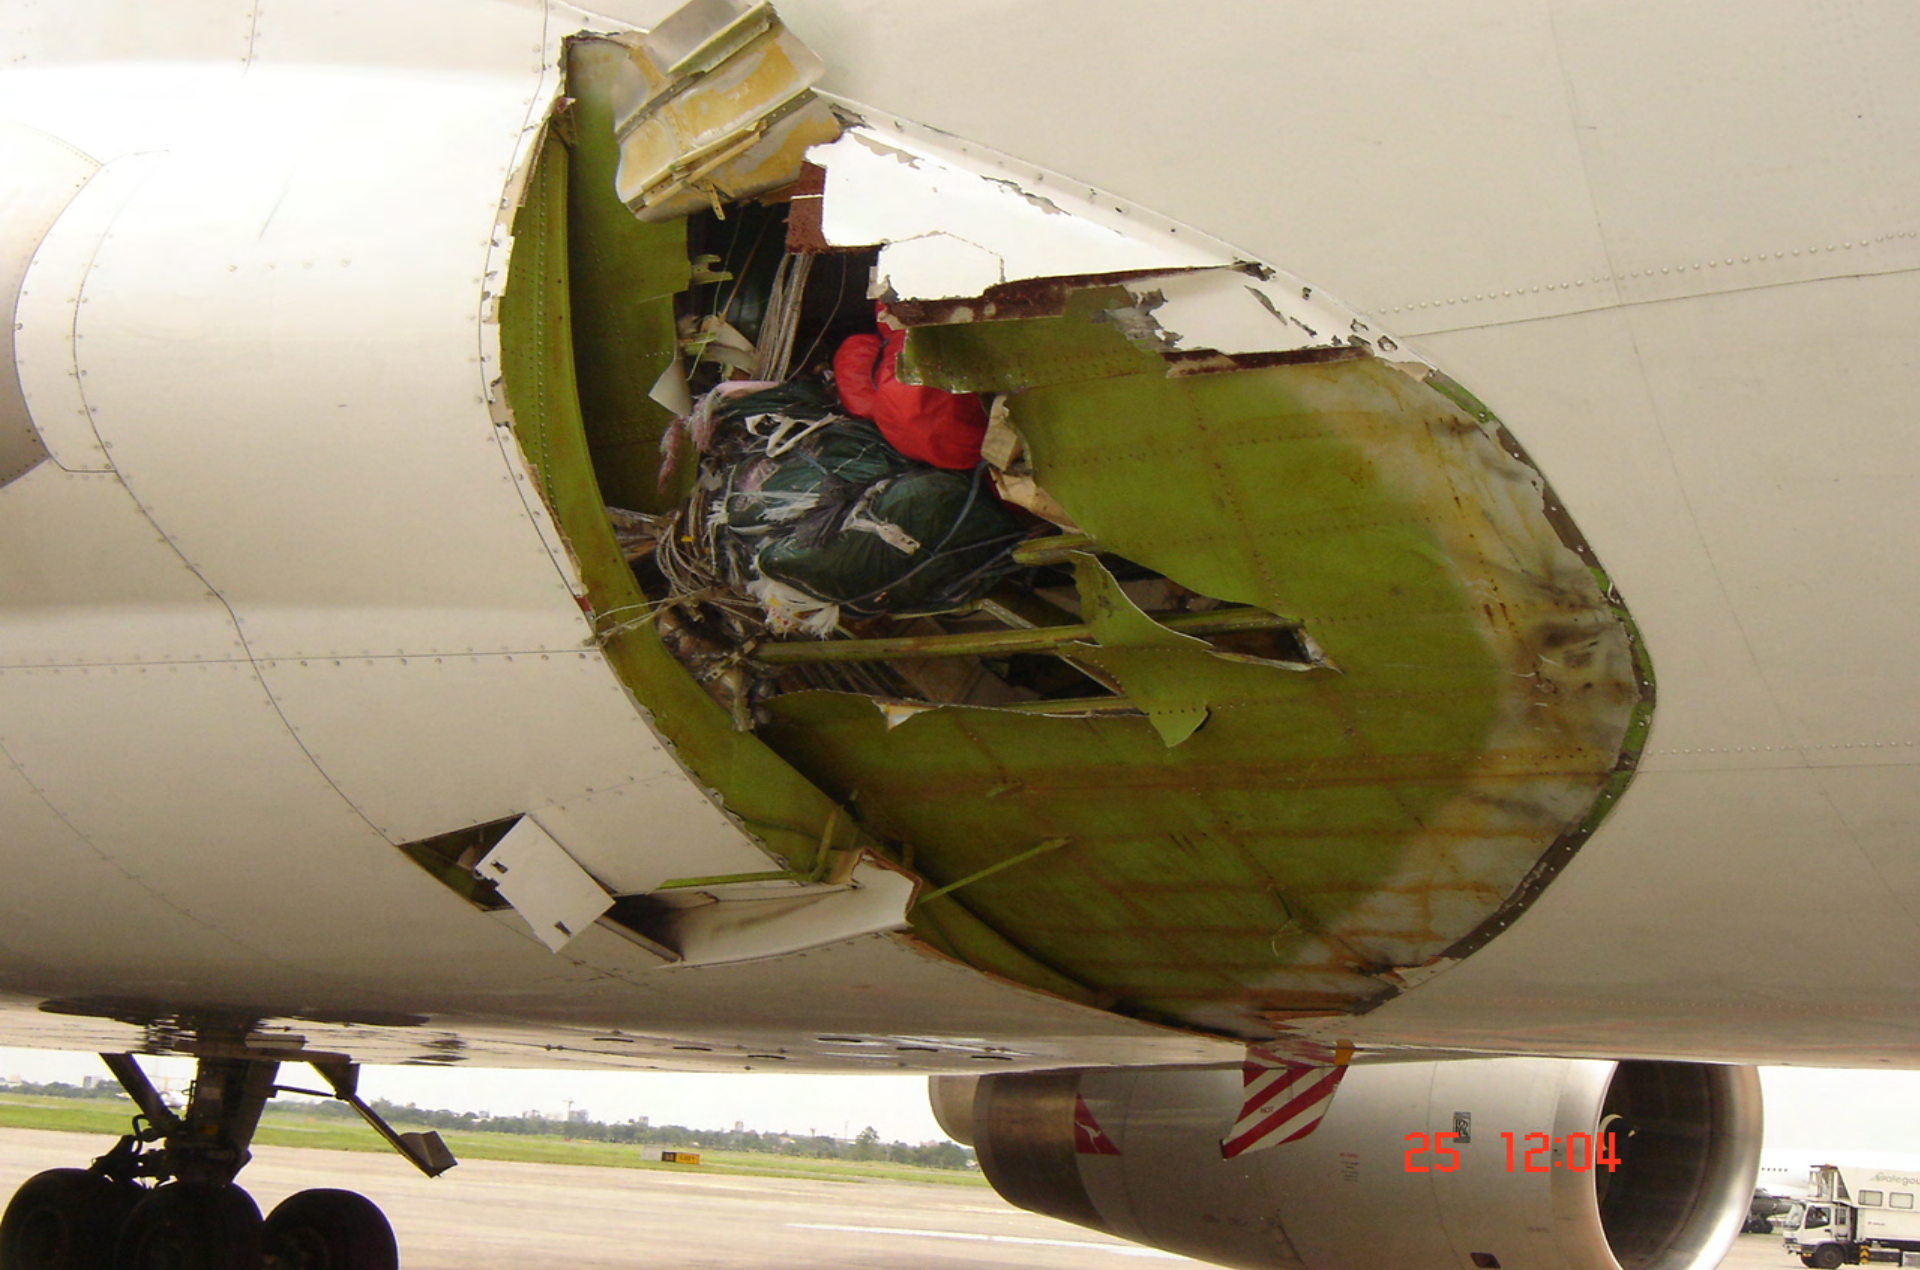
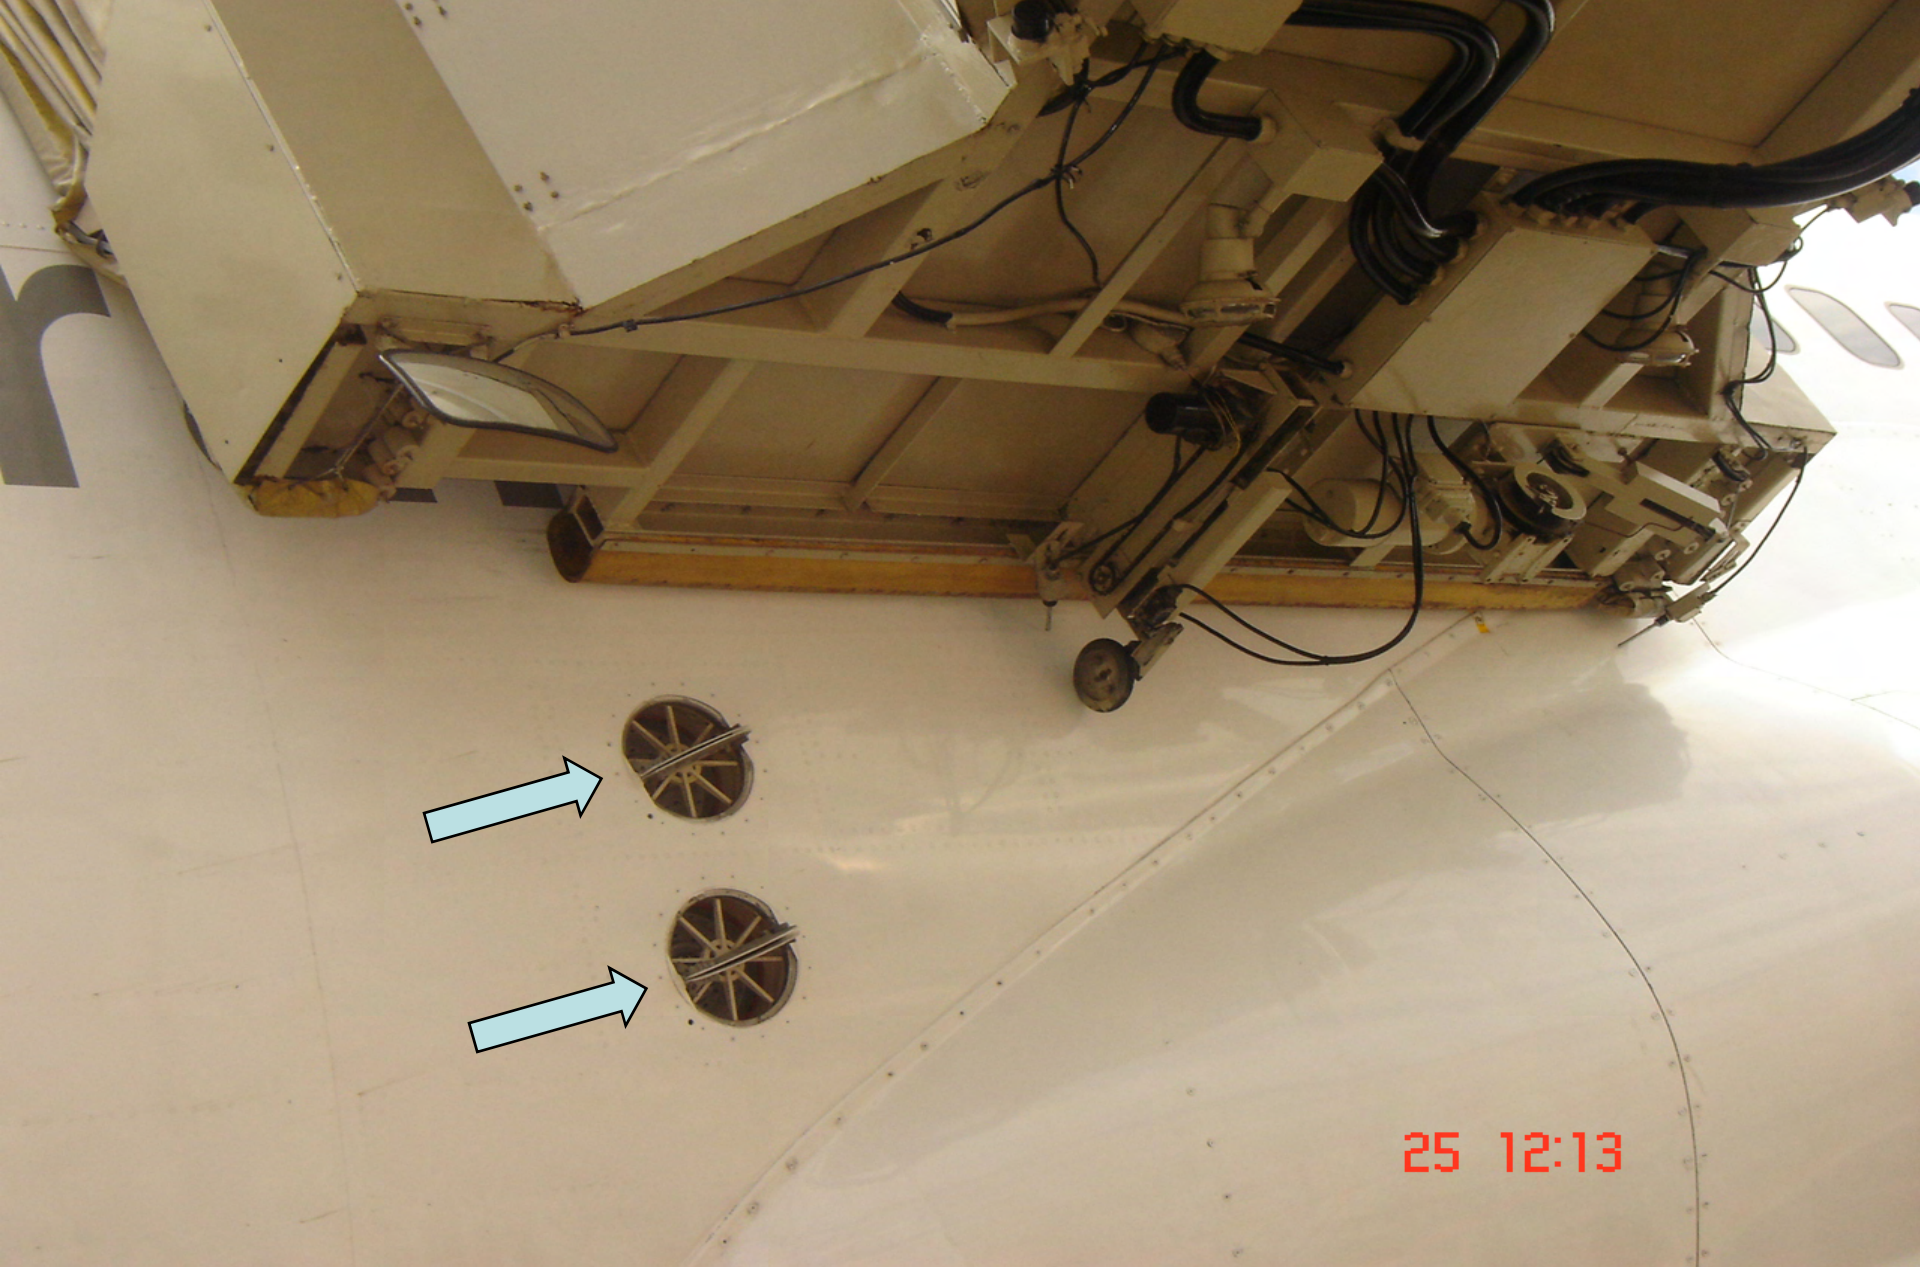
- ATSB team met with Philippine Civil Aviation Authority (CAAP) staff. As the event occurred >12nm from the Philippine coast, the occurrence was over 'international' waters & thus responsibility for investigation fell to the State of Registry under Annex 13....ATSB now in the 'hot seat'.
- Convened a meeting with all parties present, to outline arrangements under Annex 13 and restrictions on release of information, entry to the aircraft and conduct of the investigation.
- External damage was a large rupture in the forward right side fuselage, immediately beneath the R2 door and located underneath the wing leading-edge to body transition fairing, which had been lost.
- Cargo protruding from rupture; severed and damaged wiring visible. Oxygen cylinders visible, with one absent. Pressure relief valve blow-out doors opened.

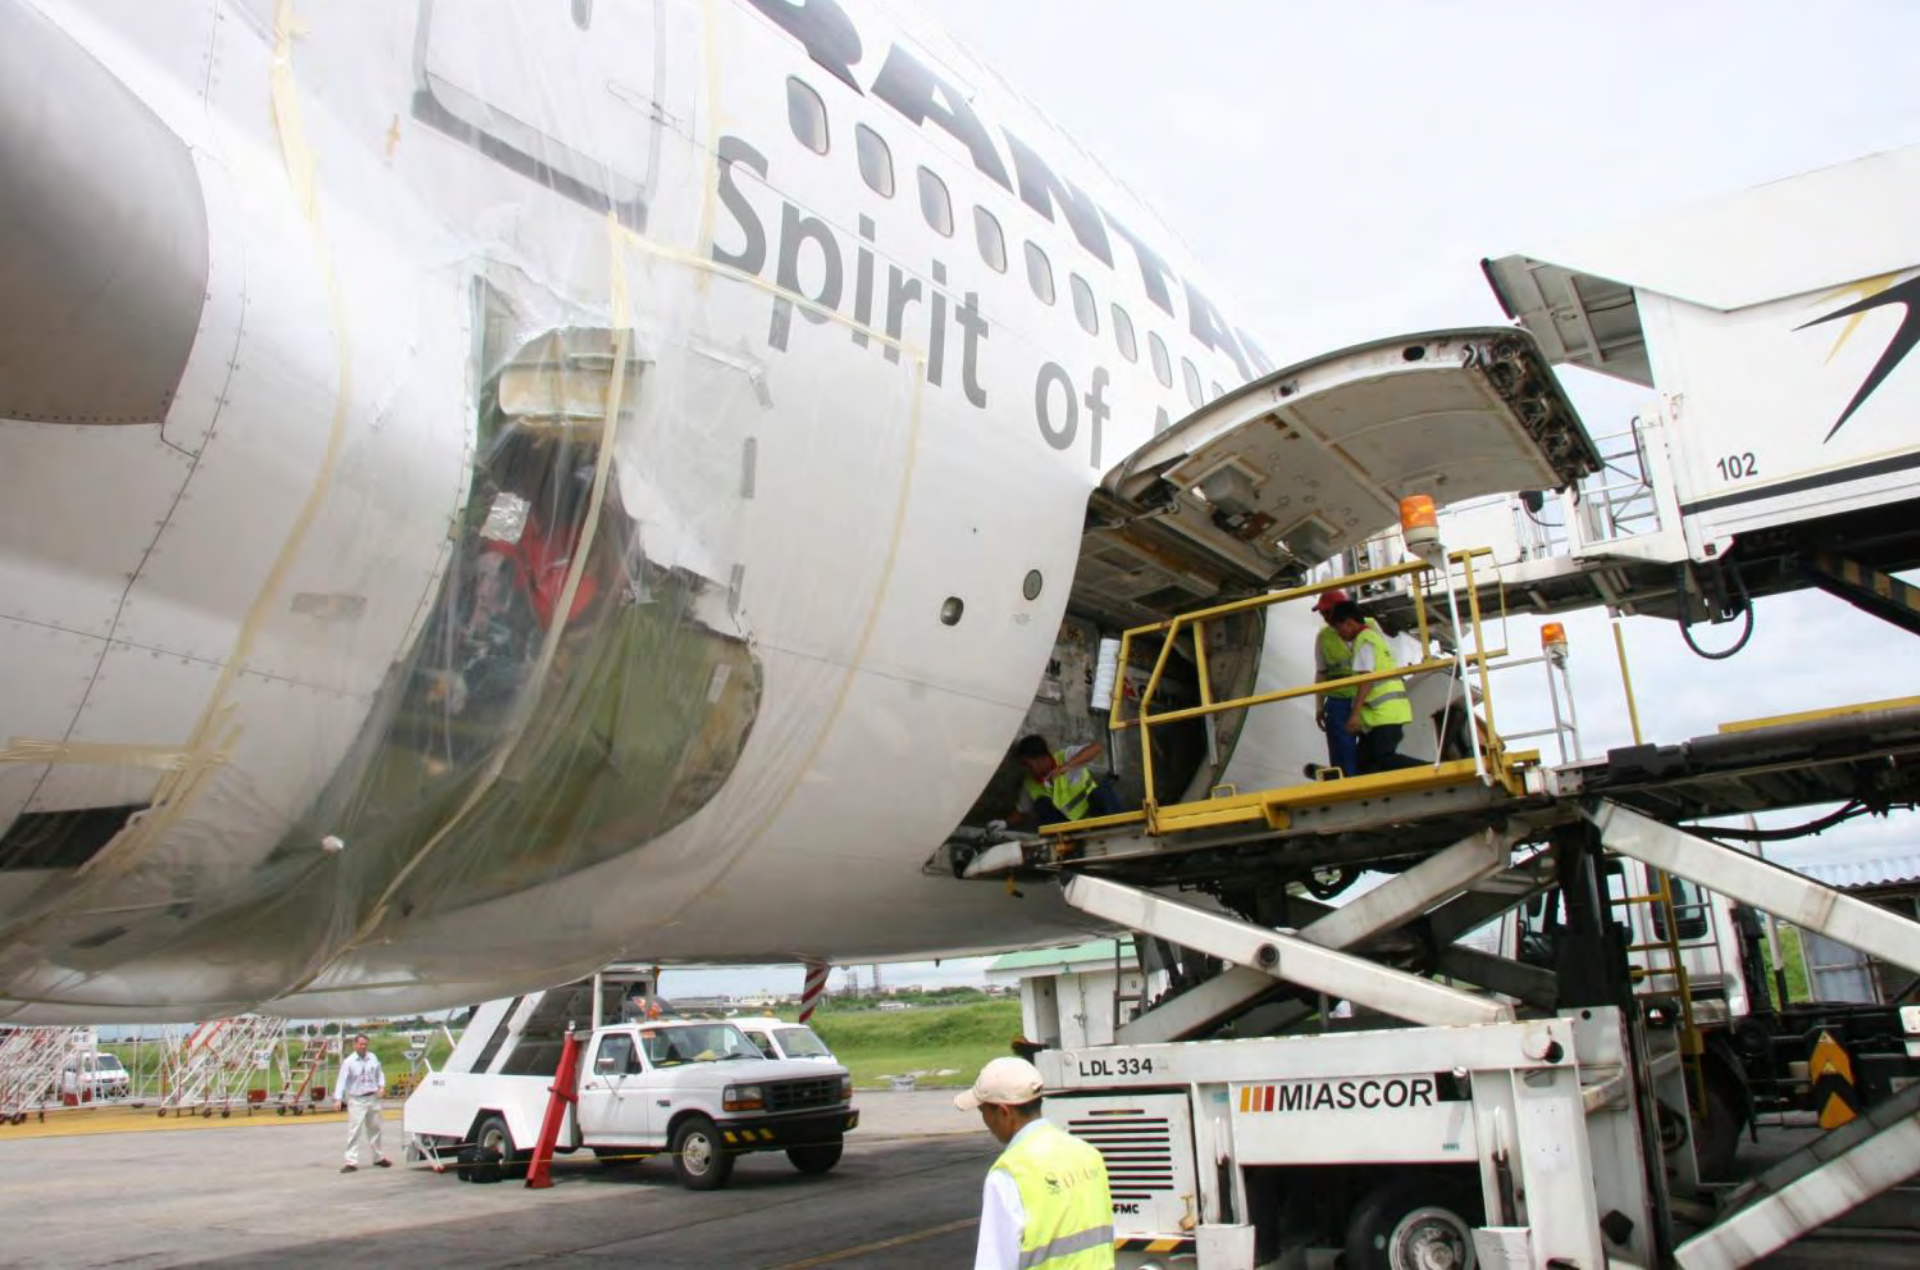
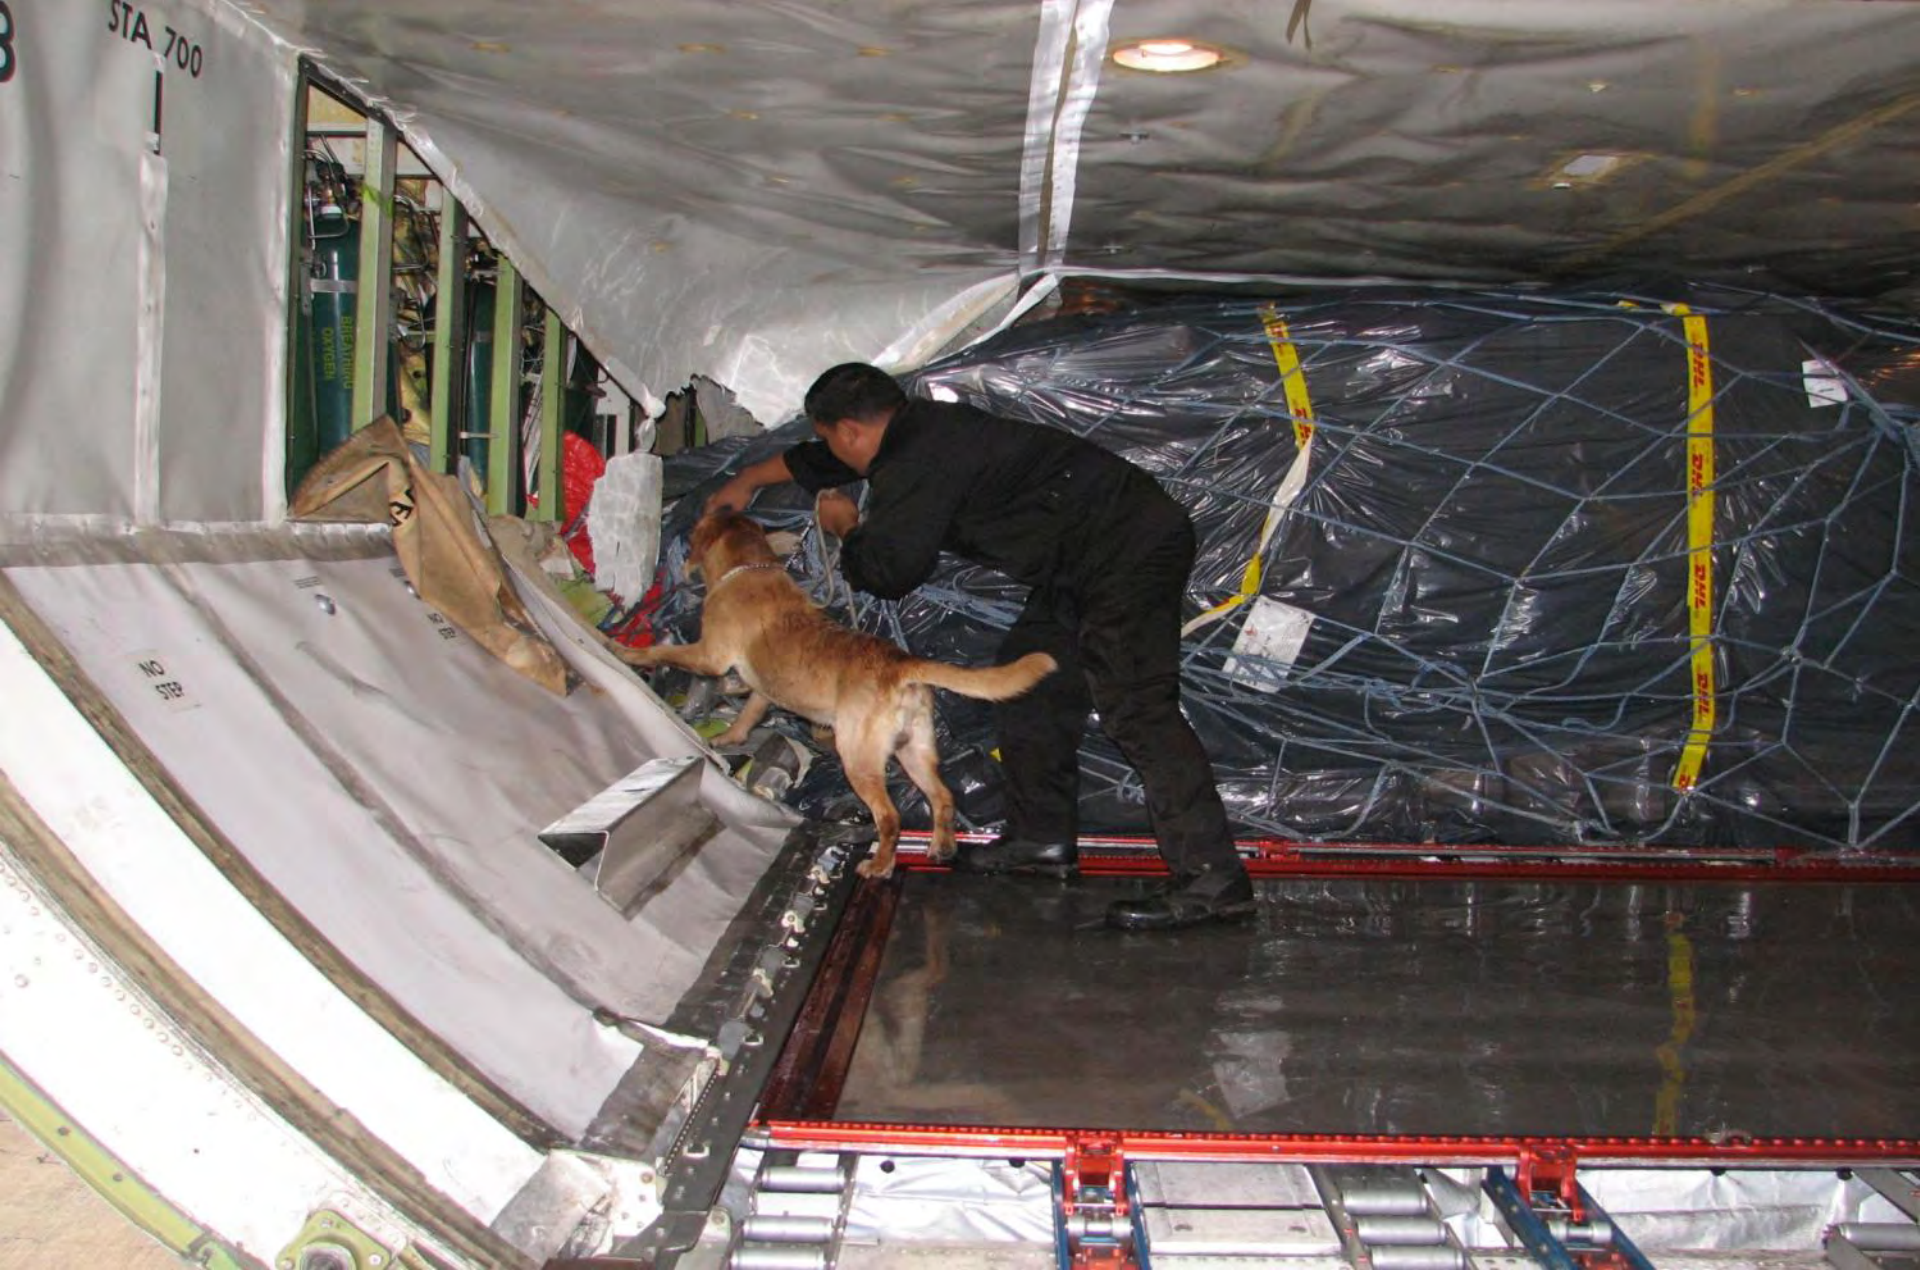
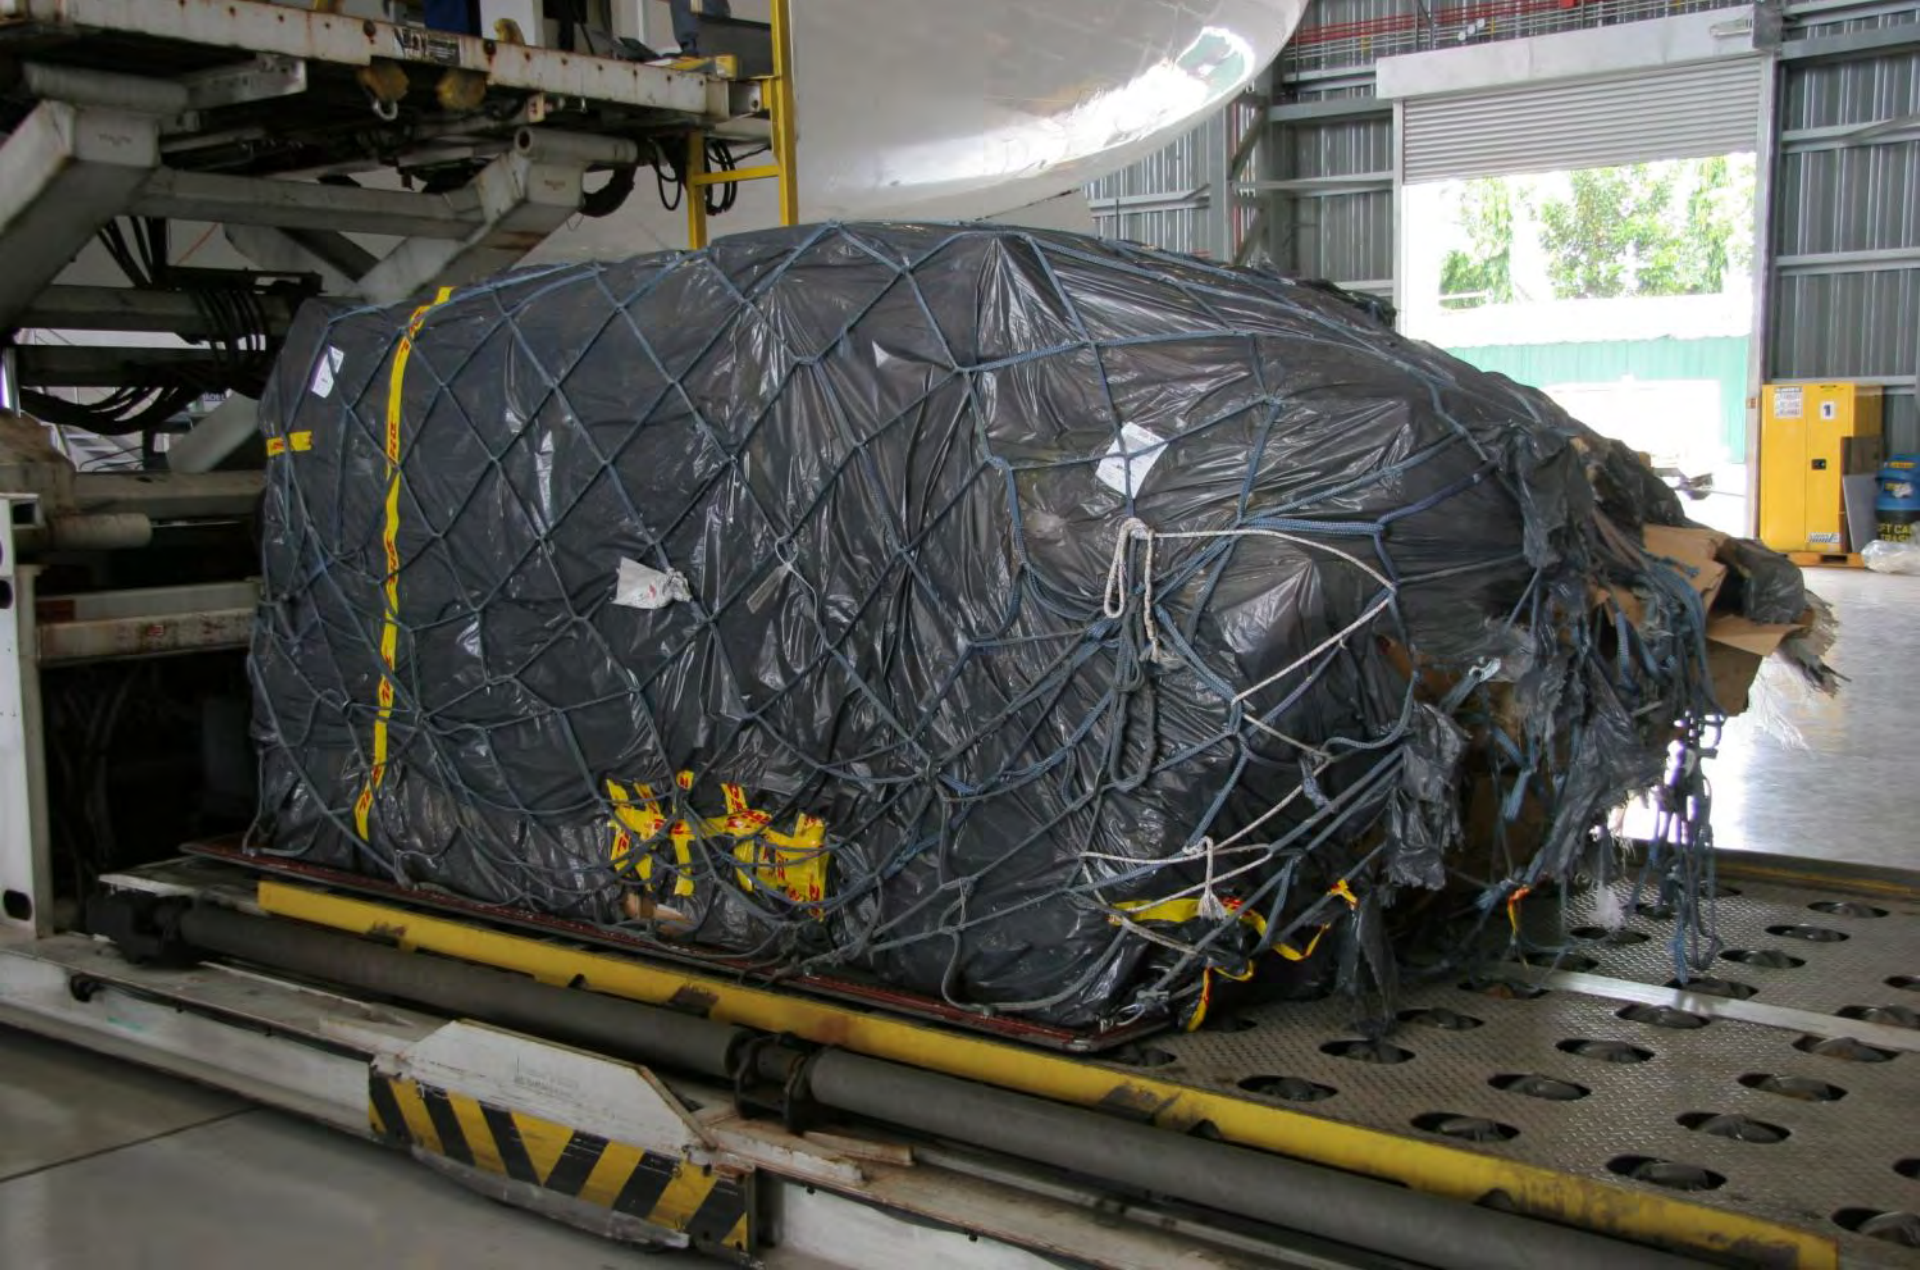
- Stripping of the body panels revealed the full extent of the rupture – 2 m wide x 1.5 m high, in an inverted T shape. Approximately 1.7m² total exposed area.
- Several fractured transverse frames and longitudinal stringers, but no evidence of associated cracking, corrosion, seam-line failure or other potential pre-existing defects.
- One missing passenger oxygen cylinder (number-four from the bank of seven) along right side of cargo hold – immediately above ruptured area. Oxygen line connections broken away in overstress from the valve fittings. Remnants of the cylinder valve recovered from within the cabin near the R2 door.
- No part or remnant of the number-four passenger oxygen cylinder recovered – presumed lost during depressurisation.
- Circular hole in cabin floor immediately above number-four cylinder location.

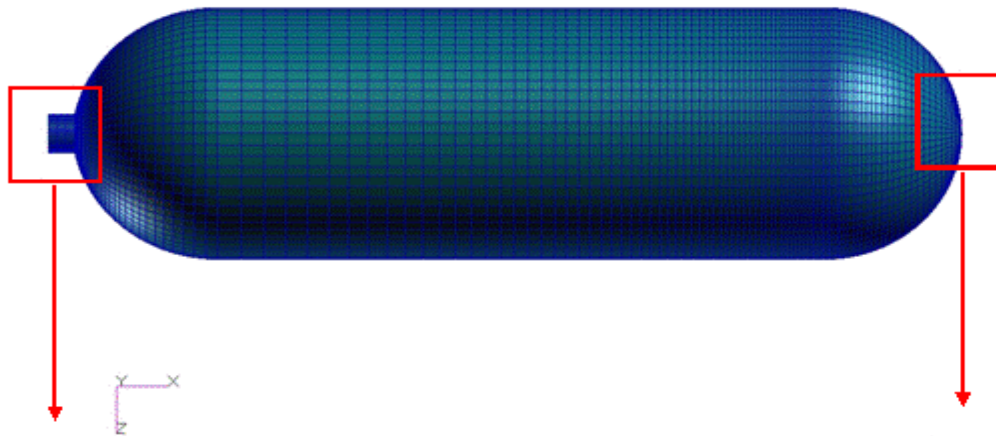
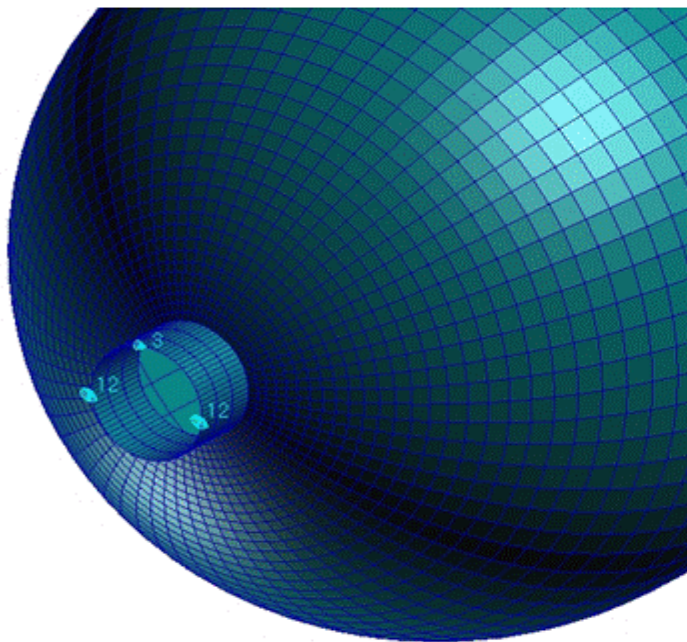
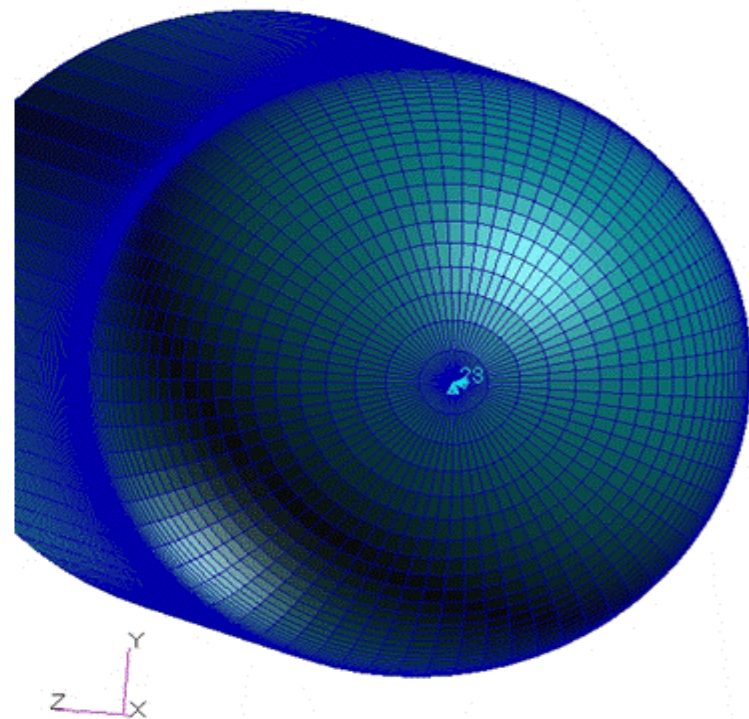
- A finite element model was created to ascertain the stresses developed within the cylinder under internal pressure.
- Linear Elastic Fracture Mechanics (LEFM) methods were used to numerically estimate the size of a cylinder shell defect that could cause unstable fracture at both the cylinder service pressure (1,850 psi) and re-test pressure (3,083 psi).

- Work ongoing to examine the study findings and correlate with the investigation evidence.
