# **ANZSASI 2003: THE OBVIOUS CAUSE!!**

## **Case Study: Report 01-011 - History of the flight.**

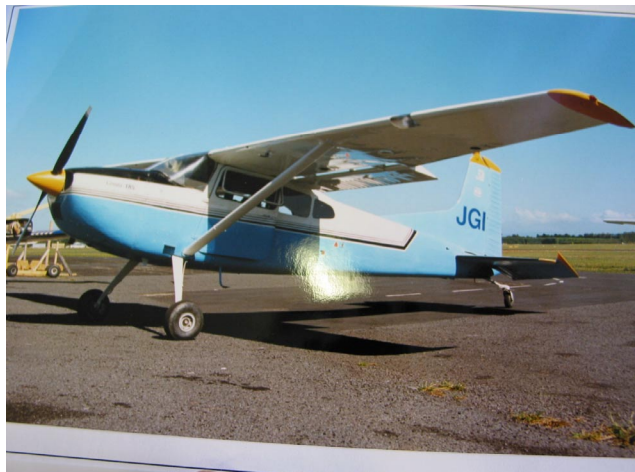
Shortly after take-off, at about 100 feet and passing the end of the runway, there was a sudden and total loss of engine power. The pilot established a glide and manoeuvred away from some buildings towards a clearer area. The aircraft clipped a row of trees surrounding a kiwifruit orchard before striking the ground heavily 15 m past the trees. The aircraft slid for about 10 m before coming to rest. As the aircraft slid along the ground the left wing struck some kiwifruit vines and a post, spinning it around to the left through 120°.
