## More than just VFR into IMC

Decision making and data analysis in accident investigation

**AO-2021-017 – In-flight  
breakup involving Van’s  
Aircraft RV-7A,  
registered VH-XWI**

90 km south of Charter  
Towers, QLD, 23 April 2021.

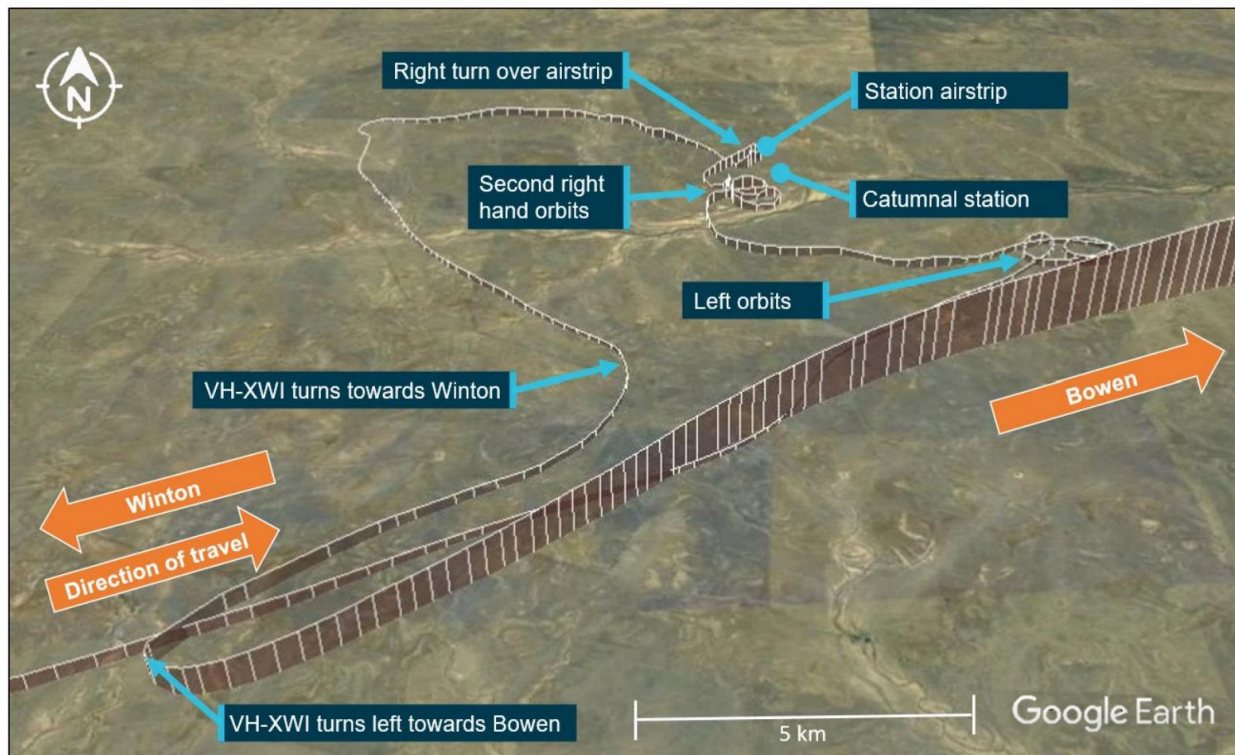
VH-XWI recovered at low level from the stalls overhead the station, then navigated at low level back to its original track and turned towards Winton

However, at 0838, about 11 km after turning towards Winton, the aircraft conducted a left climbing turn then re-commenced a track towards Bowen and climbed to about 10,500 ft AMSL.

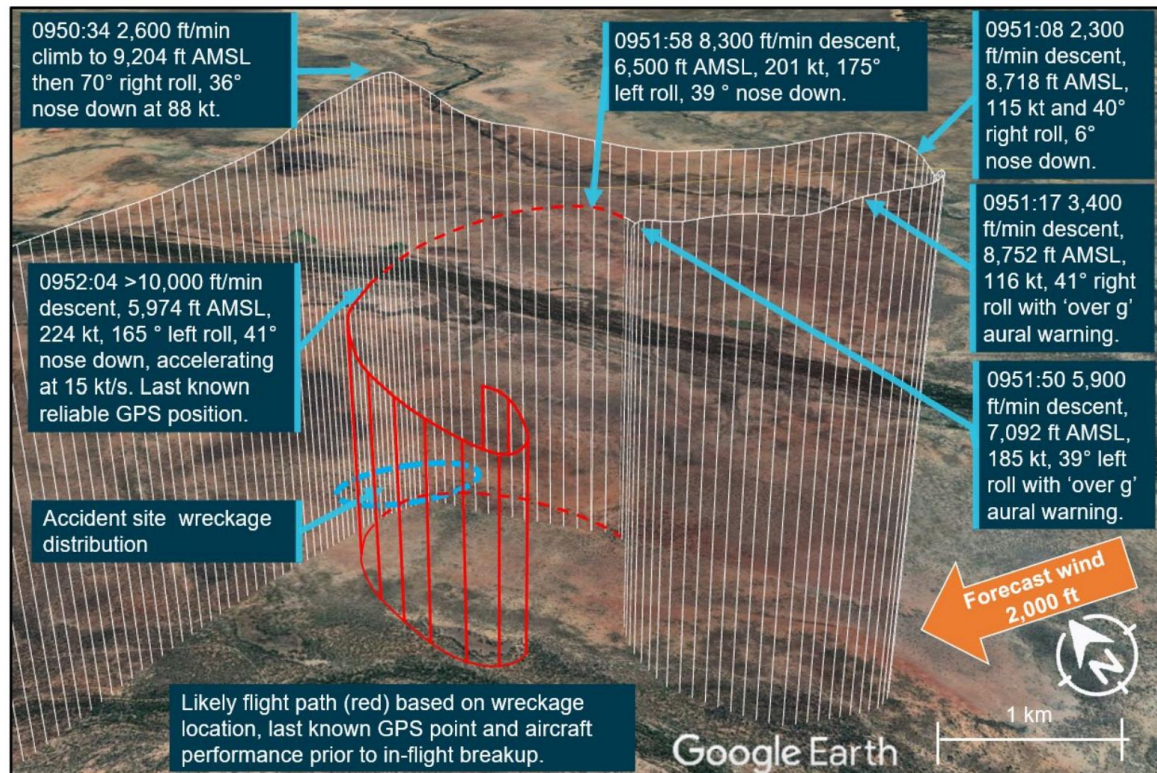
The last 90 seconds of flight was originally not accounted for, due to likely power disruption during the in-flight break-up

Subsequent data recovery found an additional 70.5 seconds and assisted us in identifying the final stages of flight.

- Review of the raw data download was conducted
- Previous data was extracted using a Windows based system
- An additional download was conducted using a Linux based system
- Additional analysis was undertaken on the final flight performance.
