Australian Government  
Australian Transport Safety Bureau

# **AO-2023-001 Sea World mid-air survivability assessment**

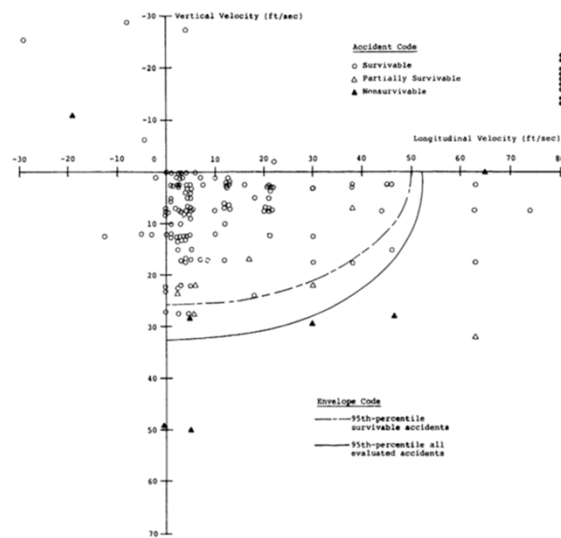
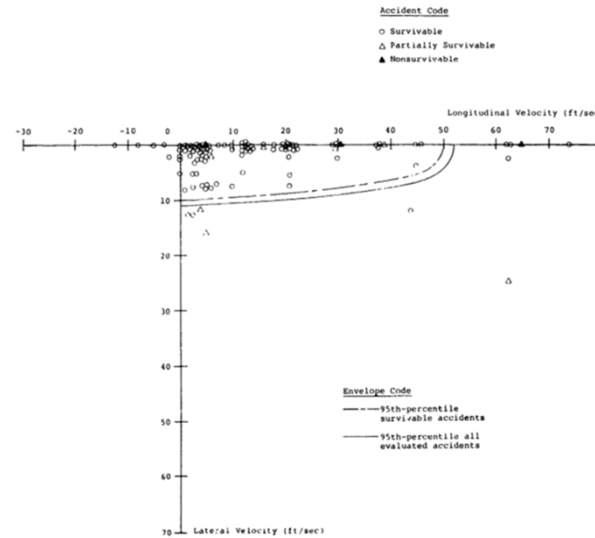
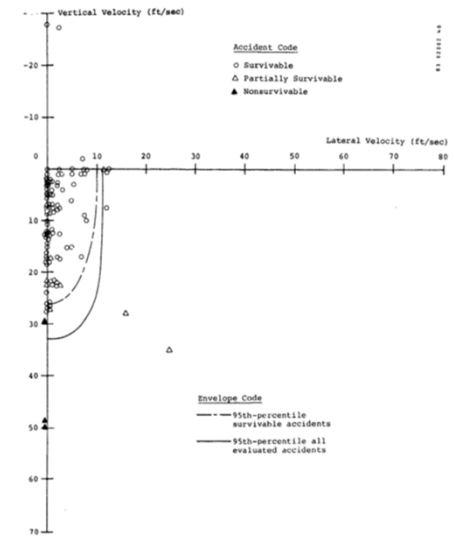
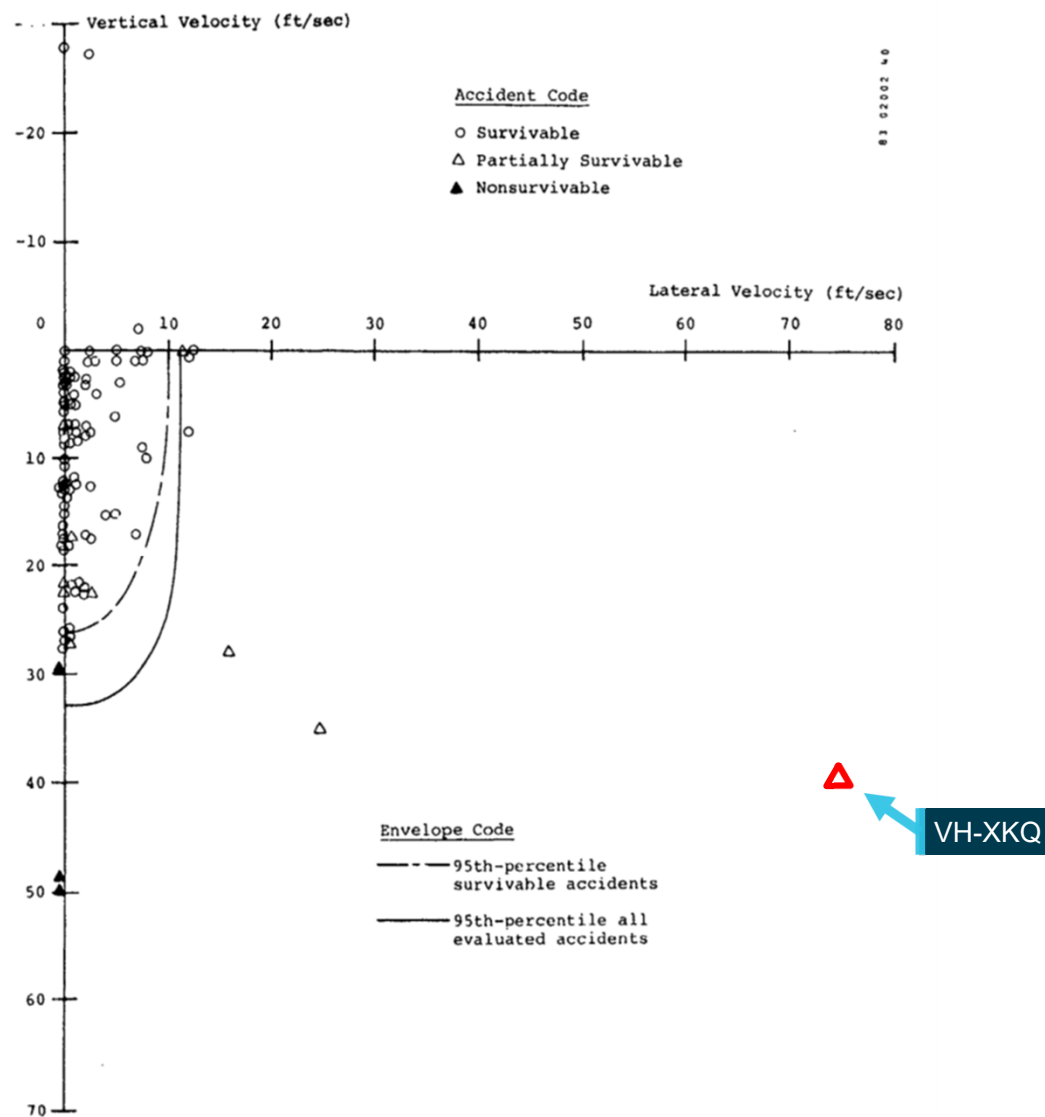
# Reference material

- Coltman, et al (1985) *'Analysis of rotorcraft crash dynamics for development of improved crashworthiness design criteria'*
