406MHz ELT's and 406MHz Antenna's

Lloyd Klee
www.aviationsafety.co.nz

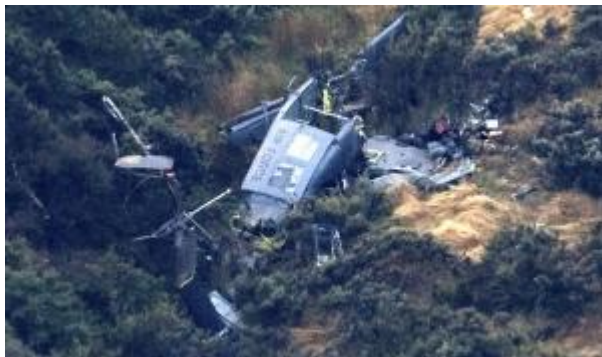
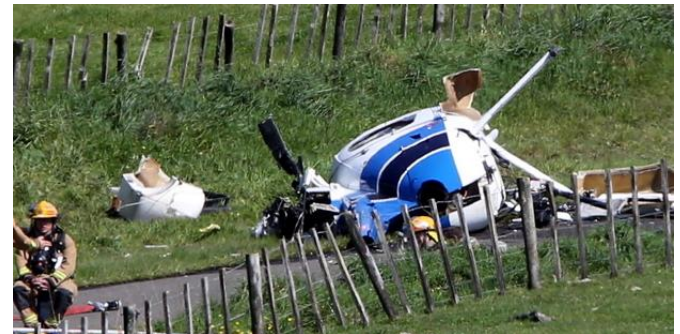
Antenna Location

One of the major issues is the location of the Antenna

- Many are installed on the side of the helicopter – **Which side?**
- ***The side that the helicopter naturally lies on due the torsional rotation of the blades***

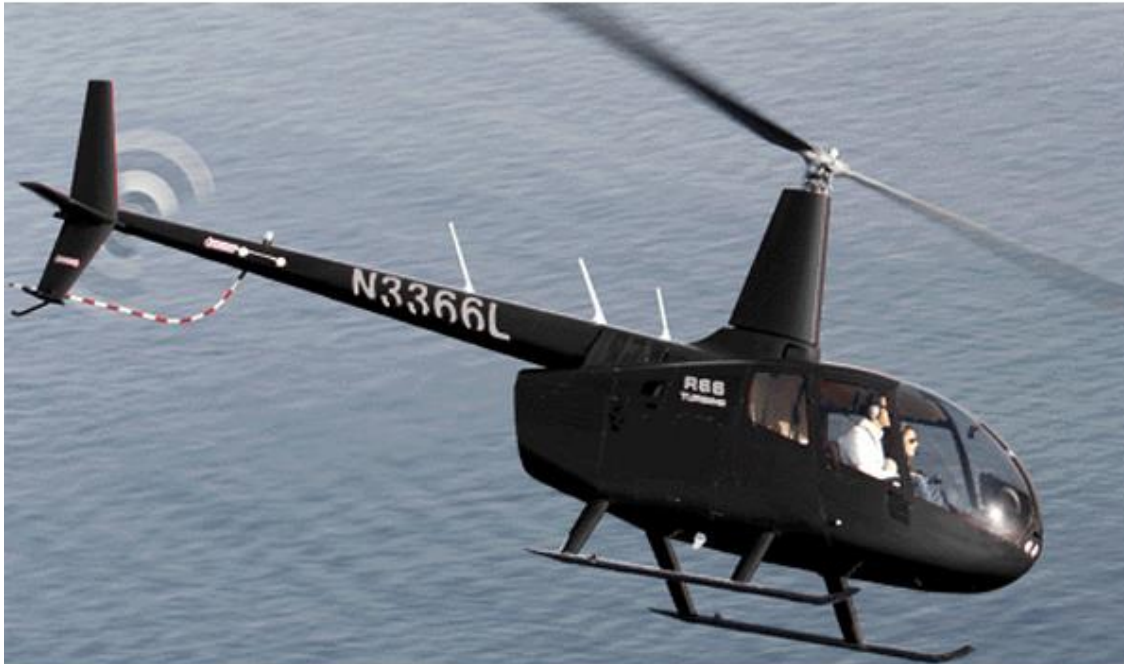
Antenna Location

The rest are on the top and just as vulnerable

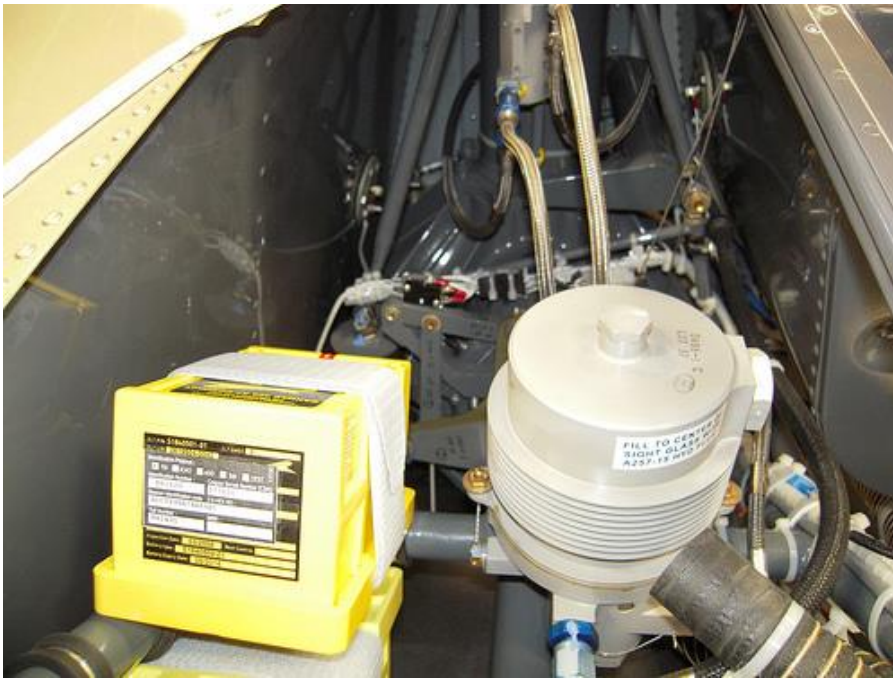
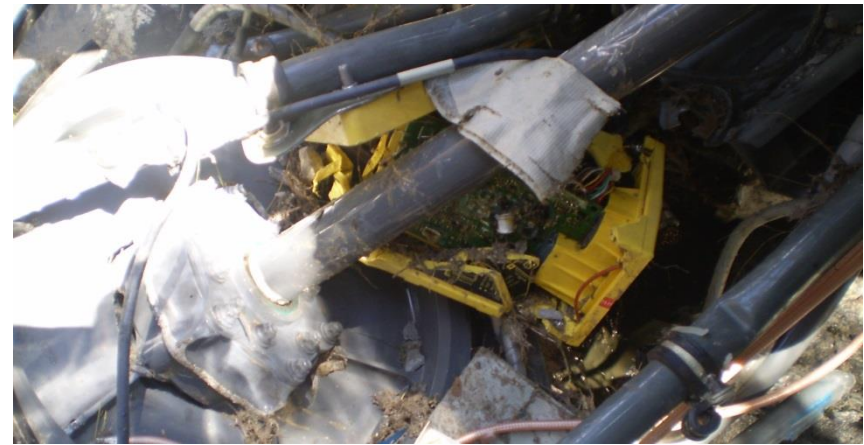
Results of ELT location

Then there is the issue with the location of the ELT !

The main mast to the rotor can crush the ELT especially if it is a R22 or R44

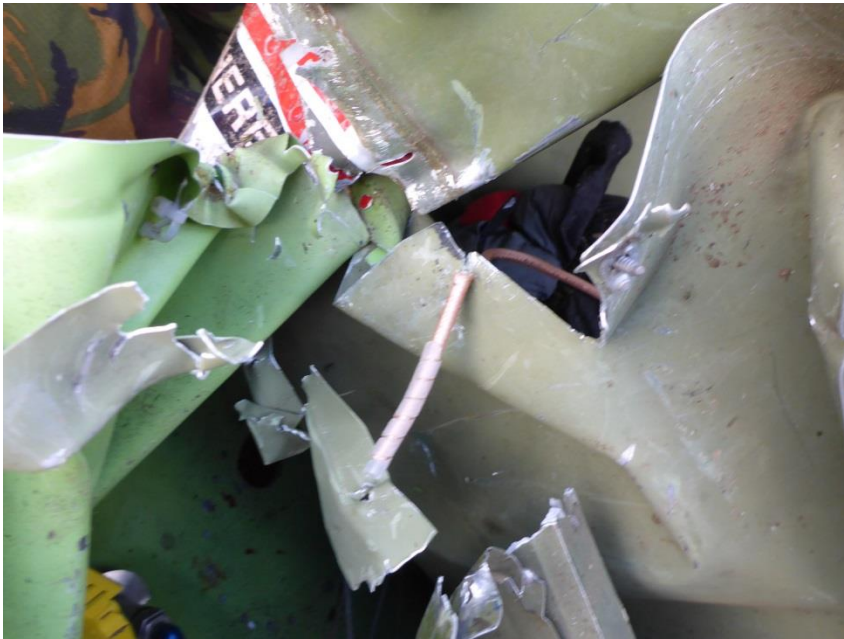
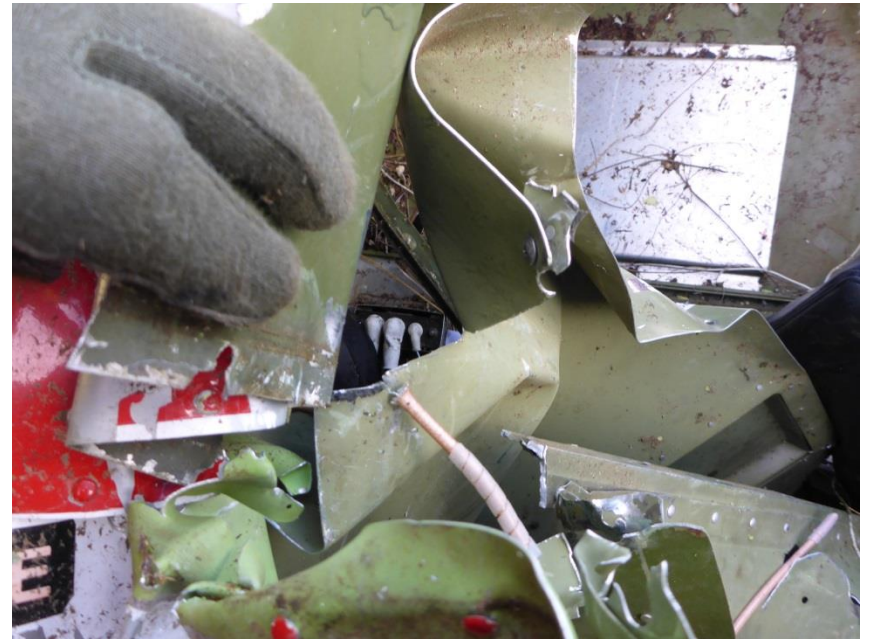
Antenna Cables through bulkheads

The new cable “stripper”

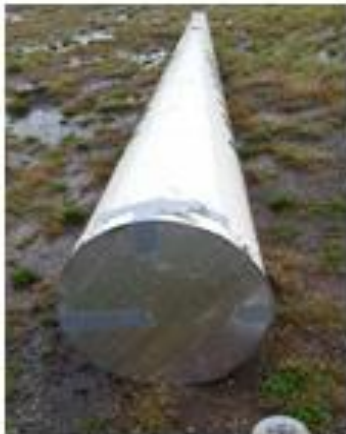
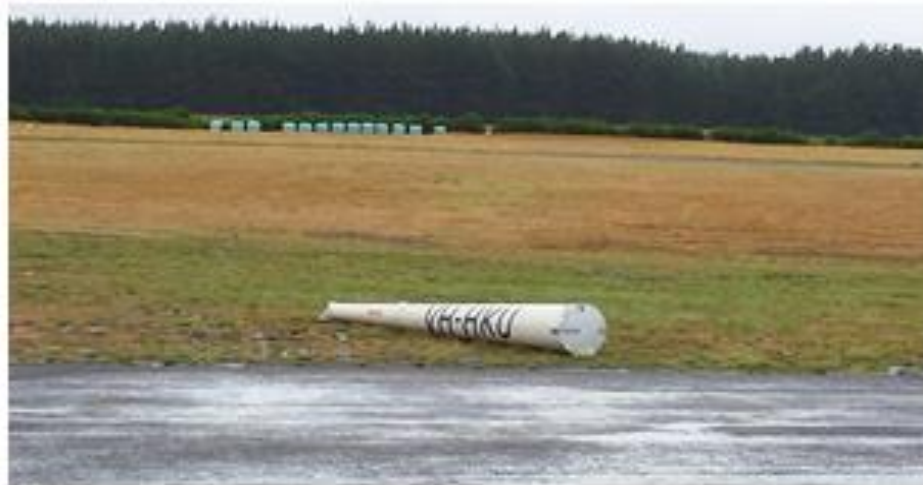
Testing an antenna within a Tail Boom – R44

Test location Taupo

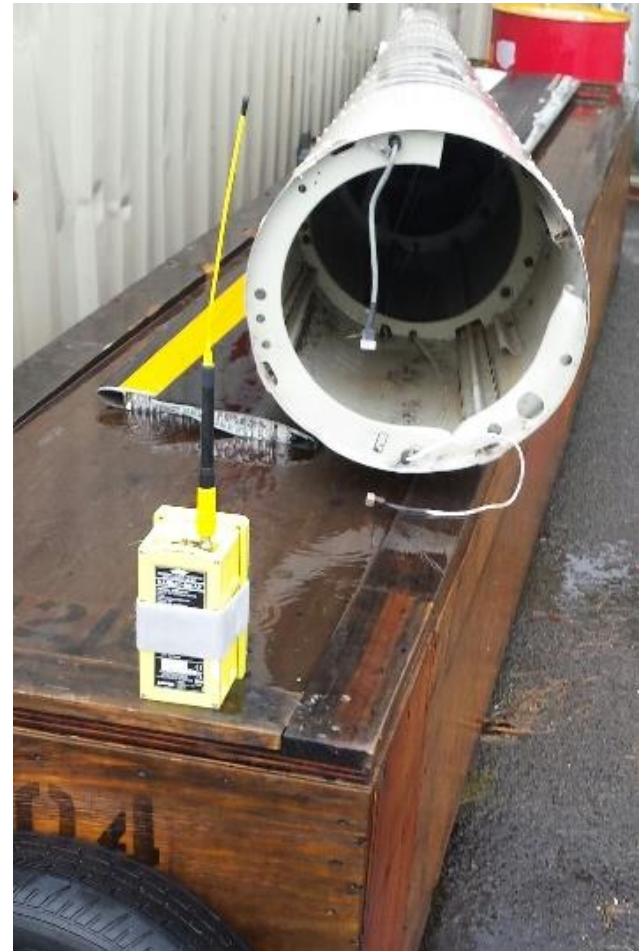
Test of an antenna within a tail boom

- Check BT100 2015- 043
- Power measured BT100 = 35.2dBm
- Power receipted on GEO satellite
- -134.55 dBm average

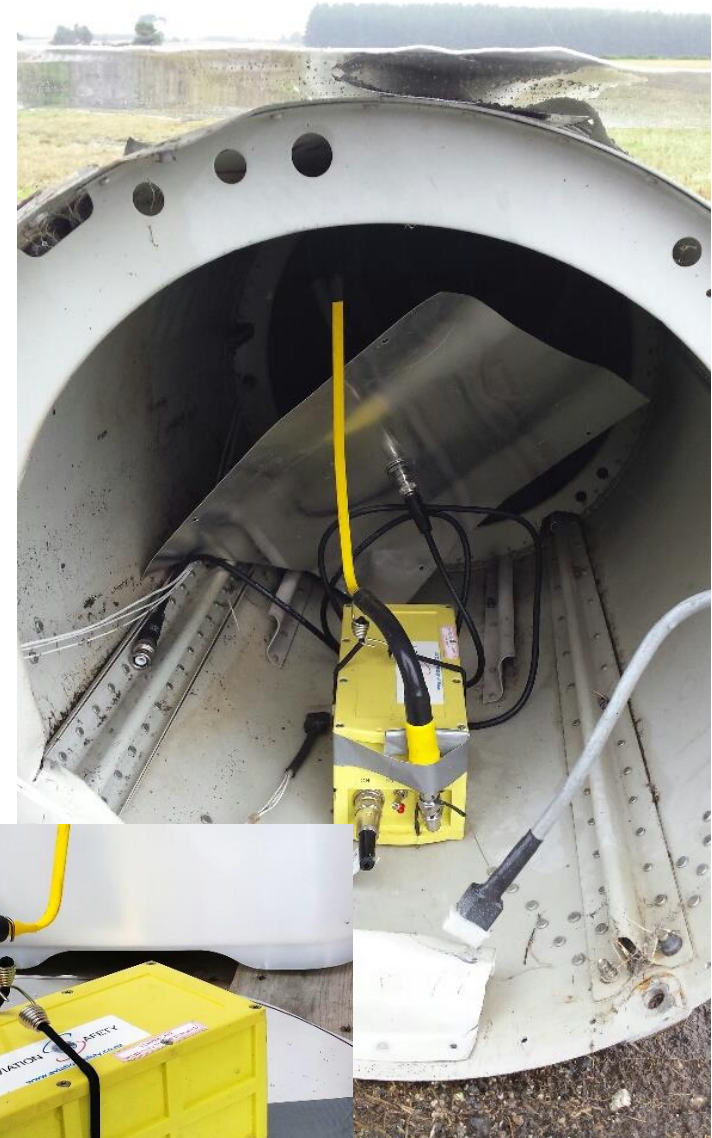
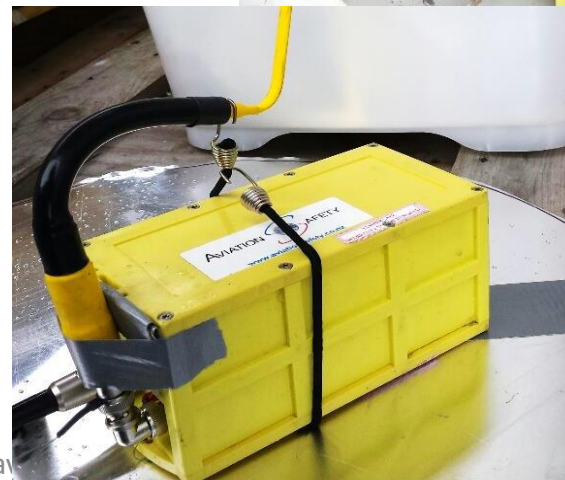
Test- (successful)

406AP- Vertical Antenna bent in “h” shape to fit boom then boom enclosed

External Radiated power measured BT100 2015-045 = **43%**

Power measured on LEO satellite

-138.23dBm average

This test was also successfully repeated with a whip antenna enclosed in the tail boom

- *That a 406MHz antenna within an aircraft fuselage will transmit successfully to the Cospas-sarsat system*
- *The tests show that it matters little if the fuselage material is composite or aluminium*
i.e. You do not need a window
- **NOTE** *that the signal will not transmit through a carbon fibre fuselage*

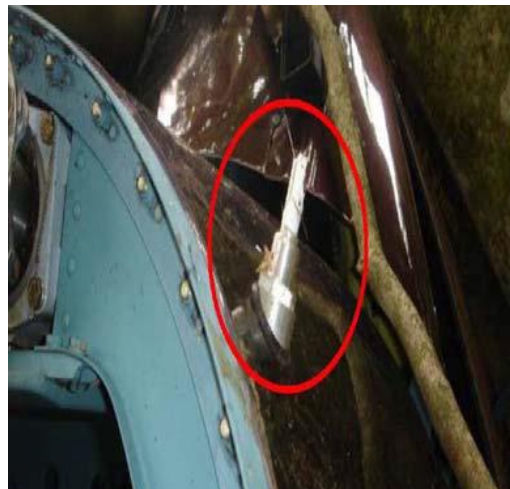
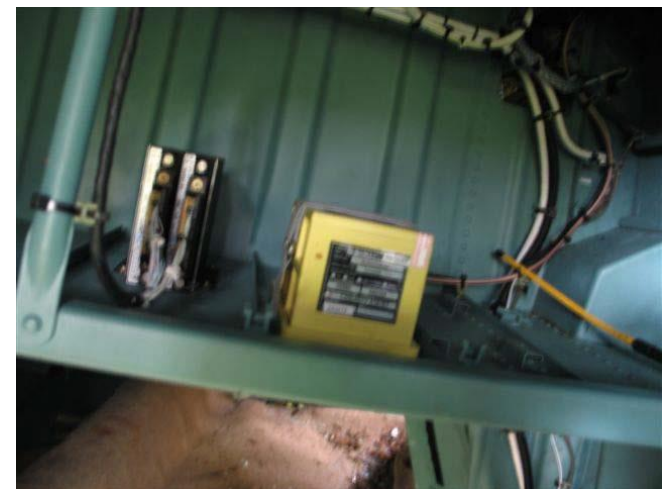
- *Engineers will be able to install 406MHz ELT systems in the most crash worthy position and still comply with regulations*
- ELT systems currently fail due to regulations
