# **ASSESSING ADHESIVE BOND FAILURES: MIXED-MODE BOND FAILURES EXPLAINED<sup>1</sup>**

## **Summary**

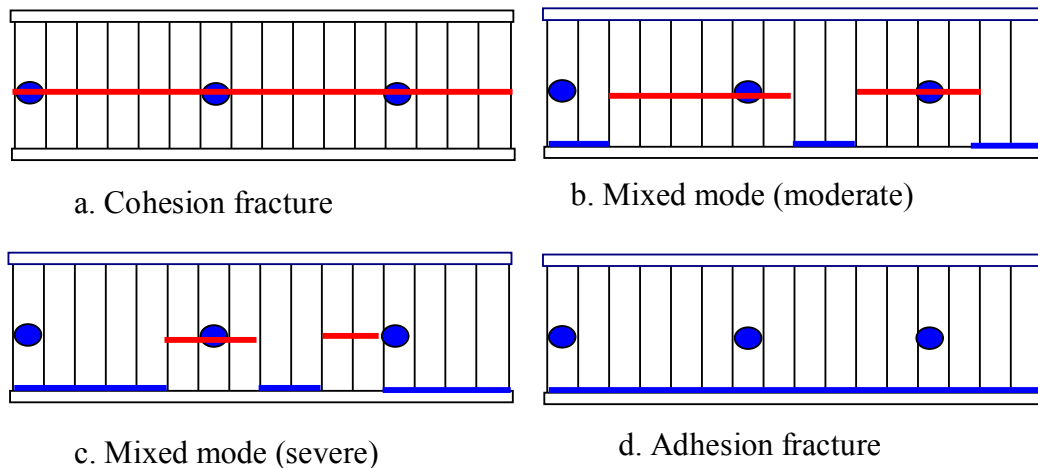
**Figure 4: Model explaining how the progression of interfacial degradation changes the locus of failure of an adhesive bond**

Next, introduce a limited amount of interfacial degradation such that the bond in those columns is weaker than the plane of the carrier cloth, see Figure 4(b). The failure will be partially through the interface and partially through the plane of the carrier cloth. As interfacial degradation progresses, see Figure 4(c), the plane of failure becomes dominated by the weaker interface. Eventually once the entire interface is degraded, see Figure 4(d), the failure is totally interfacial. *It is important to understand that as the plane of failure progresses towards the interface, the bond strength is decreasing.*
