Li-Ion Batteries, SMS and Incidents

ANZSASI

Michael Burdick

June 2017

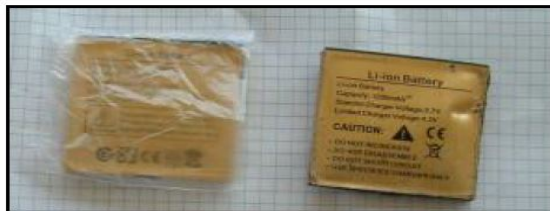
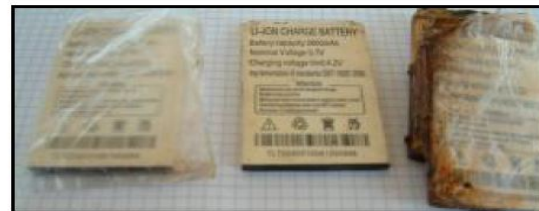
Lithium-ion, mobile phone type battery

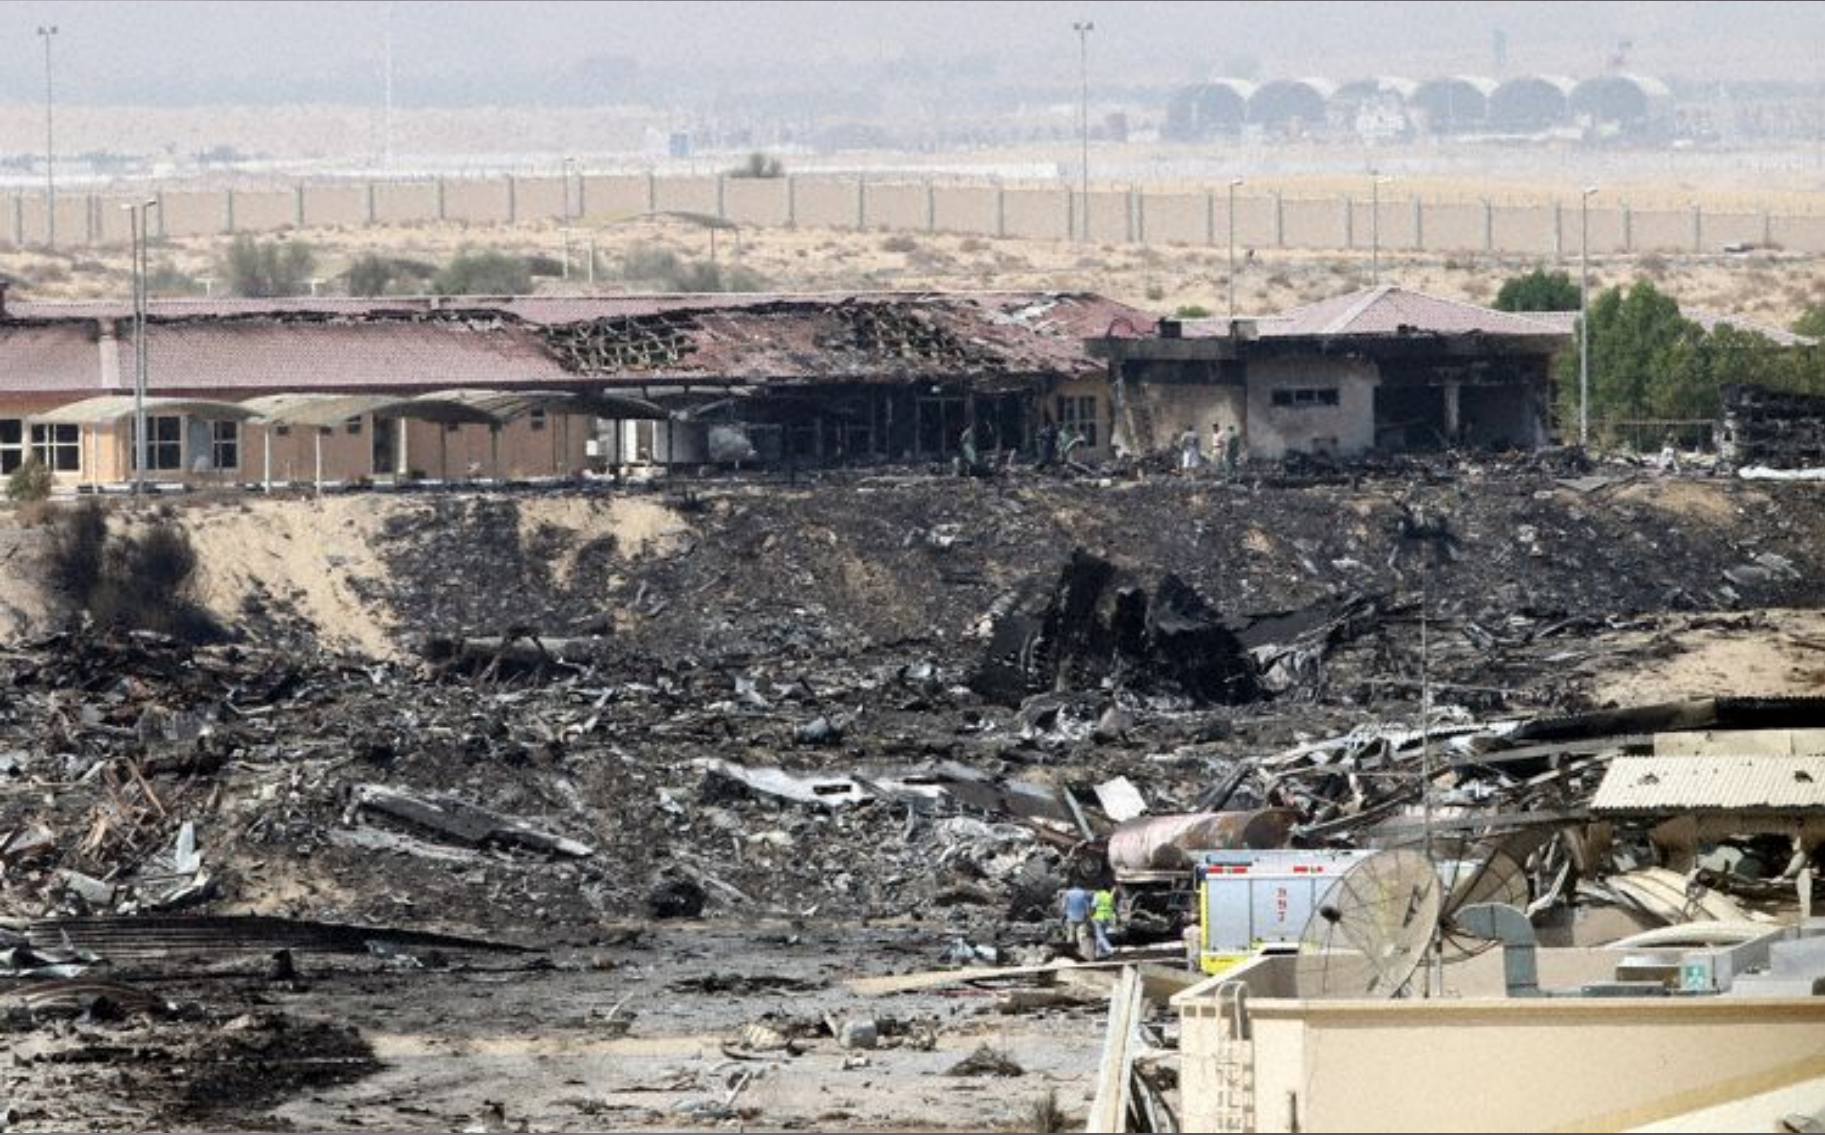
Asiana Cargo B744, West of Jeju International Airport on July 28, 2011, crashed result of a cargo fire

Obtained from Aircraft and Railway Accident Investigation Board (ARAIB)
Interim Report Reference: AAR1105

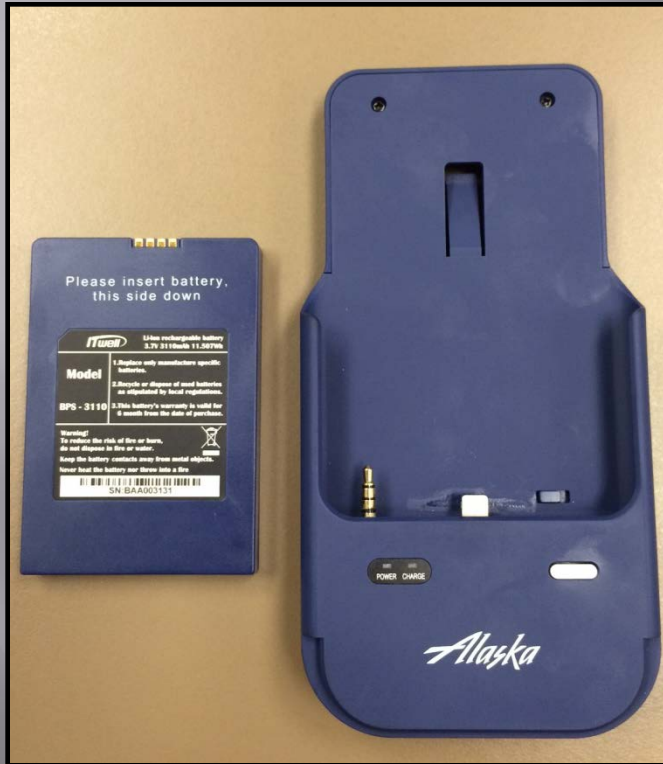
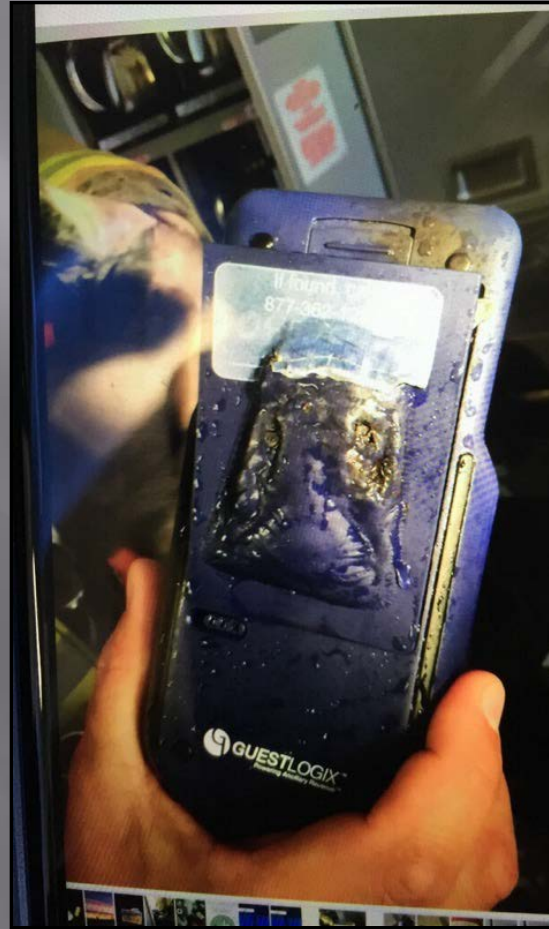
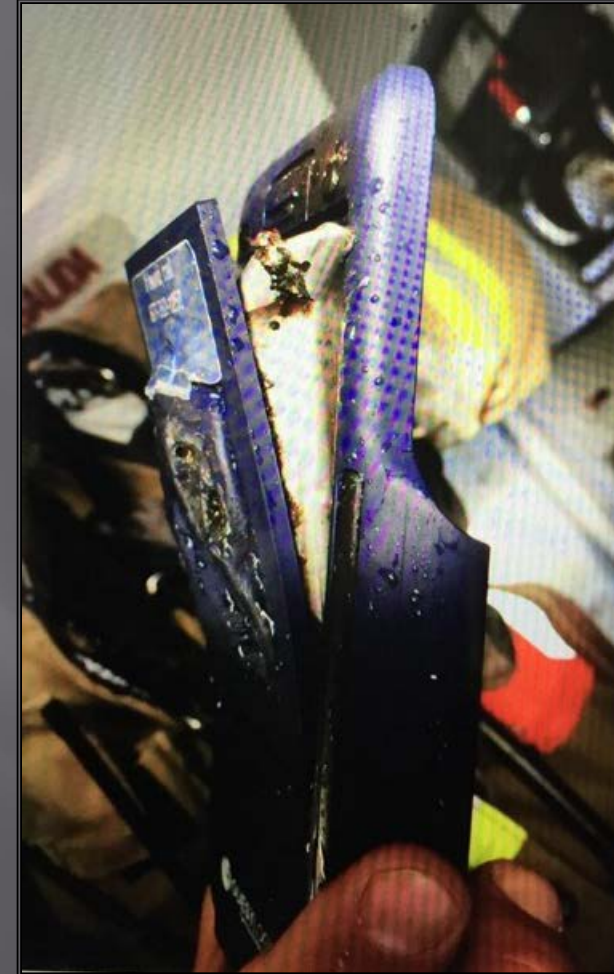
ASAA POS EVENT

October 12, 2015

SMOKE AFFECTED AREA

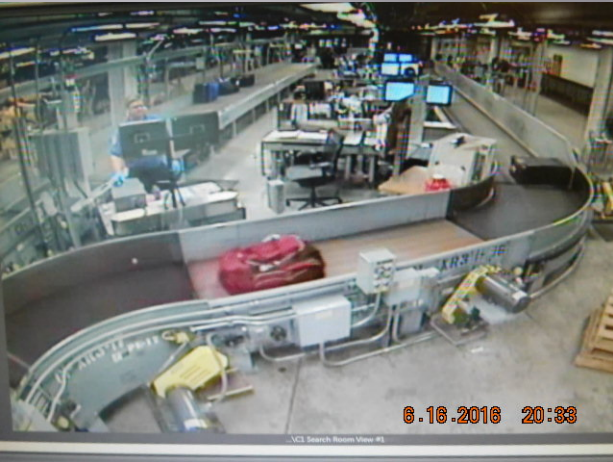
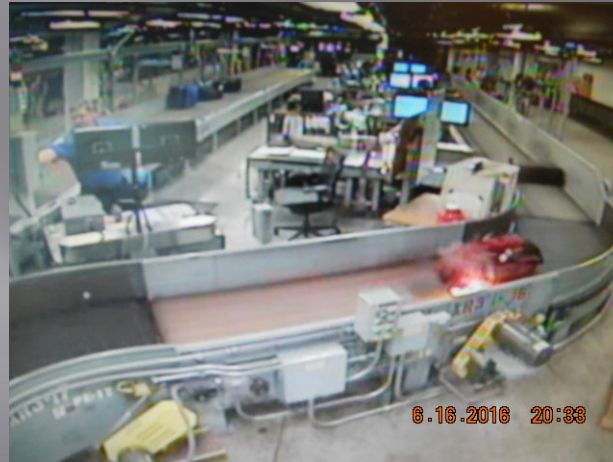
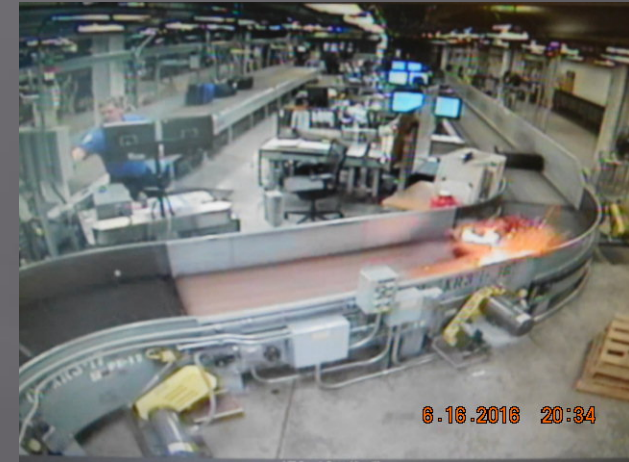
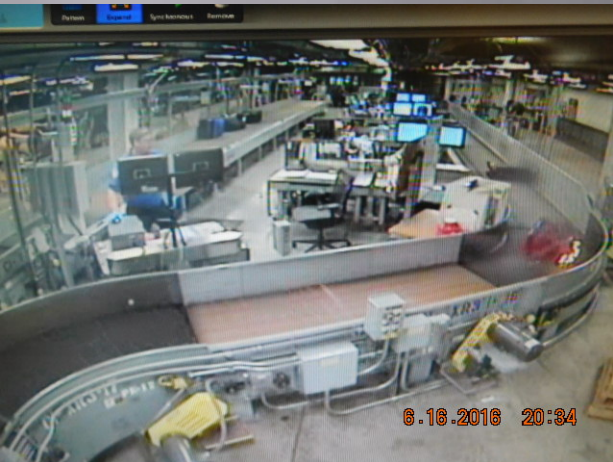
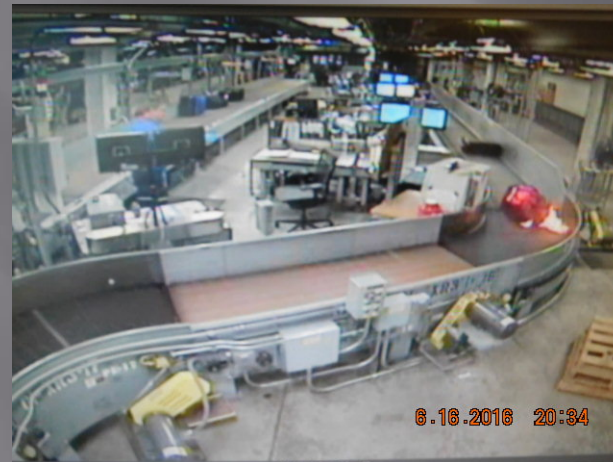
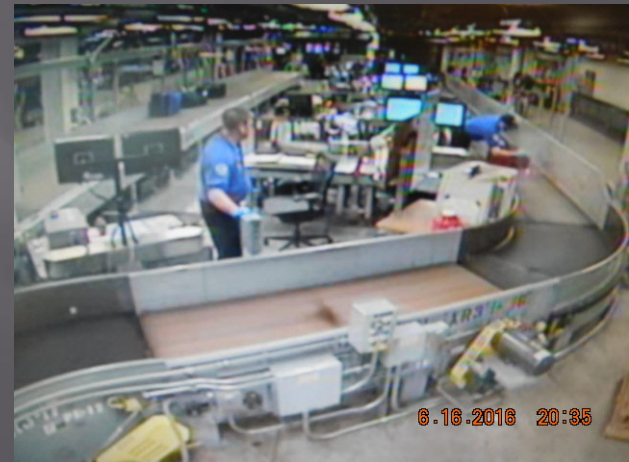
Incident One: JUNE 16, 2017 a 22 year old female passenger on ASAA

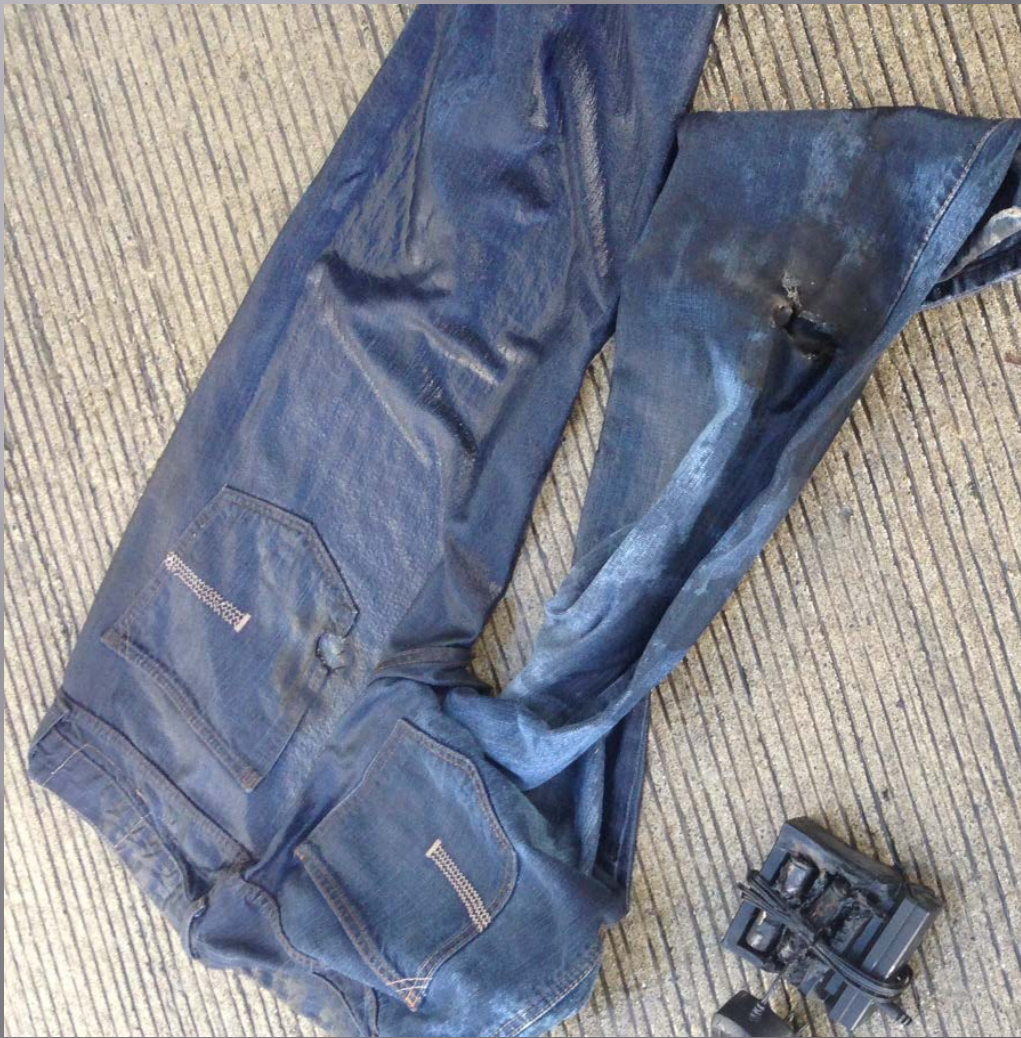
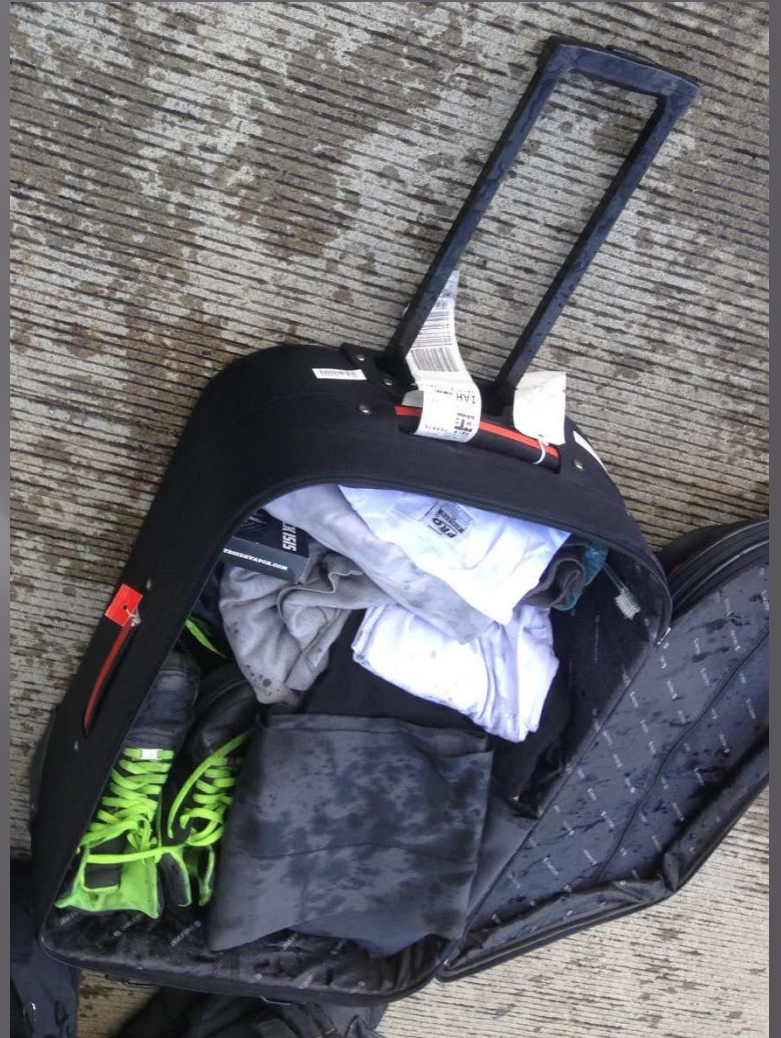
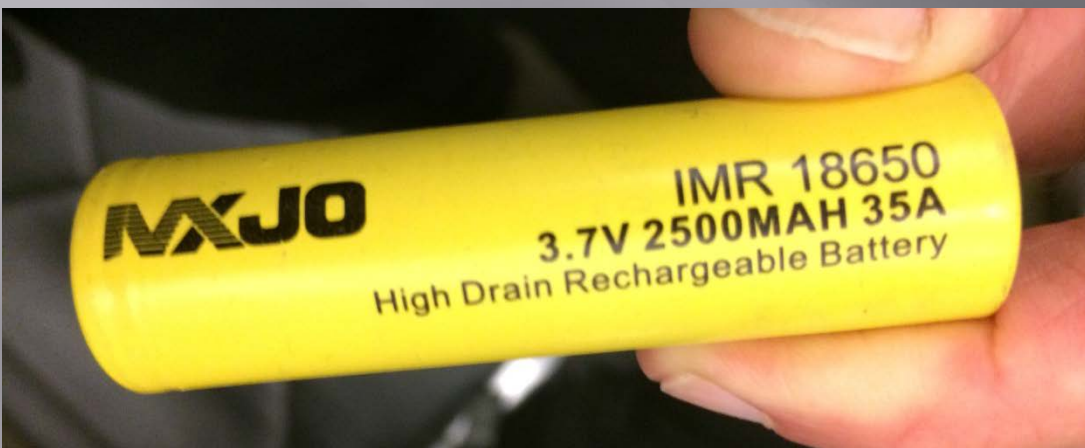
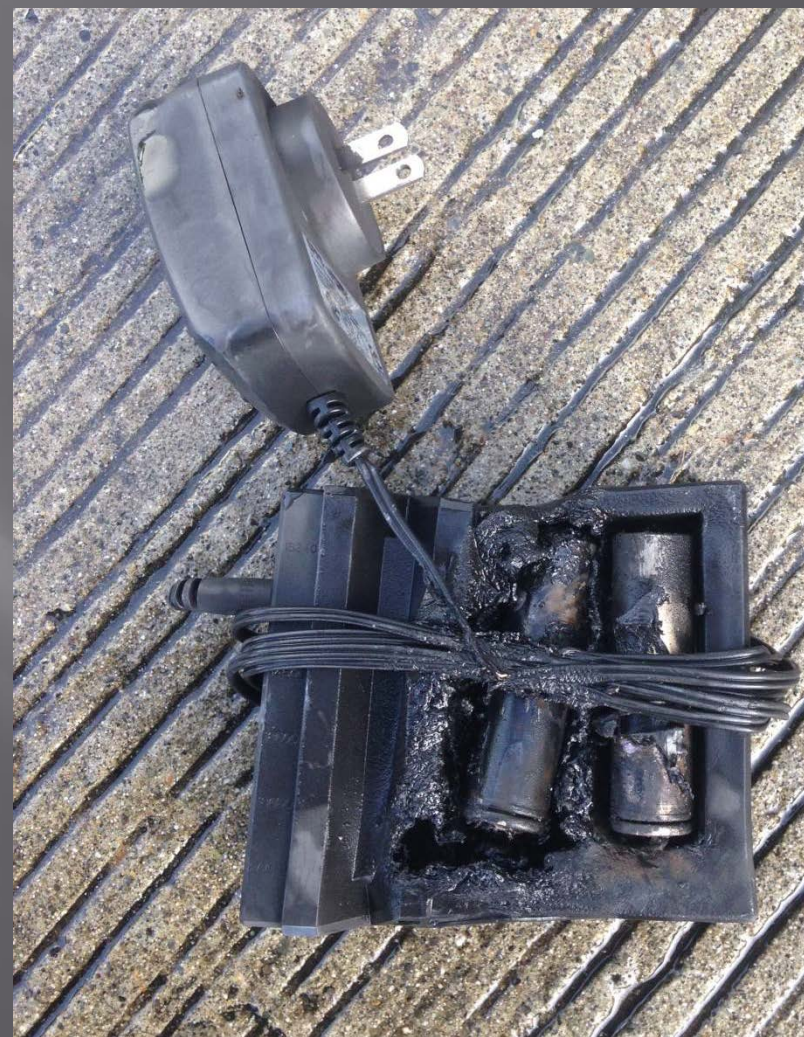
Incident Two: OCTOBER 23, 2016 a 28 year old male passenger on CALA

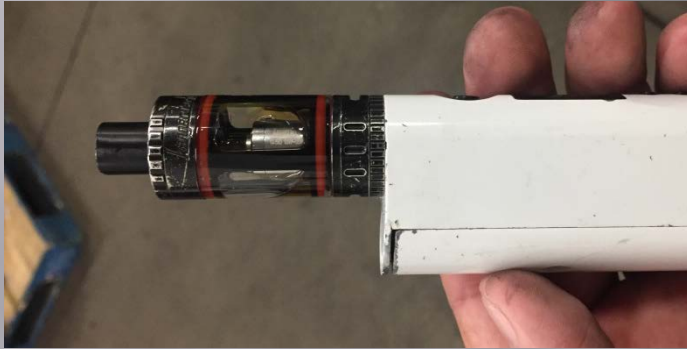
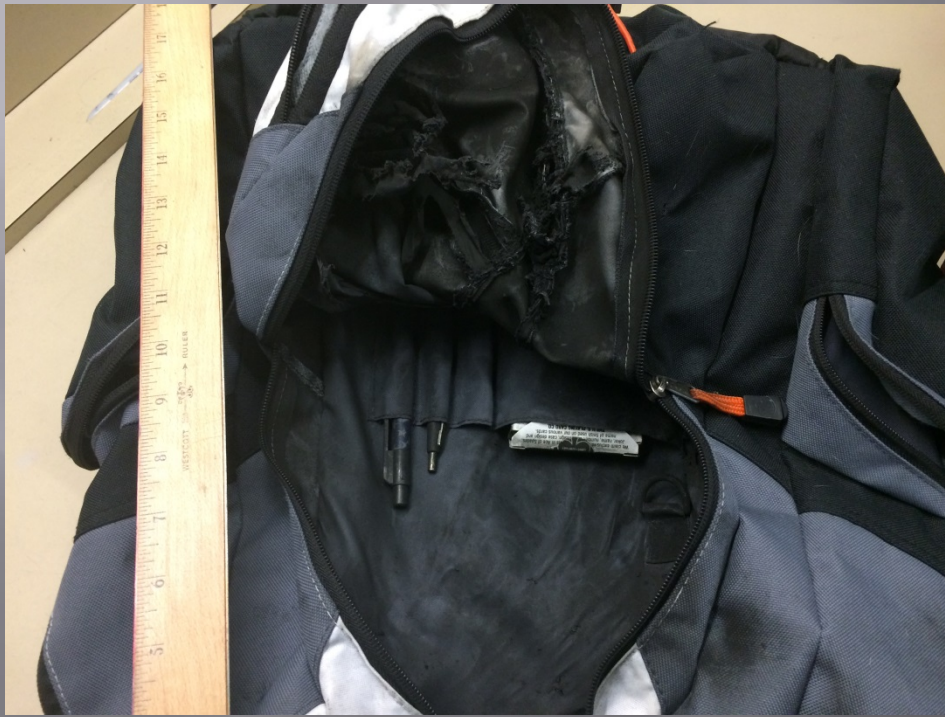
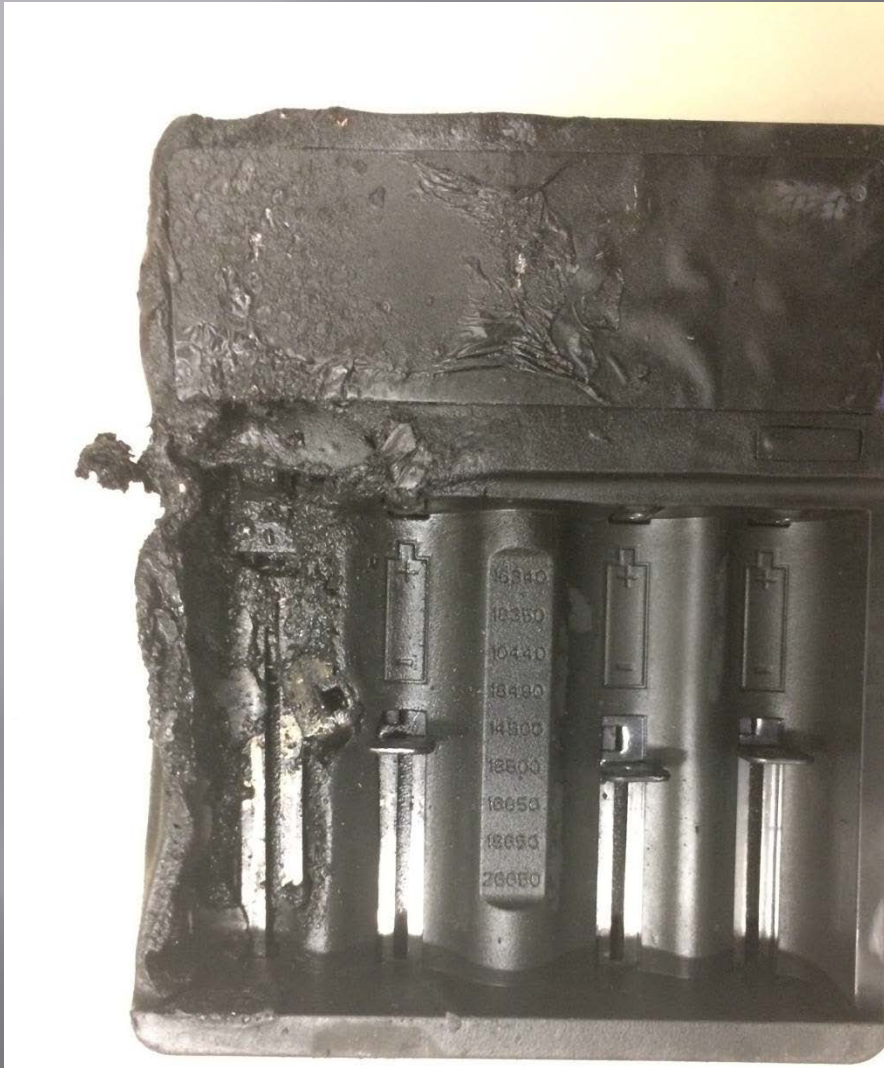
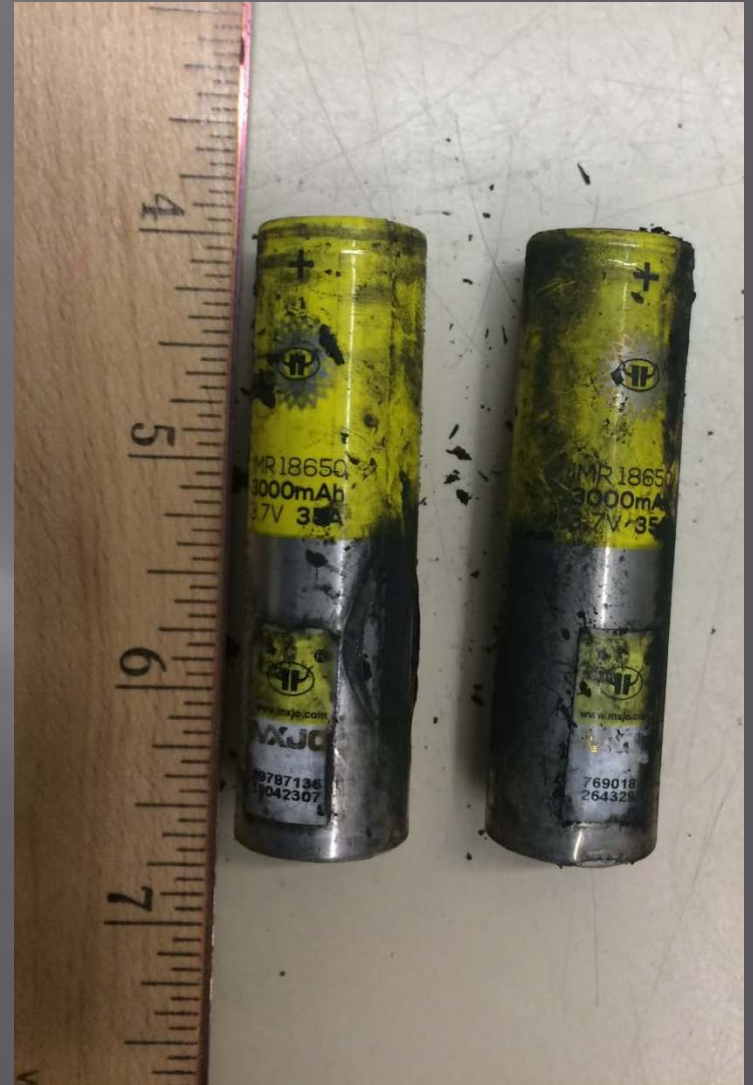
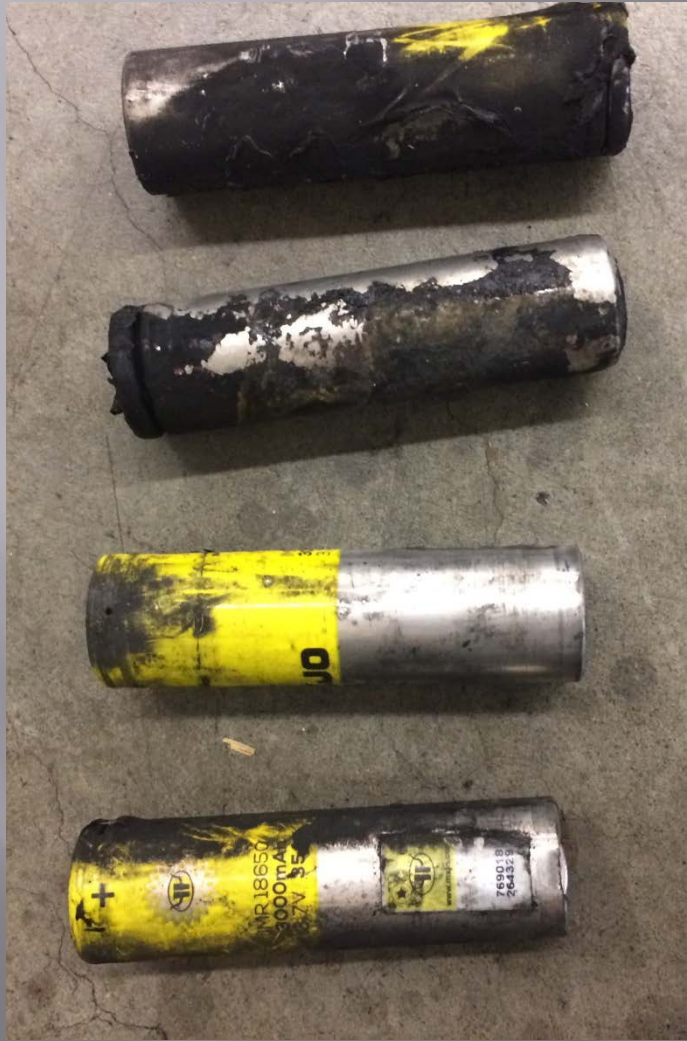
Incident Three: November 16, 2016 a 50 year old male passenger

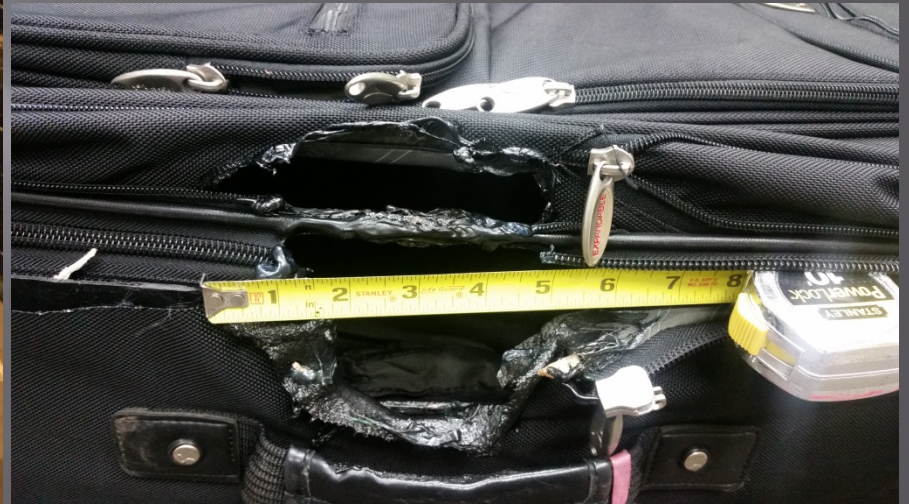
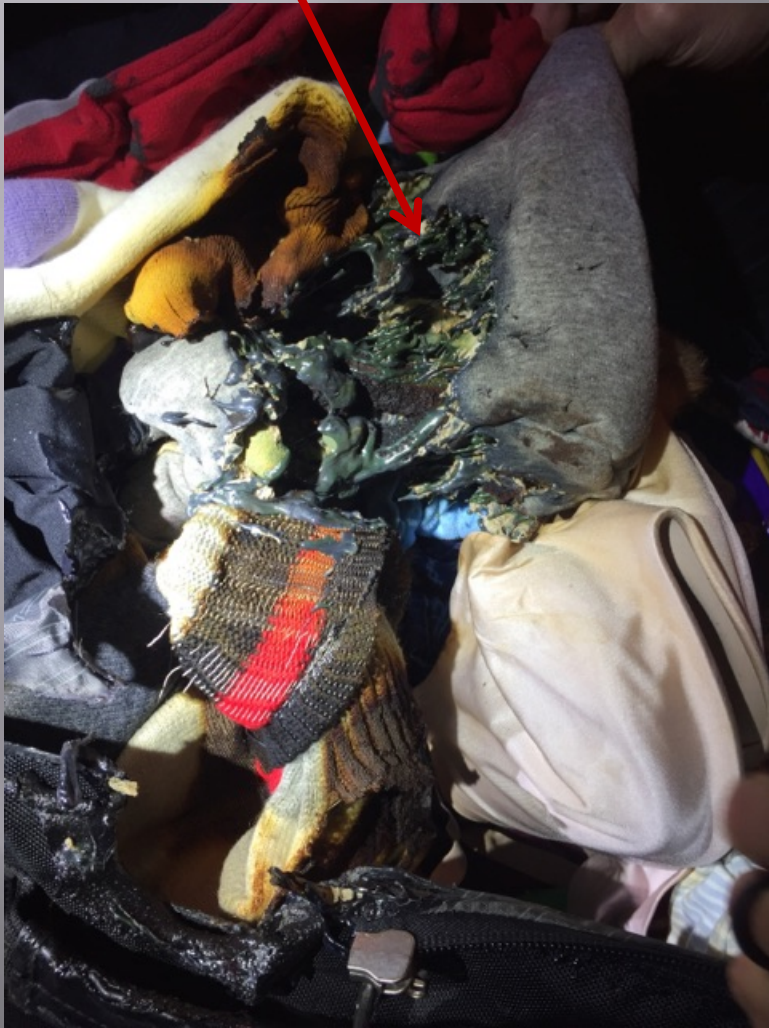
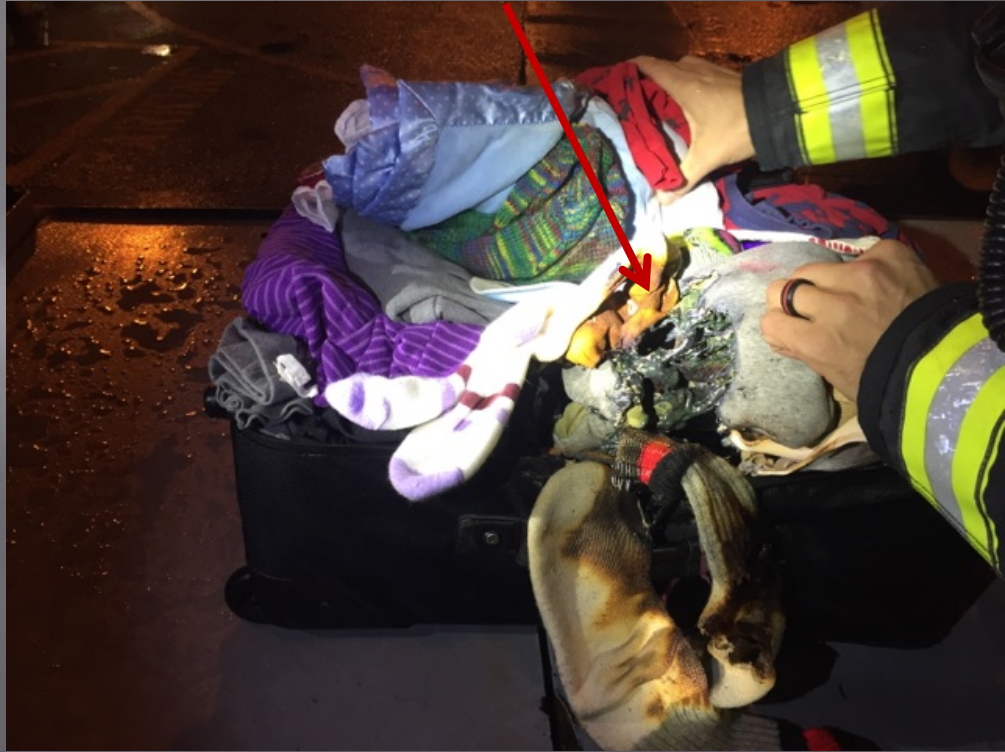
Incident Four: December 29, 2016 a unknown age female passenger

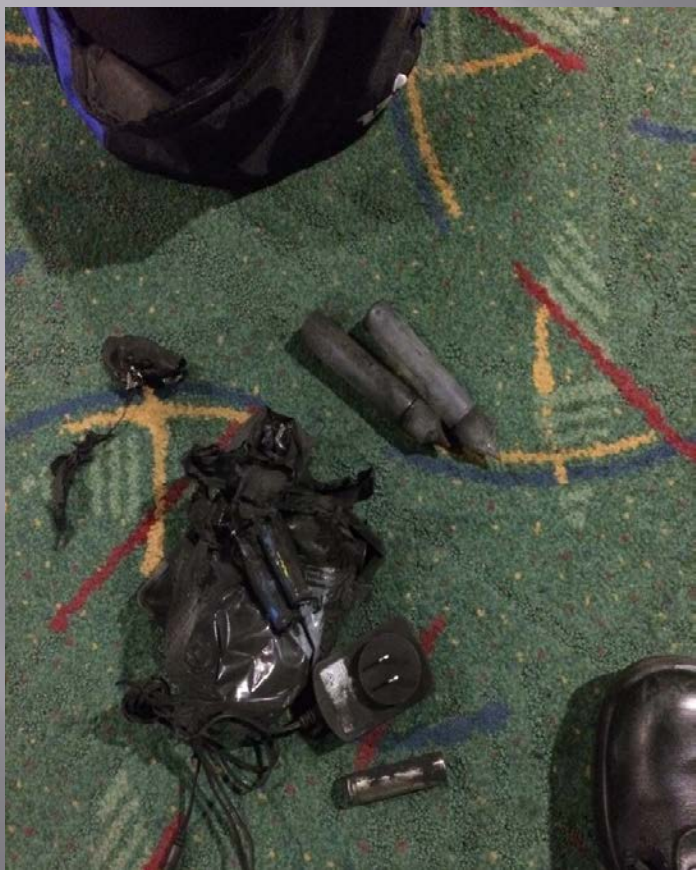
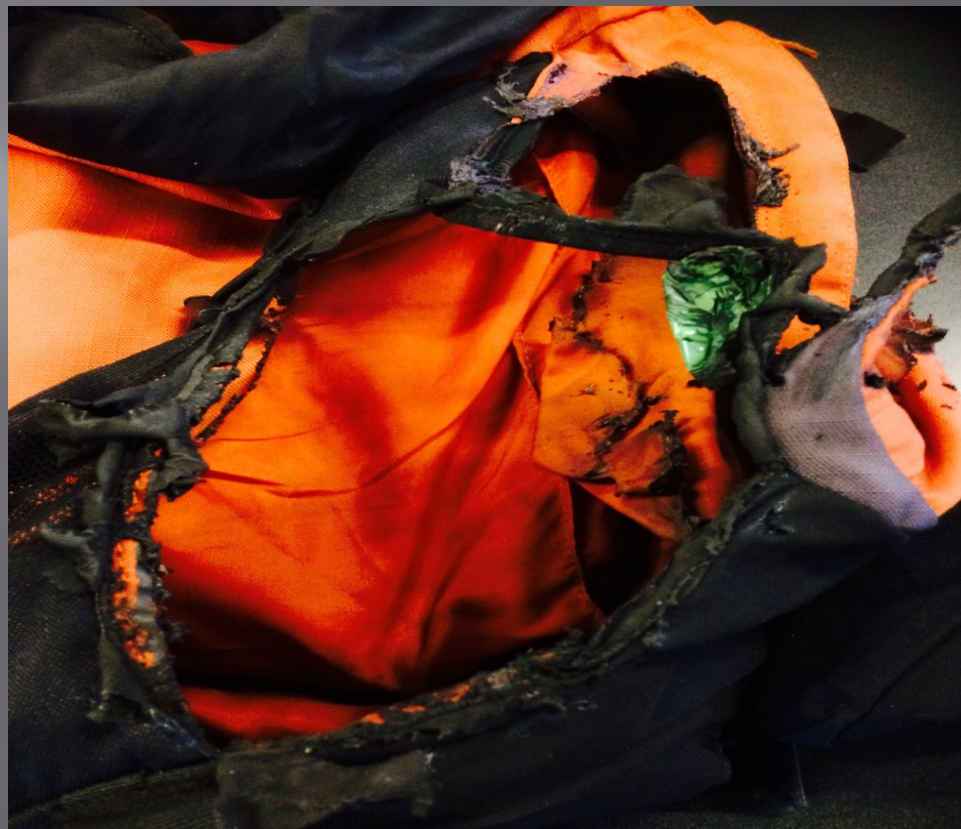
3 Unreported Incidents in PDX
